TEST REPORT

HANDLING OF SURPLUS PUBLIC FILL

TSEUNG KWAN O AREA 137 FILL BANK

MONTHLY EM&A REPORT NO.35

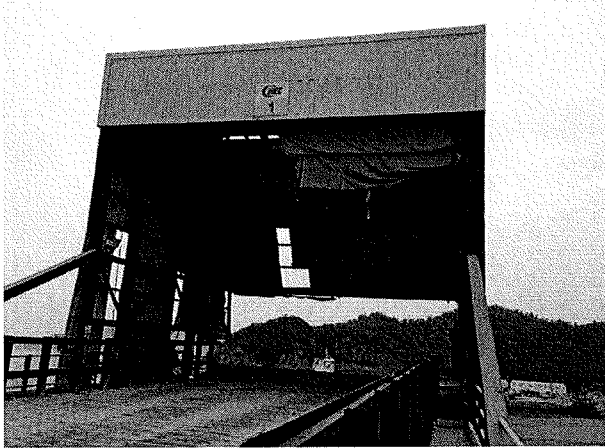
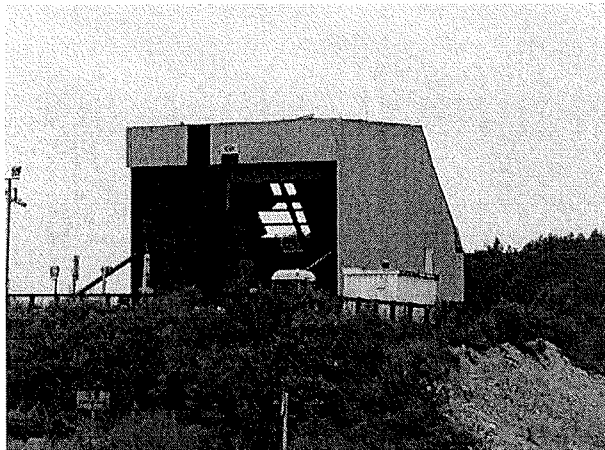
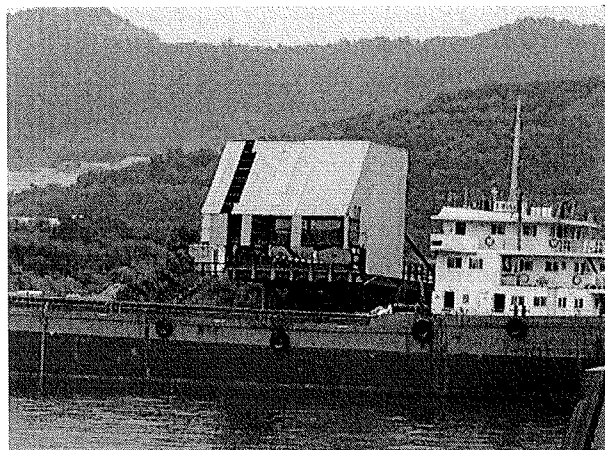
Photo 1 – Tipping Hall No.1

Tipping Hall No.1 to No.3 were damaged.
The Contractor should repair the damaged parts of tipping hall.

| Date | Key Findings | Action(s) Taken recommended by IEC | Action(s) Taken by the Contractor during the site audit | Rectification Status by IEC |
|---|--|---|---|---|
| 10 October 2012 | Tipping hall No.1 to No. 3 was damaged. (Previous item) | The Contractor was reminded to repair the damaged parts of tipping hall. | Tipping halls (No.1 to No.3) had been repaired. | Closed |

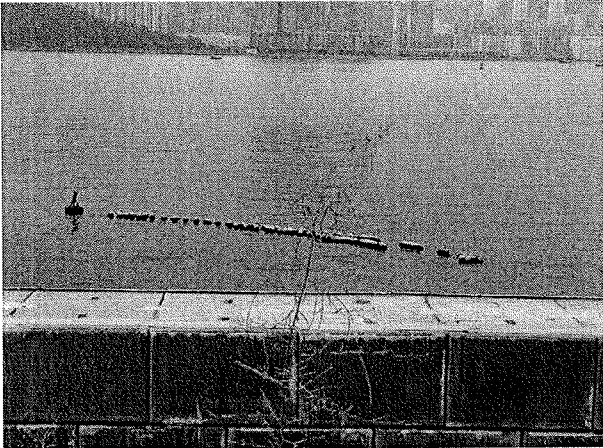
Photo 7

Silt curtain near Pier No.1 was not properly fixed.

The Contractor was reminded to provide silt curtain properly at TKOFB. **(Follow up)**

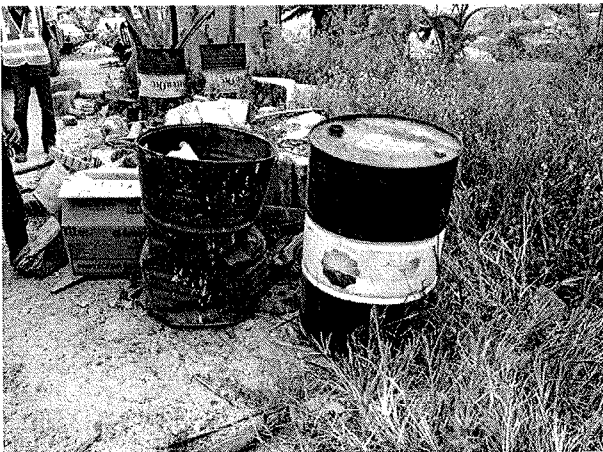
Photo 9

Poor housekeeping was observed at Tyre Workshop.

The Contractor was reminded to tidy up the area properly.

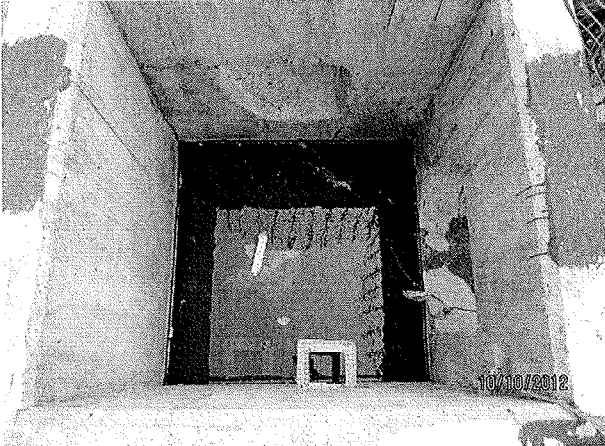
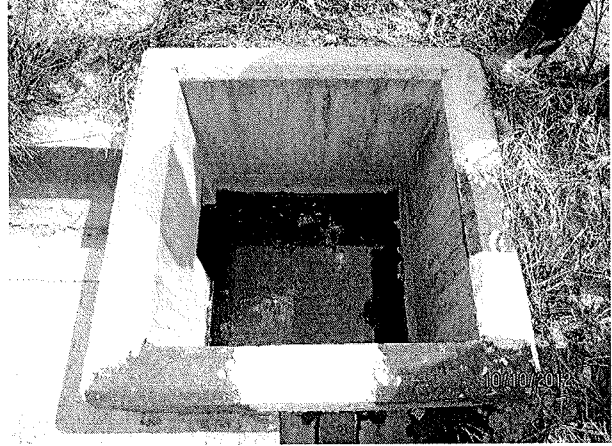
Photo 1 and 2

| Date | Key Findings | Action(s) Taken recommended by IEC | Action(s) Taken by the Contractor during the site audit | Rectification Status by IEC |
|---|--|---|---|---|
| | Turbid water and rubbish were found at catchpits at CREO. (New item) | The Contractor was reminded to properly maintain all drainage facilities at site. | --- | Follow-up |

The Contractor is reminded to properly maintain all drainage facilities at site.

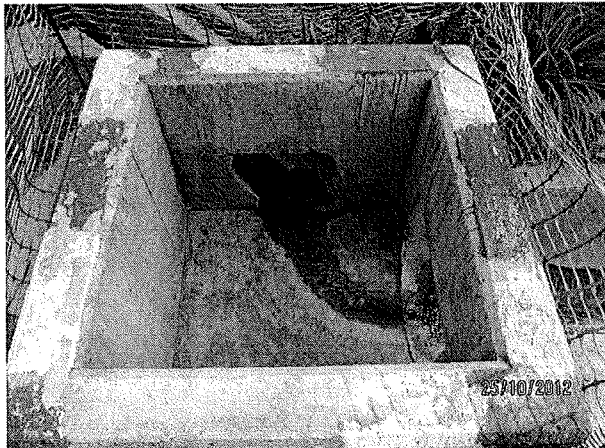
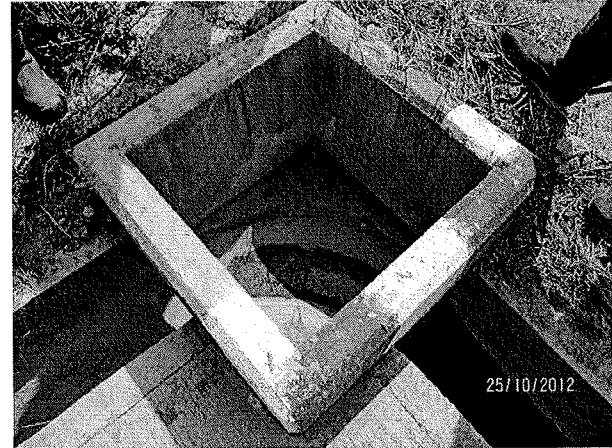
Photo 3 and 4

Catchpit had been temporarily filled to keep water running at u-channel. **(Closed)**

| Date | Key Findings | Action(s) Taken recommended by IEC | Action(s) Taken by the Contractor during the site audit | Rectification Status by IEC |
|---|--|---|---|---|
| | Turbid water and rubbish were found at catchpits at CREO. (Previous item) | The Contractor was reminded to properly maintain all drainage facilities at site. | Catchpit at CREO had been temporarily filled and kept water running at u-channel. | Closed |

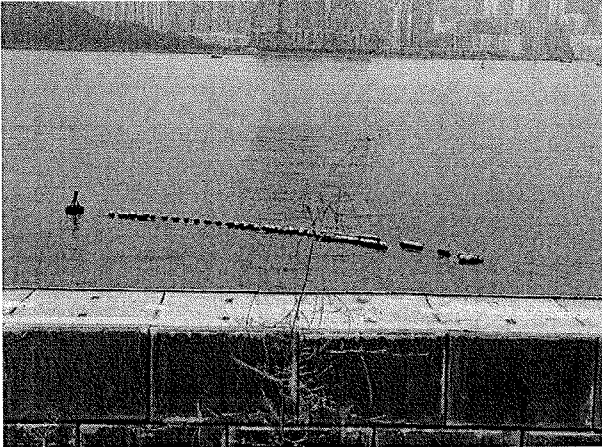
Photo 5
Silt Curtain
Silt curtain near Pier No.1 was not properly fixed.

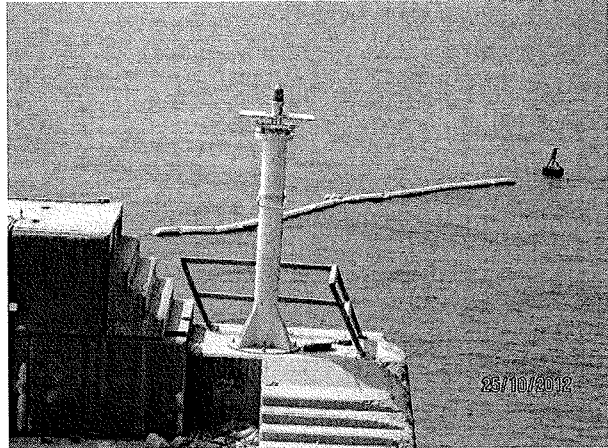
Photo 6
Silt Curtain
Silt curtain had been properly fixed near Pier No.1.
(Closed)

- Follow up action to the outstanding finding in the previous month, the silt curtain near tipping hall No.1 were repaired during the weekly site inspection on 25 October 2012;

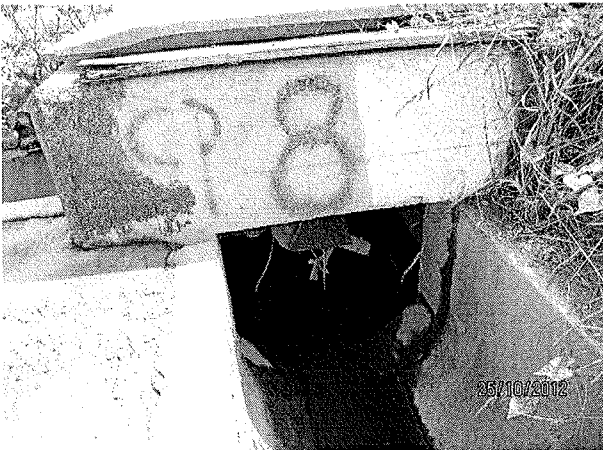
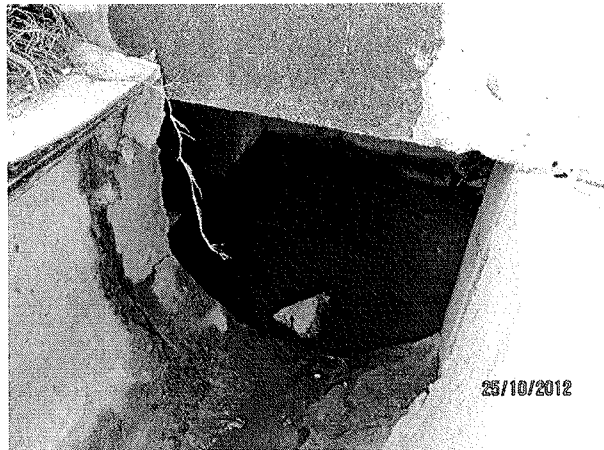
| Date | Key Findings | Action(s) Taken recommended by IEC | Action(s) Taken by the Contractor during the site audit | Rectification Status by IEC |
|---|--|---|---|---|
| | Deposition of silt and silty water were found at Catchpit No.8 at CREO. (New item) | The Contractor was reminded to frequently clean and maintain the catchpit. | --- | Follow-up |

Photo 7 and 8
Catchpit No.8
Deposition of silt and silty water are found at Catchpit No.8 at CREO.
The Contractor is reminded to frequently clean and maintain the catchpit.

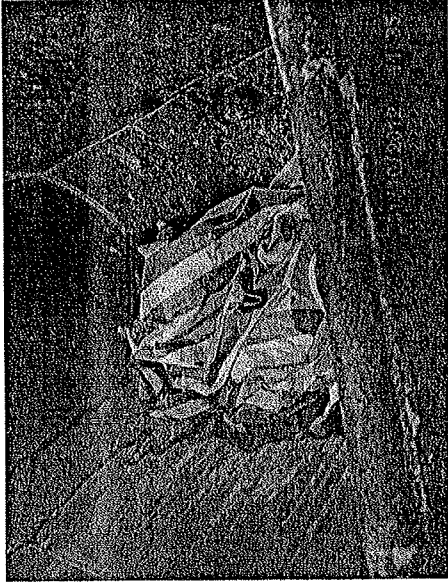
Photo 121031_002 (Near Chemical Waste Storage Area)

- Stagnant water was found inside the bucket of a repairing excavator near chemical waste storage area during the weekly site inspection on 31 October 2012. The Contractor was reminded to clear the stagnant water to avoid mosquito breeding. Since the finding was observed in the last weekly site inspection on 31 October 2012, it will be verified in the coming month.

- Rubbish was noted discarded inside the bucket of a repairing excavator near chemical waste storage area during the weekly site inspection on 31 October 2012. The Contractor was reminded to collect the rubbish and dispose of properly. Since the finding was observed in the last weekly site inspection on 31 October 2012, it will be verified in the coming month; and
- Sufficient rubbish skips had been provided at site by the Contractor in this reporting month.
