CONTRACT NO. CV/2009/02

HANDLING OF SURPLUS PUBLIC FILL

TSEUNG KWAN O AREA 137 FILL BANK

MONTHLY EM&A REPORT NO.38

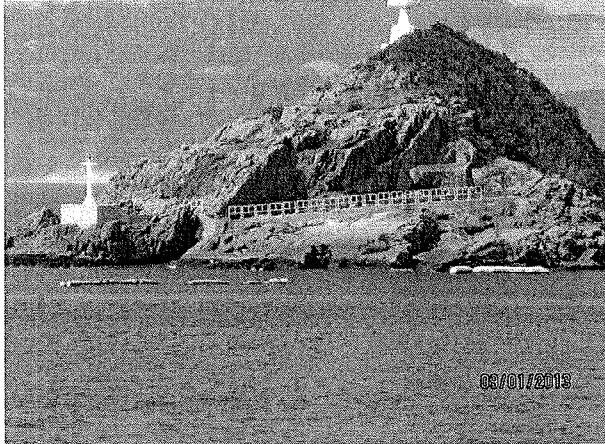
Photo 1

Silt Curtain

Silt curtain provided near the Contractor's office was found damaged.

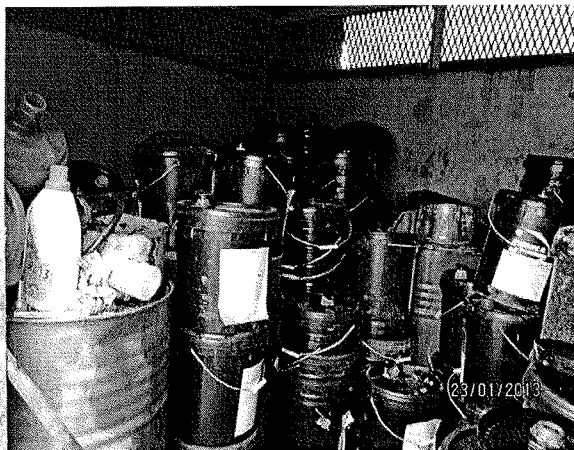
Photo 3

Workshop

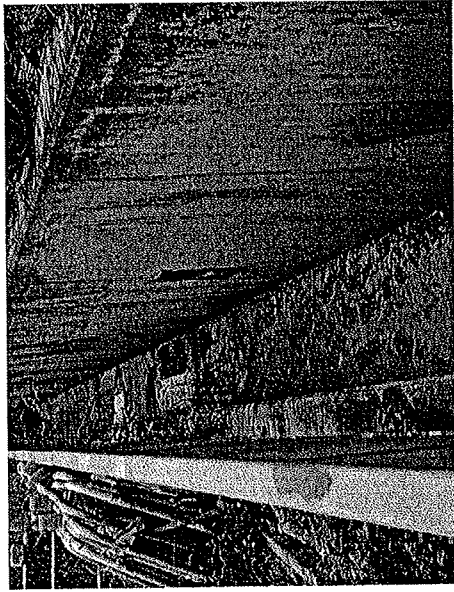
Photo 130109_001 (Contractor's site office)

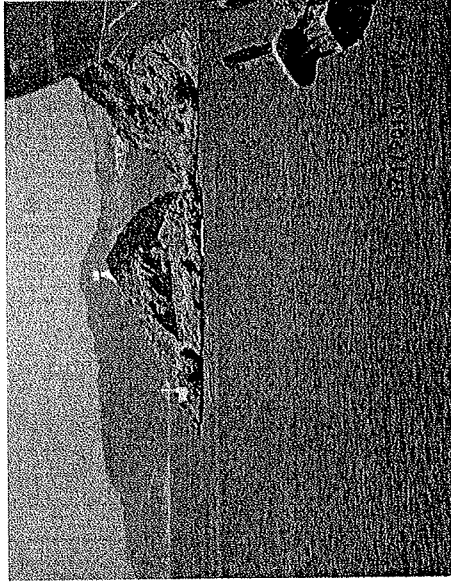
Photo 130109_002 (Sit curtain near the Contractor's site office)

Date	Key Findings	Action(s) Taken recommended by IEC	Action(s) Taken by the Contractor during the site audit	Rectification Status by IEC
09 January 2013	Silt curtain provided near the Contractor's office was found damaged. (New item)	The Contractor was requested to rectify this situation and fix the silt curtain properly at TKOFB.	---	Follow-up
23 January 2013	Silt curtain provided near the Contractor's office was found damaged. (Previous item)	The Contractor was requested to rectify this situation and fix the silt curtain properly at TKOFB.	---	Follow-up
	Oil containers were over accumulated at the chemical waste storage area. (New item)	The Contractor was reminded to carry out regular disposal of chemical wastes.	---	Follow-up

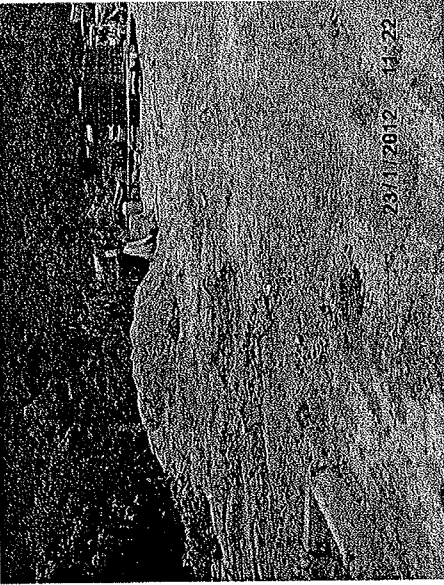
<p>Photo 130123_002 (Near chemical waste storage area) (Improved)</p>

Item	Details of defective works or observations	Proposed Follow Up Action	Photo Ref.	Further Action Required (Yes/No)	Target Completion Date
1	Follow action to the item 2 on 09/01/13 and item 1 on 16/01/13, the floating booms of silt curtain near Contractor's site office were still found damaged.	To repair the silt curtain as soon as possible.	130123_001	Yes	30/01/13
2	Follow action to the item 2 on 16/01/13, leaked oil noted near chemical waste storage area was cleared.	---	130123_002	No	---
