**TEST REPORT**

**HANDLING OF SURPLUS PUBLIC FILL**

**TSEUNG KWAN O AREA 137 FILL BANK**

**MONTHLY EM&A REPORT NO.39**

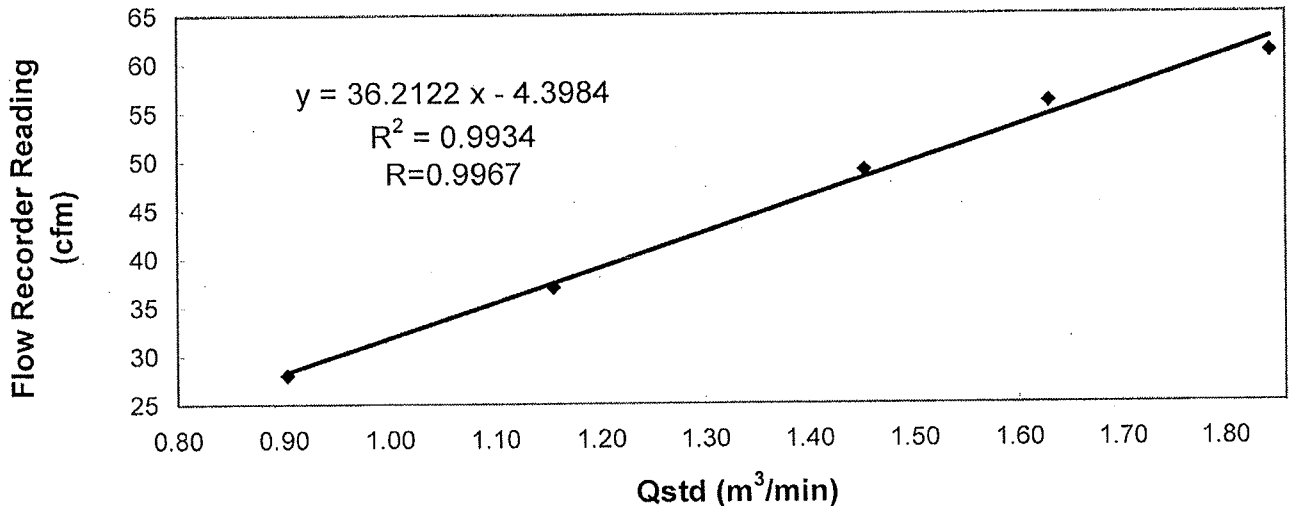
**Sampler 10581 Calibration Curve**  
Site: Tseung Kwan O A-1

Results	Flow recorder reading (cfm)	61	56	49	37	28
	Qstd (Actual flow rate, m <sup>3</sup> /min)	1.84	1.63	1.45	1.16	0.90
	Pressure :	763.56	mm Hg	Temp. :	289	K

Acceptance Criteria : Correlation coefficient (r) of the calibration curve greater than 0.990 after a 5-point calibration.

The high volume sampler complies\* / does not comply\* with the specified requirements and is deemed acceptable\* / unacceptable\* for use.

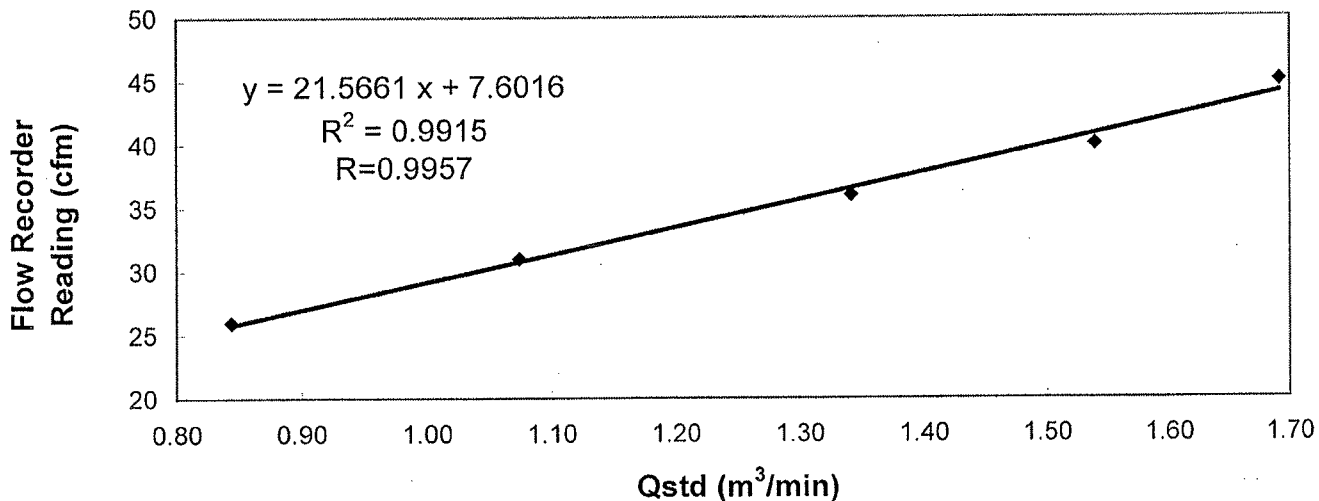
**Sampler 1172 Calibration Curve**  
Site: Tseung Kwan O A-2

Results	Flow recorder reading (cfm)	45	40	36	31	26
	Qstd (Actual flow rate, m <sup>3</sup> /min)	1.69	1.54	1.34	1.07	0.84
	Pressure :	763.56 mm Hg		Temp. :	289 K

Acceptance Criteria : Correlation coefficient (r) of the calibration curve greater than 0.990 after a 5-point calibration.

The high volume sampler complies\* / does-not-comply\* with the specified requirements and is deemed acceptable\* / unacceptable\* for use.

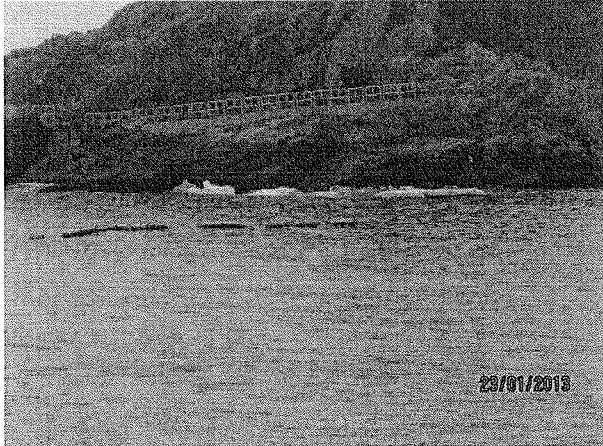
**Photo 1**

Silt Curtain

Silt curtain provided near the Contractor's office was found damaged.

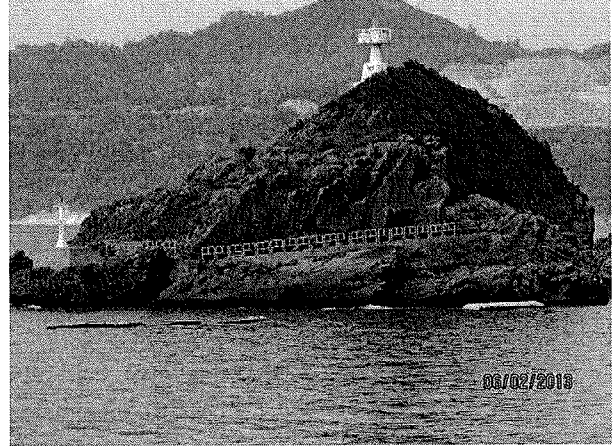
**Photo 2**

Silt Curtain

Silt curtain was still found damaged.

The Contractor was requested to rectify this situation and fix the silt curtain properly at TKOFB. **(Follow-up)**

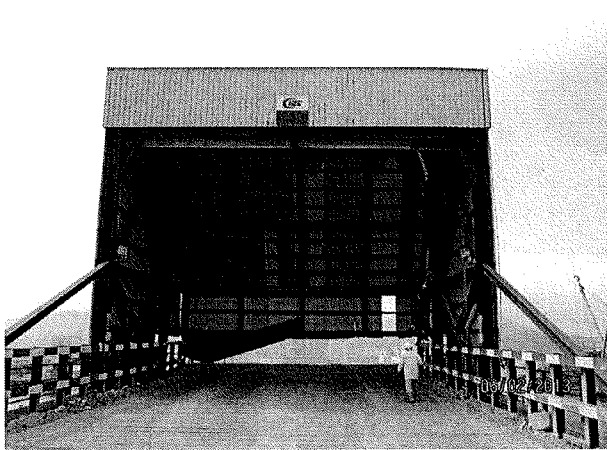
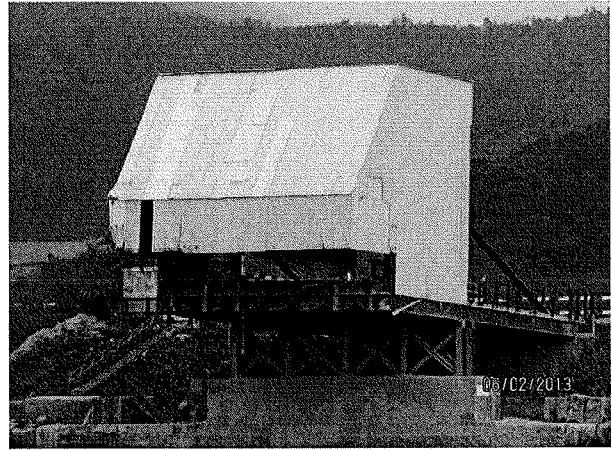
Photo 5 and 6

-obs① - Lowers of tipping hall no.3 were found damaged.

Tipping Hall No.3

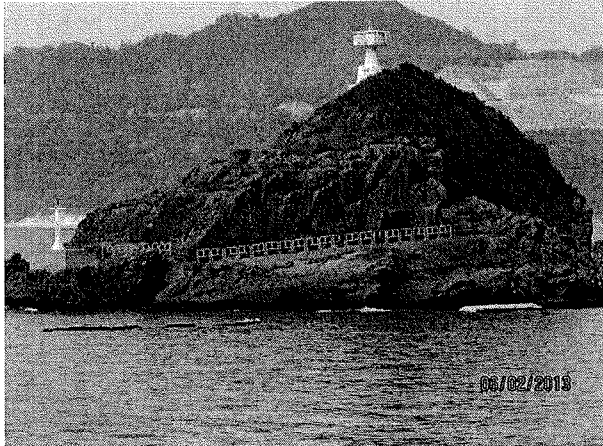
Photo 1

Silt Curtain

Silt curtain provided near the Contractor's office was found damaged.

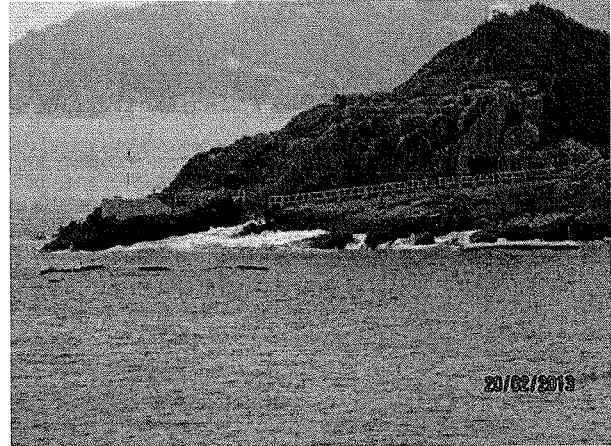
Photo 2

Silt Curtain

The Contractor was requested to rectify this situation and fix the silt curtain properly at TKOFB. **(Follow-up)**

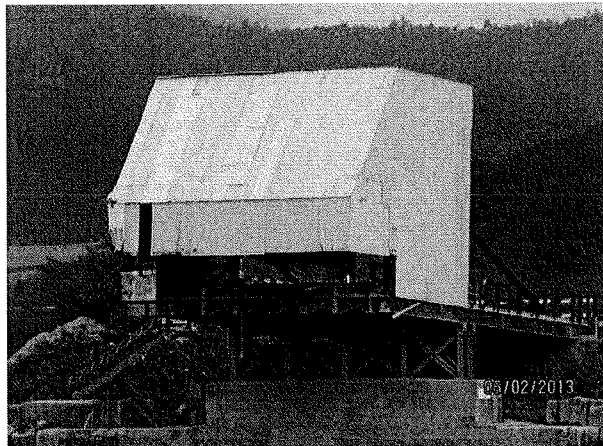
Photo 3

Tipping Hall No.3

Louvers of tipping hall were found damaged.

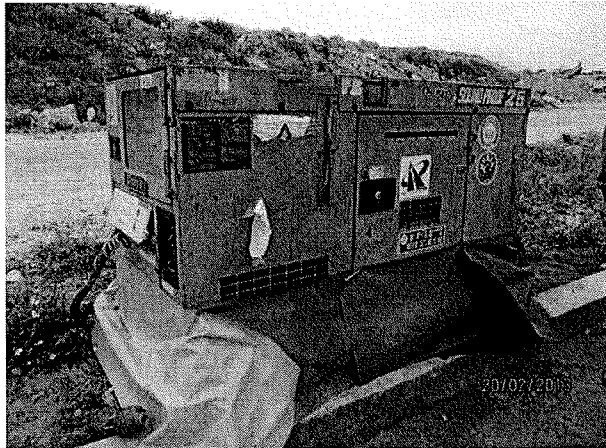
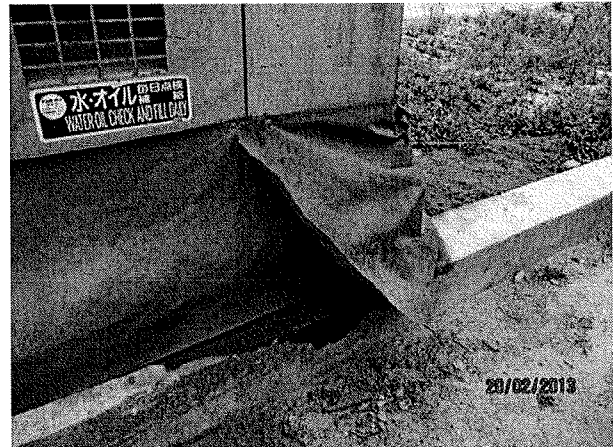
Photo 5 and 6

Workshop

Oil leakage was found at the drip tray for the generator.

The Contractor was reminded to avoid oil leakage from generator and drip tray.

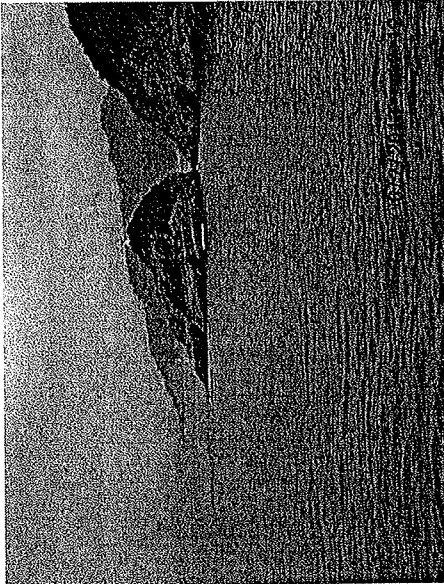
<p>Photo 130206_001 (Sit curtain near the Contractor's site office)</p>

Date	Key Findings	Action(s) Taken recommended by ET	Action(s) Taken by the Contractor during the site audit	Rectification Status by IEC
06 February 2013	Some floating booms of silt curtain near Contractor's site office were found damaged. (Previous item)	The Contractor was requested to repair the silt curtain as soon as possible.	---	Follow-up
	Idle oil buckets were discarded at worker's rest area near check point. (Previous item)	To collect and store / dispose of the oil buckets properly.	Idle oil buckets discarded at worker's rest area near check point were collected.	Closed
	Skirt curtain for a generator at work shop was broken. (Previous item)	To replace the new skirt curtain.	New skirt curtain was used properly.	Closed
	The enclosure of tipping hall No.3 was broken. (New item)	To repair the damaged part of tipping hall properly.	---	Follow-up
14 February 2013	Some floating booms of silt curtain near Contractor's site office were found damaged. (Previous item)	The Contractor was requested to repair the silt curtain as soon as possible.	---	Follow-up

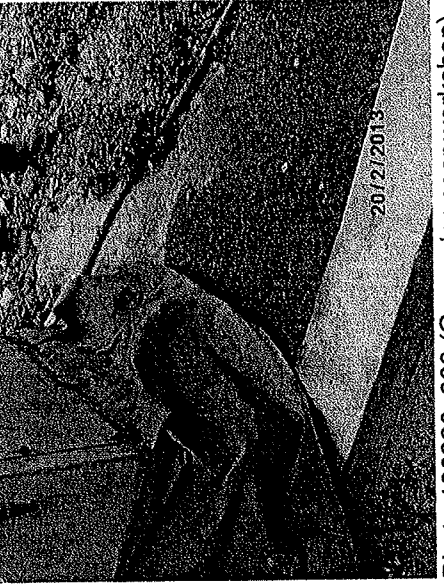
<p>Photo 130220_003 (Generator near workshop)</p>

Louvers of tipping hall were found damaged. (New item)	The Contractor should repair the damaged part of tipping hall.	---	Follow-up
	Oil leakage was found at the drip tray for the generator at workshop (New item)	The Contractor was reminded to avoid oil leakage for generator and drip tray.	---	Follow-up

The Contractor should provide sufficient preventive measures during equipment maintenance works so as to avoid oil leakage on the ground. In the event of any oil leakage, the Contractor should clean up the polluted soil and handle all the materials used for this cleaning works as chemical waste.

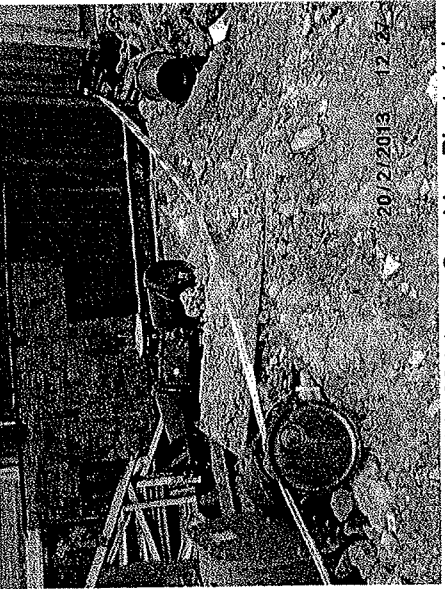
<p>Photo 130220_004 (near Crushing Plant at dry soil deposition area in Section A4)</p>

Date	Key Findings	Action(s) Taken recommended by IEC	Action(s) Taken by the Contractor during the site audit	Rectification Status by IEC
20 February 2013	Oil containers were discarded on the ground near crushing plant. (New item).	The Contractor was reminded to dispose of properly for the emptied oil container.	---	Follow-up

Date	Key Findings	Action(s) Taken recommended by ET	Action(s) Taken by the Contractor during the site audit	Rectification Status by IEC
20 February 2013	Idle oil buckets were discarded near the crushing plant at dry soil deposition area in Section A4. (New item)	The Contractor was reminded to collect and store / dispose of the oil buckets properly.	---	Follow-up
25 February 2013	Some floating booms of silt curtain near Contractor's site office were found damaged. (Previous item)	The Contractor was requested to repair the silt curtain as soon as possible.	---	Follow-up
	The enclosure of tipping hall No.3 was broken. (Previous item)	The Contractor was reminded to repair the damaged part of tipping hall properly.	---	Follow-up
	Oil leakage was noted from a generator near work shop. (Previous item)	The Contractor was reminded to clean up the leaked oil and contaminated materials as chemical waste and cover the ground with impermeable sheet properly.	Oil leaked from a generator near work shop was cleaned up.	Closed
