TEST REPORT

HANDLING OF SURPLUS PUBLIC FILL

TSEUNG KWAN O AREA 137 FILL BANK

MONTHLY EM&A REPORT NO.47

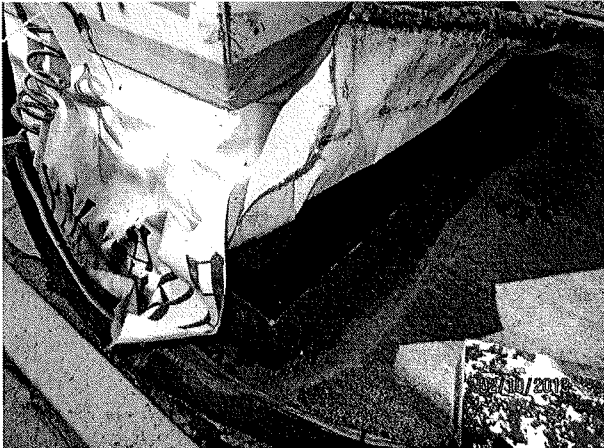
Photo 1

Site Office

Water is accumulated inside the drip tray.

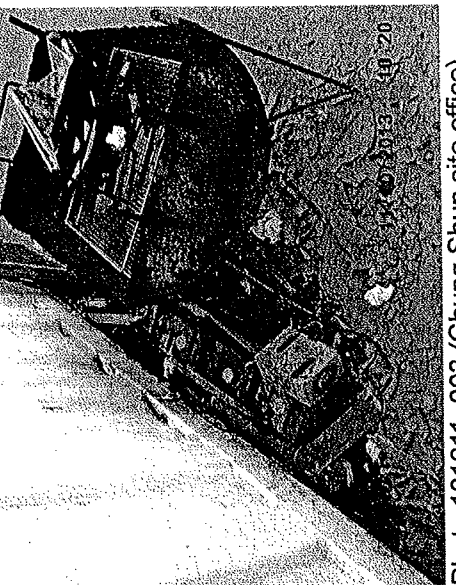
<p>Photo 131011_003 (Chung Shun site office)</p>

C&D waste (e.g. metals) was discarded at Chung Shun site office. (New item)	To collect and store / dispose of the waste properly.	---	Follow-up
	Oil leakage was noted from a generator near weighbridge. (New item)	To clear and treat the leaked oil and contaminated materials as chemical waste.	---	Follow-up
	The floating booms of silt curtain near the tipping hall No.1 were found damaged. (New item)	To repair the silt curtain as soon as possible.	---	Follow-up
18 October 2013	Mud and silt were noted accumulated inside the drainage near temporary construction waste sorting facility. (Previous item)	To clear the accumulated mud and silt and maintain the drainage properly.	Mud and silt noted accumulated inside the drainage near temporary construction waste sorting facility were cleaned.	Closed
	C&D waste (e.g. metals) was discarded at Chung Shun site office. (Previous item)	To collect and store / dispose of the waste properly.	C&D waste discarded at Chung Shun site office was collected.	Closed

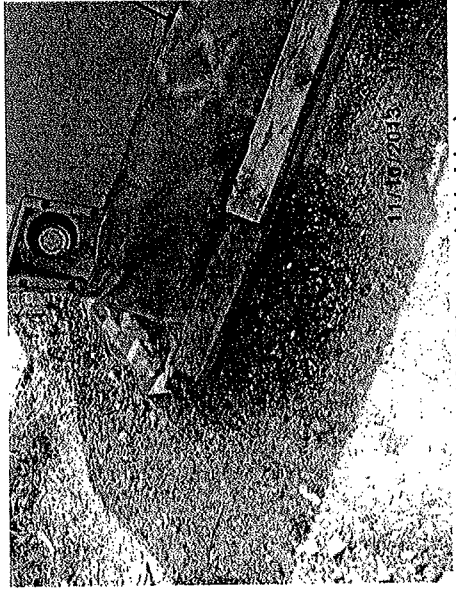
<p>Photo 131011_004 (Near weighbridge)</p>

Oil leakage was noted from a generator near weighbridge. (Previous item)	To clear and treat the leaked oil and contaminated materials as chemical waste.	Oil leakage noted from a generator near weighbridge was cleaned and treated.	Closed
	The floating booms of silt curtain near the tipping hall No.1 were found damaged. (Previous item)	To repair the silt curtain as soon as possible.	---	Follow-up
	Chemical storage area was not tidy enough. (New item)	The Contractor was reminded to improve and keep tidy of the chemical storage area.	---	Follow-up

The Contractor should provide sufficient preventive measures during equipment maintenance works so as to avoid oil leakage on the ground. In the event of any oil leakage, the Contractor should clean up the polluted soil and handle all the materials used for this cleaning works as chemical waste.

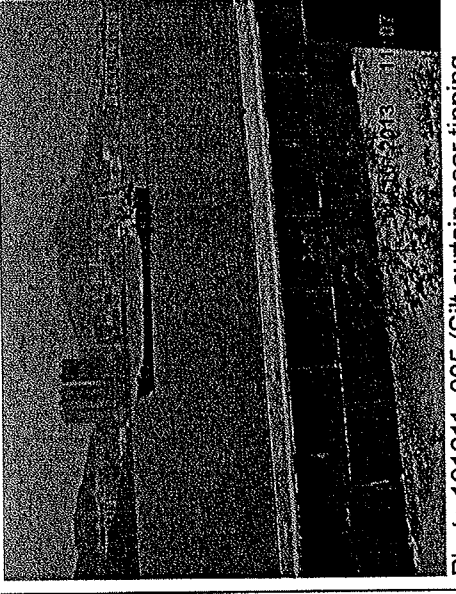
<p>Photo 131011_005 (Silt curtain near tipping No.1)</p>

Date	Key Findings	Action(s) Taken recommended by ET	Action(s) Taken by the Contractor during the ET weekly site audit	Rectification Status by ET
23 October 2013	The floating booms of silt curtain near the tipping hall No.1 were found damaged. (Previous item)	To repair the silt curtain as soon as possible.	---	Follow-up
	Chemical storage area was not tidy enough. (Previous item)	The Contractor was reminded to improve and keep tidy of the chemical storage area.	Chemical storage area was improved.	Closed
	Tipping hall No. 2 was found damaged. (New item)	To repair the tipping hall as soon as possible.	---	Follow-up
30 October 2013	The floating booms of silt curtain near the tipping hall No.1 were found damaged. (Previous item)	To repair the silt curtain as soon as possible.	---	Follow-up
	Tipping hall No. 2 was found damaged. (Previous item)	To repair the tipping hall as soon as possible.	---	Follow-up
