CONTRACT NO. CV/2009/02

HANDLING OF SURPLUS PUBLIC FILL

TSEUNG KWAN O AREA 137 FILL BANK

MONTHLY EM&A REPORT NO.49

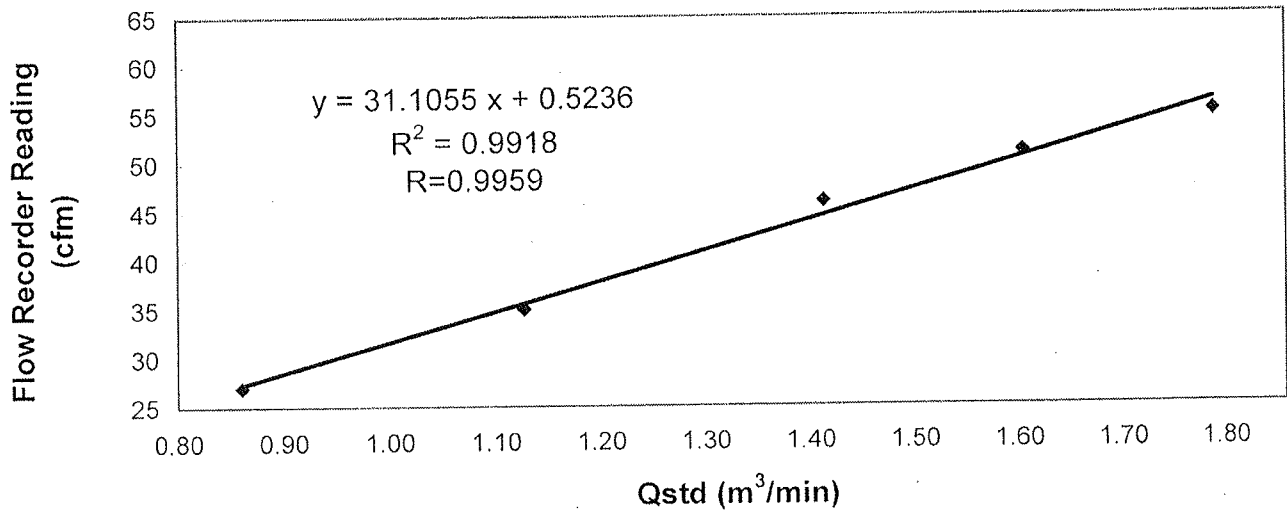
**Sampler 10581 Calibration Curve
 Site: Tseung Kwan O A-1**

Flow recorder reading (cfm)	55	51	46	35	27
Qstd (Actual flow rate, m ³ /min)	1.79	1.60	1.41	1.13	0.86
Pressure :	763.56	mm Hg	Temp. :	298	K

Acceptance Criteria : Correlation coefficient (r) of the calibration curve greater than 0.990 after a 5-point calibration.

The high volume sampler complies* / does-not-comply* with the specified requirements and is deemed acceptable* / unacceptable* for use.

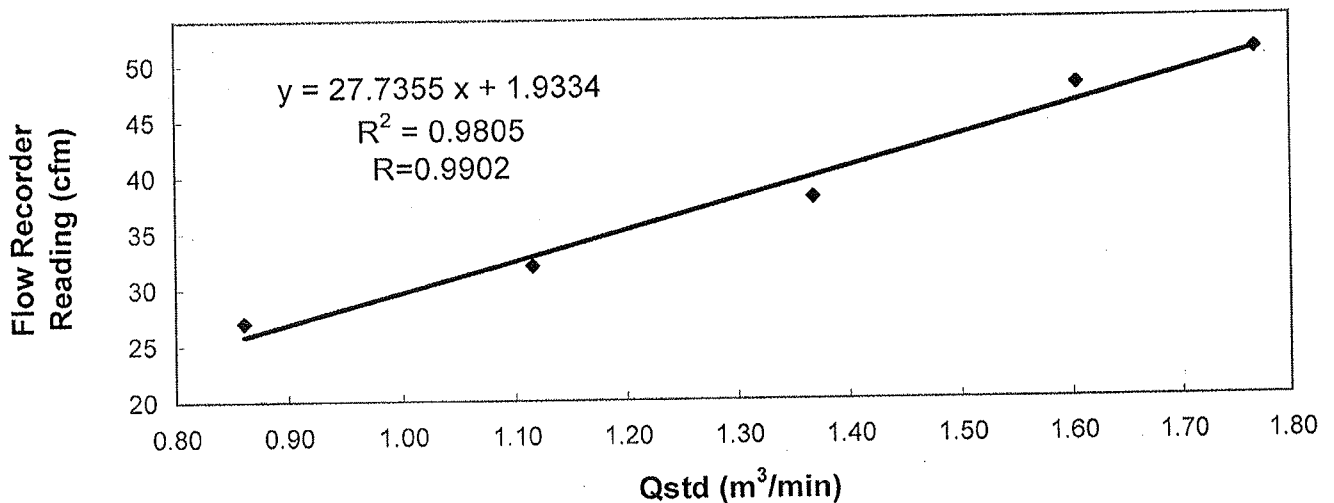
Sampler 1172 Calibration Curve
Site: Tseung Kwan O A-2

Results	Flow recorder reading (cfm)	51	48	38	32	27
	Qstd (Actual flow rate, m ³ /min)	1.77	1.60	1.37	1.12	0.86
	Pressure :	763.56	mm Hg	Temp. :	298	K

Acceptance Criteria : Correlation coefficient (r) of the calibration curve greater than 0.990 after a 5-point calibration.

The high volume sampler complies* / does not comply* with the specified requirements and is deemed acceptable* / unacceptable* for use.

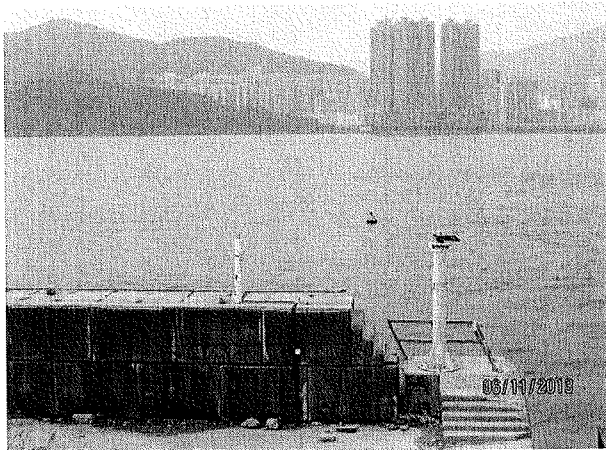
Photo 1

Silt Curtain

Silt curtain near the Tipping Hall No.1 is damaged.
The Contractor is reminded to replace the damaged silt curtain as soon as possible.

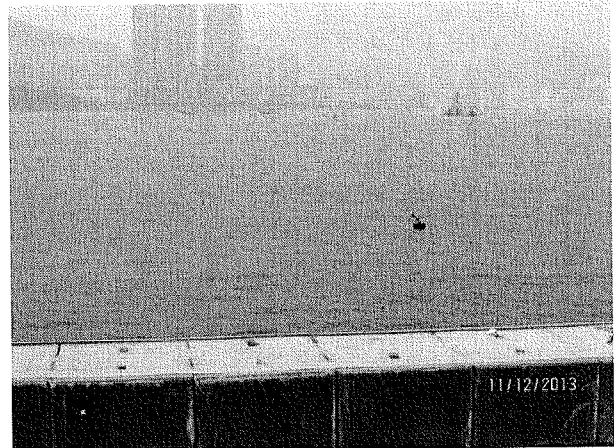
Photo 2

Silt Curtain

Silt curtain is still pending for rectification.
(Follow-up)

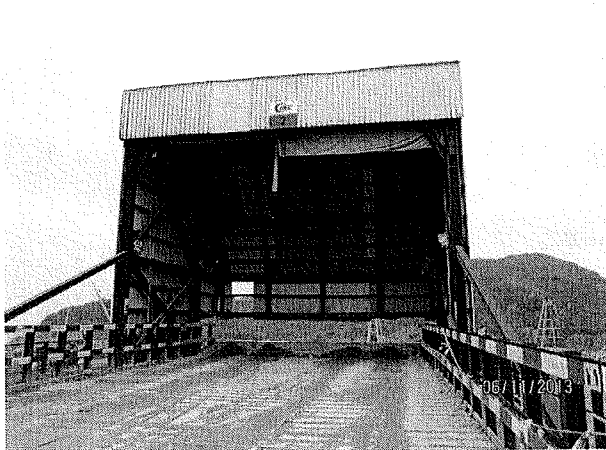
Photo 3

Tipping Hall No.2

Cladding of tipping hall is damaged.
The Contractor is reminded to repair the damaged part of tipping hall.

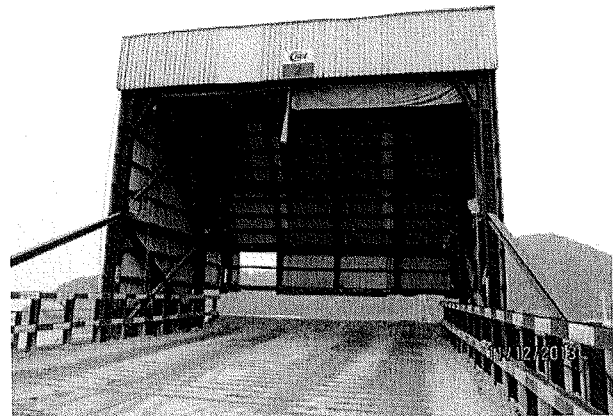
Photo 4

Tipping Hall No.2

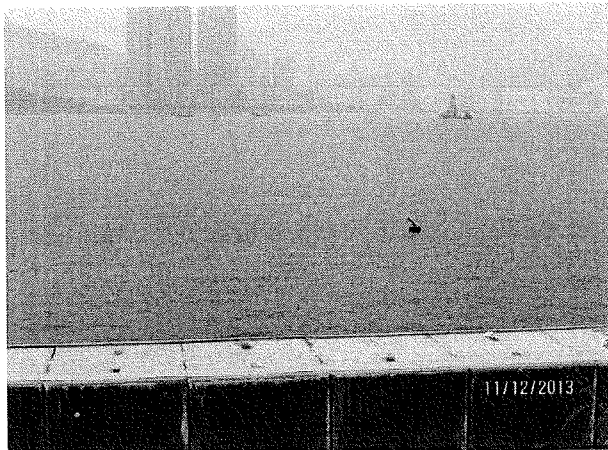
Photo 1

Silt Curtain

Silt curtain near the Tipping Hall No.1 is damaged.
The Contractor is reminded to replace the damaged silt curtain as soon as possible.

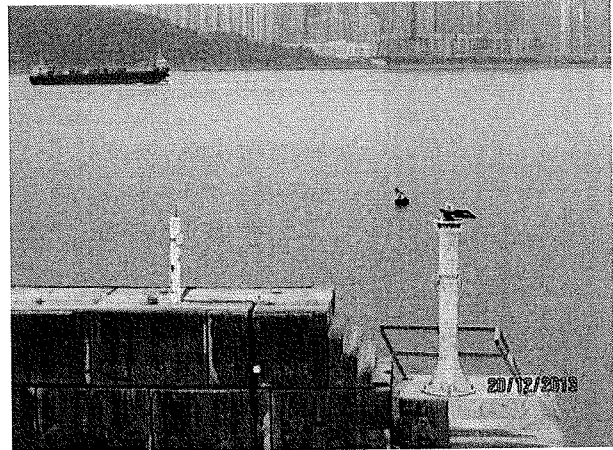
Photo 2

Silt Curtain

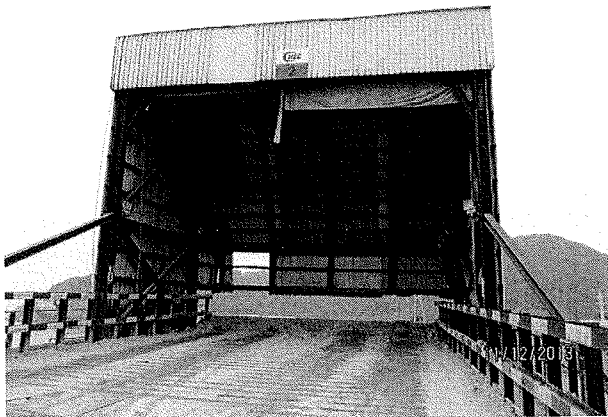
Photo 3

Silt curtain is still pending for rectification.
(Follow-up)

Tipping Hall No.2

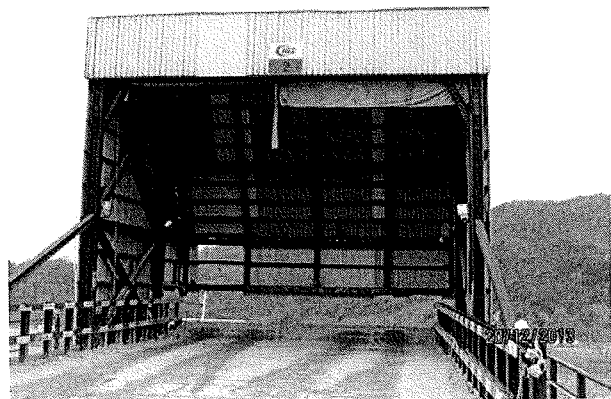
Photo 4

Cladding of tipping hall is damaged.
The Contractor is reminded to repair the damaged part of tipping hall.

Tipping Hall No.2

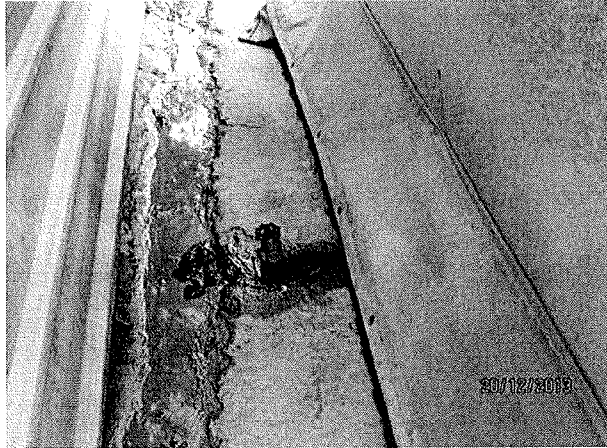
Photo 5

Chemical Waste Storage Area

Leakage of oil is observed from the chemical waste storage cabinet.

The Contractor should provide sufficient preventive measures during equipment maintenance works so as to avoid oil leakage on the ground. In the event of any oil leakage, the Contractor should clean up the polluted soil and handle all the materials used for this cleaning works as chemical waste.

The Contractor is reminded to check/repair the cabinet and clear the oil stain as soon as possible.

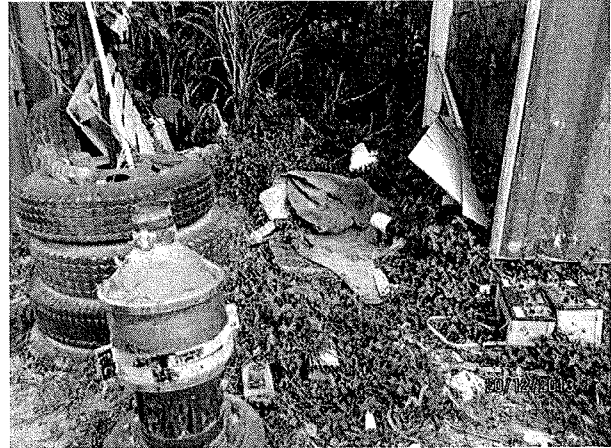
Photo 6

Portion A6

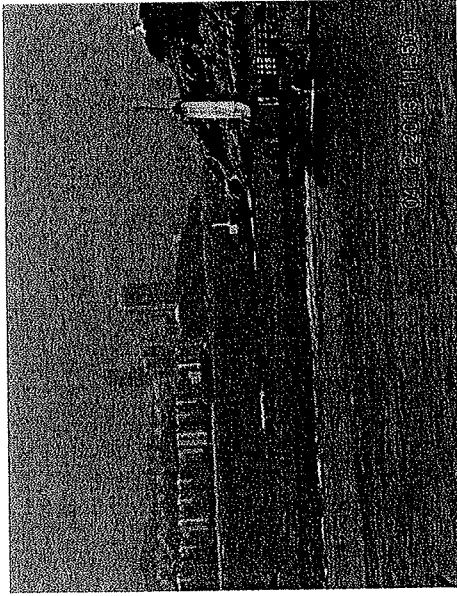
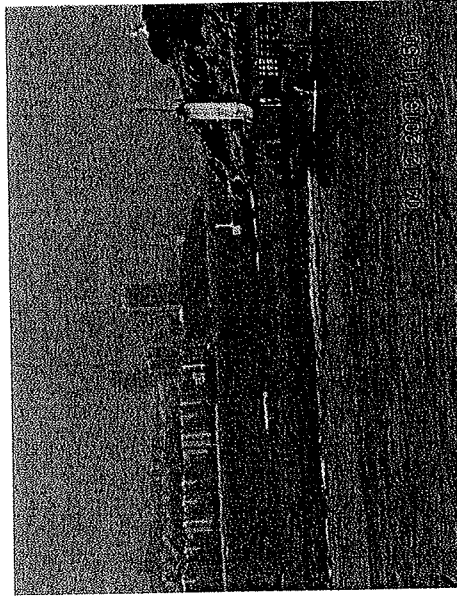
Photo 131204_001 (Silt curtain near tipping hall No.1)

Date	Key Findings	Action(s) Taken recommended by ET	Action(s) Taken by the Contractor during the ET weekly site audit	Rectification Status by ET
04 December 2013	The floating booms of silt curtain near the tipping hall No.1 were found damaged. (Previous item)	To repair the silt curtain as soon as possible.	---	Follow-up
	Tipping hall No. 2 was found damaged. (Previous item)	To repair the tipping hall as soon as possible.	---	Follow-up
11 December 2013	The floating booms of silt curtain near the tipping hall No.1 were found damaged. (Previous item)	To repair the silt curtain as soon as possible.	---	Follow-up
	Tipping hall No. 2 was found damaged. (Previous item)	To repair the tipping hall as soon as possible.	---	Follow-up
20 December 2013	The floating booms of silt curtain near the tipping hall No.1 were found damaged. (Previous item)	To repair the silt curtain as soon as possible.	---	Follow-up

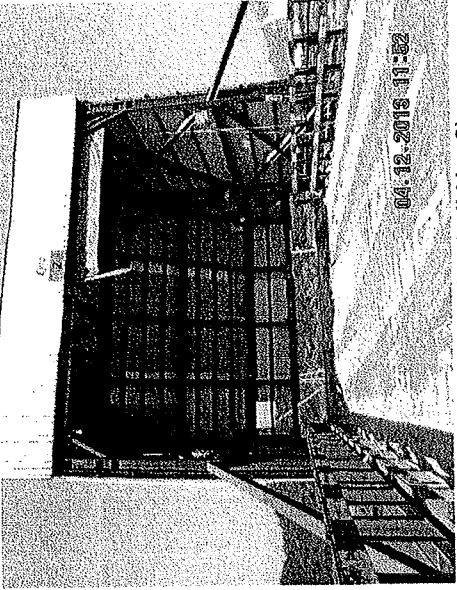
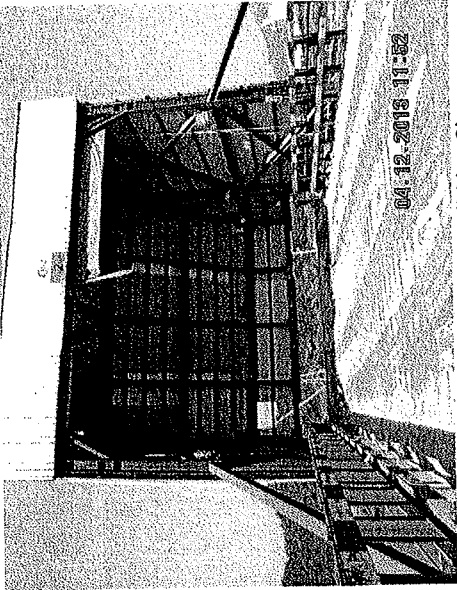
Photo 131204_002 (Tipping hall No. 2)

Tipping hall No. 2 was found damaged. (Previous item)	To repair the tipping hall as soon as possible.	---	Follow-up
	Oil leakage was noted from chemical water storage area. (New item)	To clear the leaked oil and treat the contaminated materials as chemical waste.	---	Follow-up
	C&D wastes (e.g. used battery and plastic sheets) were found discarded at Section A6 - 軟場. (New item)	To collect and dispose of the wastes properly.	---	Follow-up
24 December 2013	The floating booms of silt curtain near the tipping hall No.1 were found damaged. (Previous item)	To repair the silt curtain as soon as possible.	---	Follow-up
	Tipping hall No. 2 was found damaged. (Previous item)	To repair the tipping hall as soon as possible.	---	Follow-up
	Oil leakage was noted from chemical water storage area. (Previous item)	To clear the leaked oil and treat the contaminated materials as chemical waste.	---	Follow-up

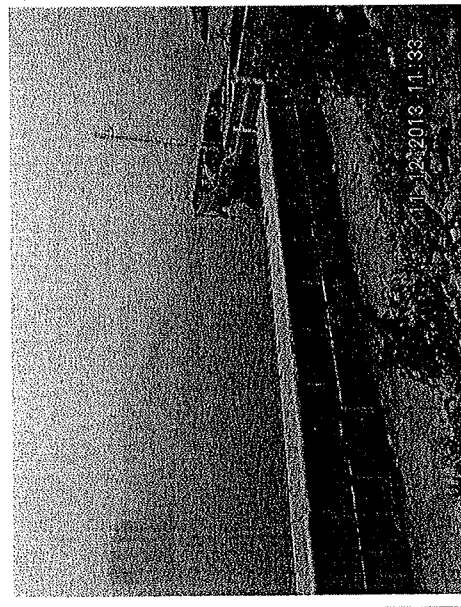
<p>11-12-2013 11:33</p> <p>Photo 131211_001 (Silt curtain near tipping hall No.1)</p>

Date	Key Findings	Action(s) Taken recommended by IEC	Action(s) Taken by the Contractor during the IEC audit	Rectification Status by IEC
11 December 2013	Silt curtain near the Tipping Hall No.1 was damaged. (Previous item).	The Contractor was reminded to replace the damaged silt curtain as soon as possible.	---	Follow-up
	Cladding of tipping hall No.2 was damaged (Previous item).	The Contractor was reminded to repair the damaged part of tipping hall.	---	Follow-up
20 December 2013	Silt curtain near the Tipping Hall No.1 was damaged. (Previous item).	The Contractor was reminded to replace the damaged silt curtain as soon as possible.	---	Follow-up
	Cladding of tipping hall No.2 was damaged (Previous item).	The Contractor was reminded to repair the damaged part of tipping hall.	---	Follow-up

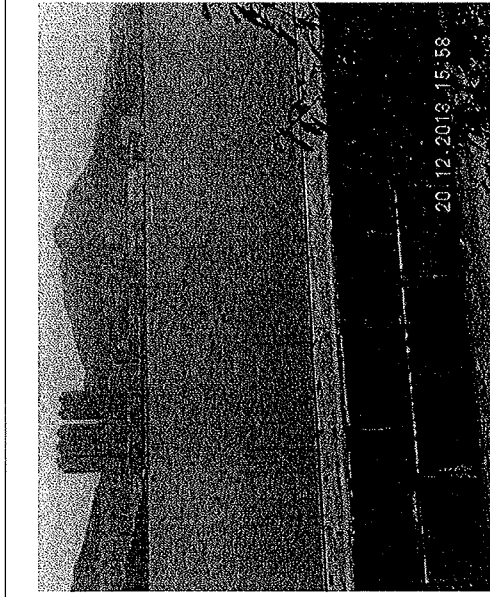
Photo 131220_001 (Slit curtain near tipping hall No.1)

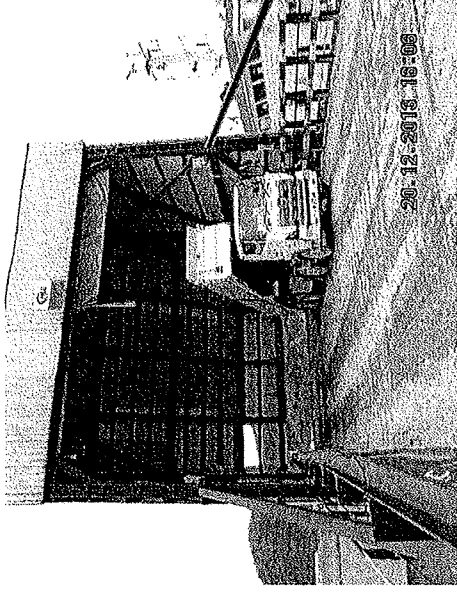
Photo 131220_002 (Tipping hall No. 2)

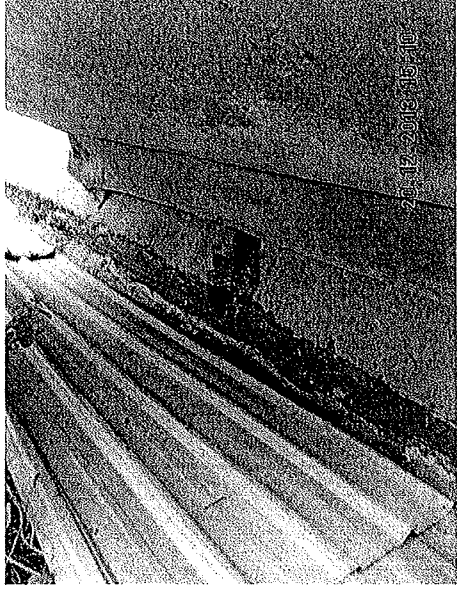
Photo 131220_003 (Chemical Waste Storage Area)

Date	Key Findings	Action(s) Taken recommended by IEC	Action(s) Taken by the Contractor during the IEC audit	Rectification Status by IEC
20 December 2013	Leakage of oil was observed from the chemical waste storage cabinet. (New item)	The Contractor was reminded to check / repair the cabinet and clear the oil stain as soon as possible.	---	Follow-up
	Debris and wastes were discarded near tyres maintenance area at Portion A6. (New item)	The Contractor was reminded to tidy up the area and dispose of the debris / wastes properly.	---	Follow-up

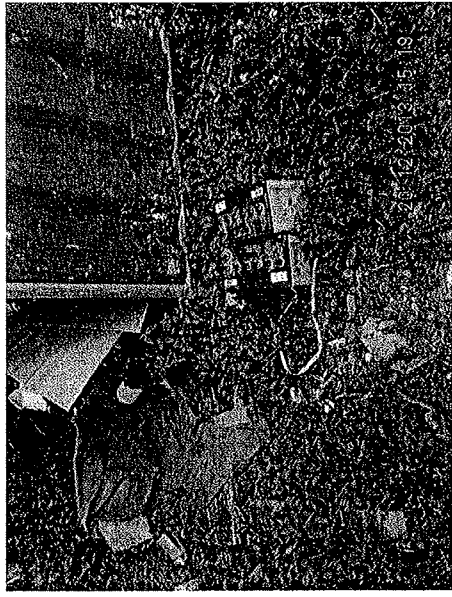
Photo 131220_004 (Section A6 - 軟場)

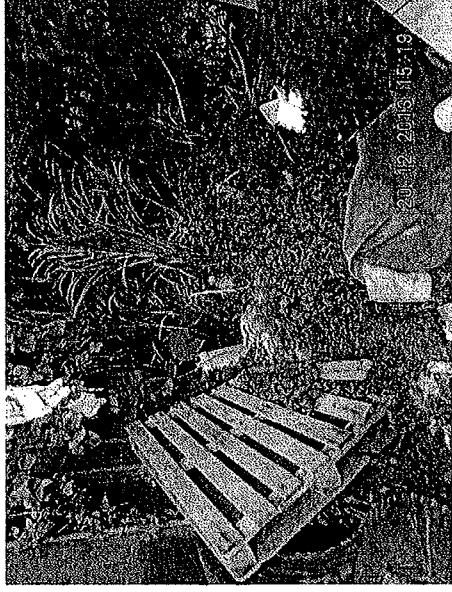
Photo 131220_005 (Section A6 - 軟場)

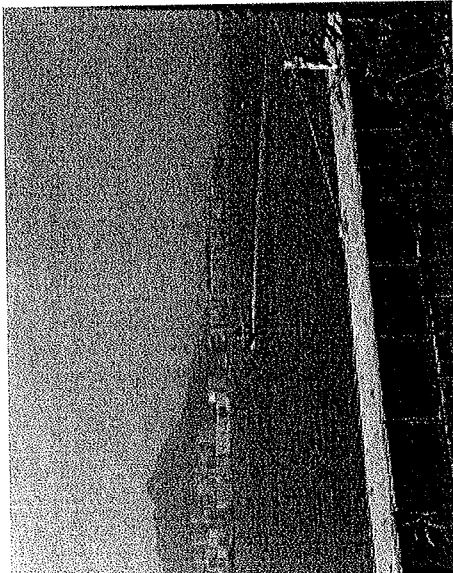
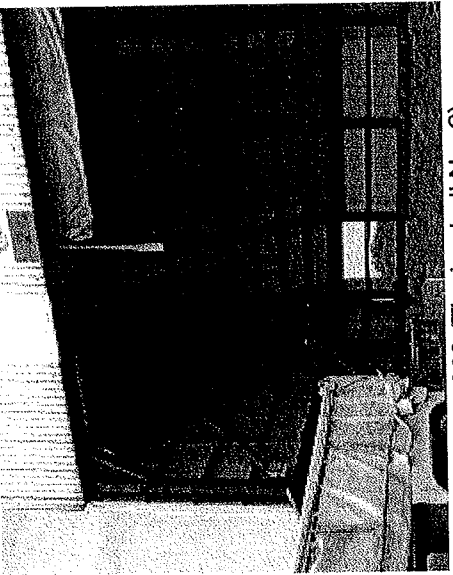
<p>Photo 131224_001 (Silt curtain near tipping hall No. 1)</p>	<p>Photo 131224_002 (Tipping hall No. 2)</p>	<p>Photo 131224_003 (Chemical Waste Storage Area)</p>

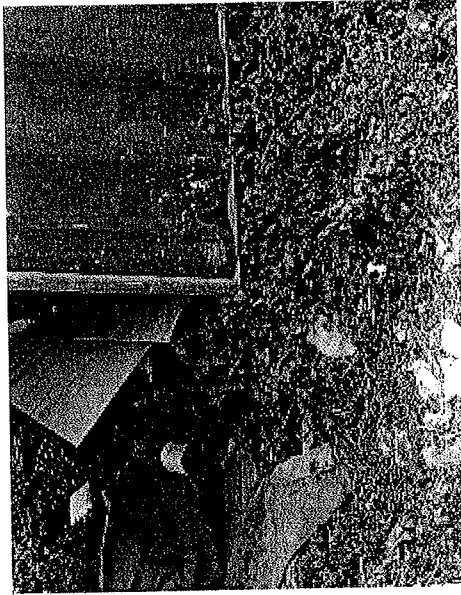
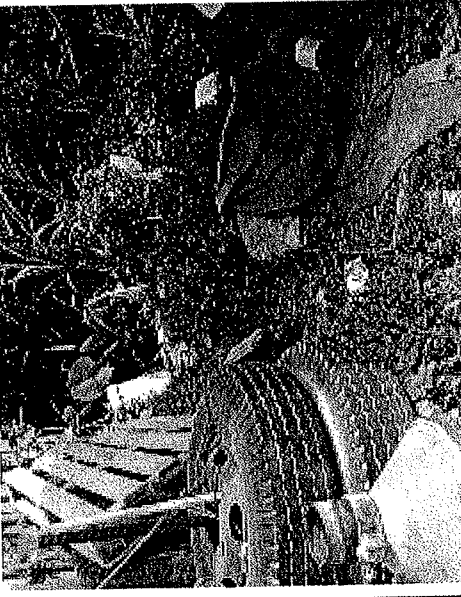
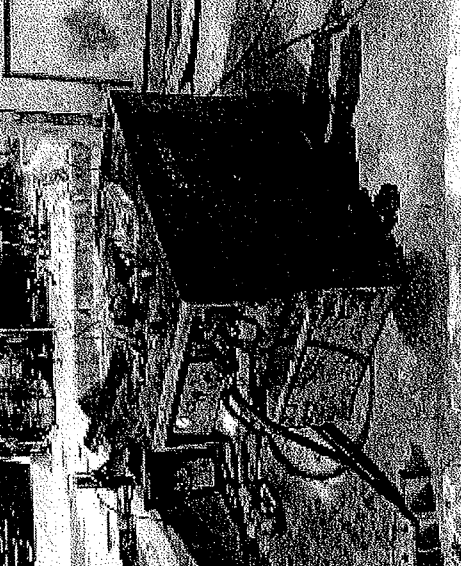
<p>Photo 131224_004 (Section A6 - 軟場) (Improved)</p>	<p>Photo 131224_005 (Section A6 - 軟場)</p>	<p>Photo 131224_006 (Workshop)</p>

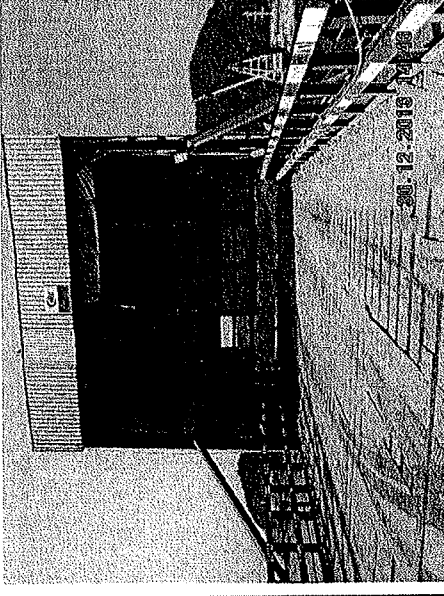
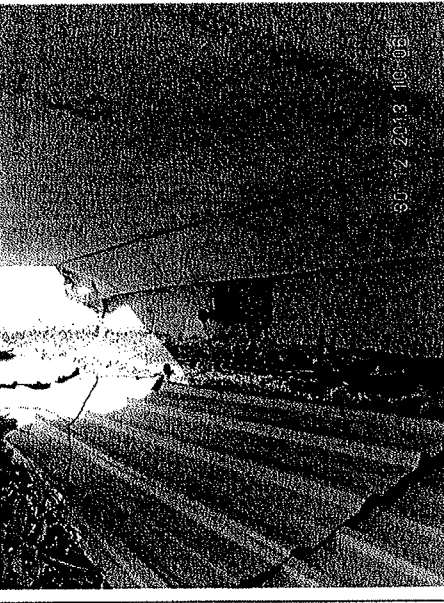
<p>30.12.2013 10:05</p>
<p>Photo 131230_001 (Silt curtain near tipping hall No.1)</p>	<p>Photo 131230_002 (Tipping hall No. 2)</p>	<p>Photo 131230_003 (Chemical Waste Storage Area) (Improved)</p>

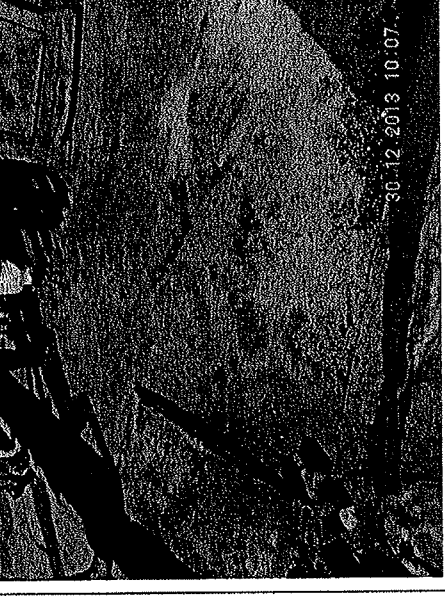
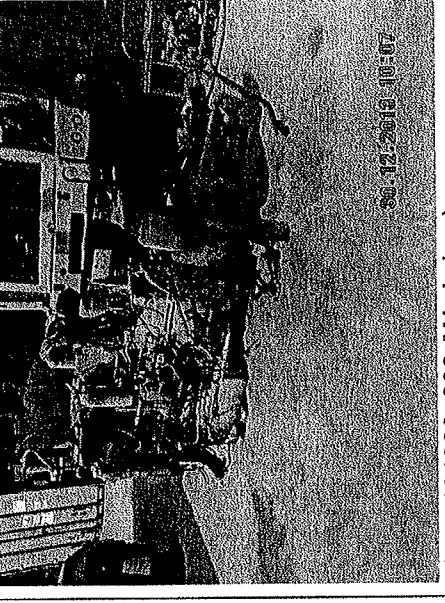
<p>30.12.2013 10:07</p>
<p>Photo 131230_004 (Section A6 - 軟場)</p>	<p>Photo 131230_005 (Workshop)</p>	<p>Photo 131230_006 (Workshop)</p>
