**Monthly Environmental Monitoring & Audit Report**  
**(December 2013)**

Contract No. : CV/2012/01  
Project : Sediment Removal at Yim Tin Tsai (East)  
Fish Culture Zone  
Client : Civil Engineering and Development  
Department (CEDD)  
Main Contractor : Zhen Hua Engineering Company Limited

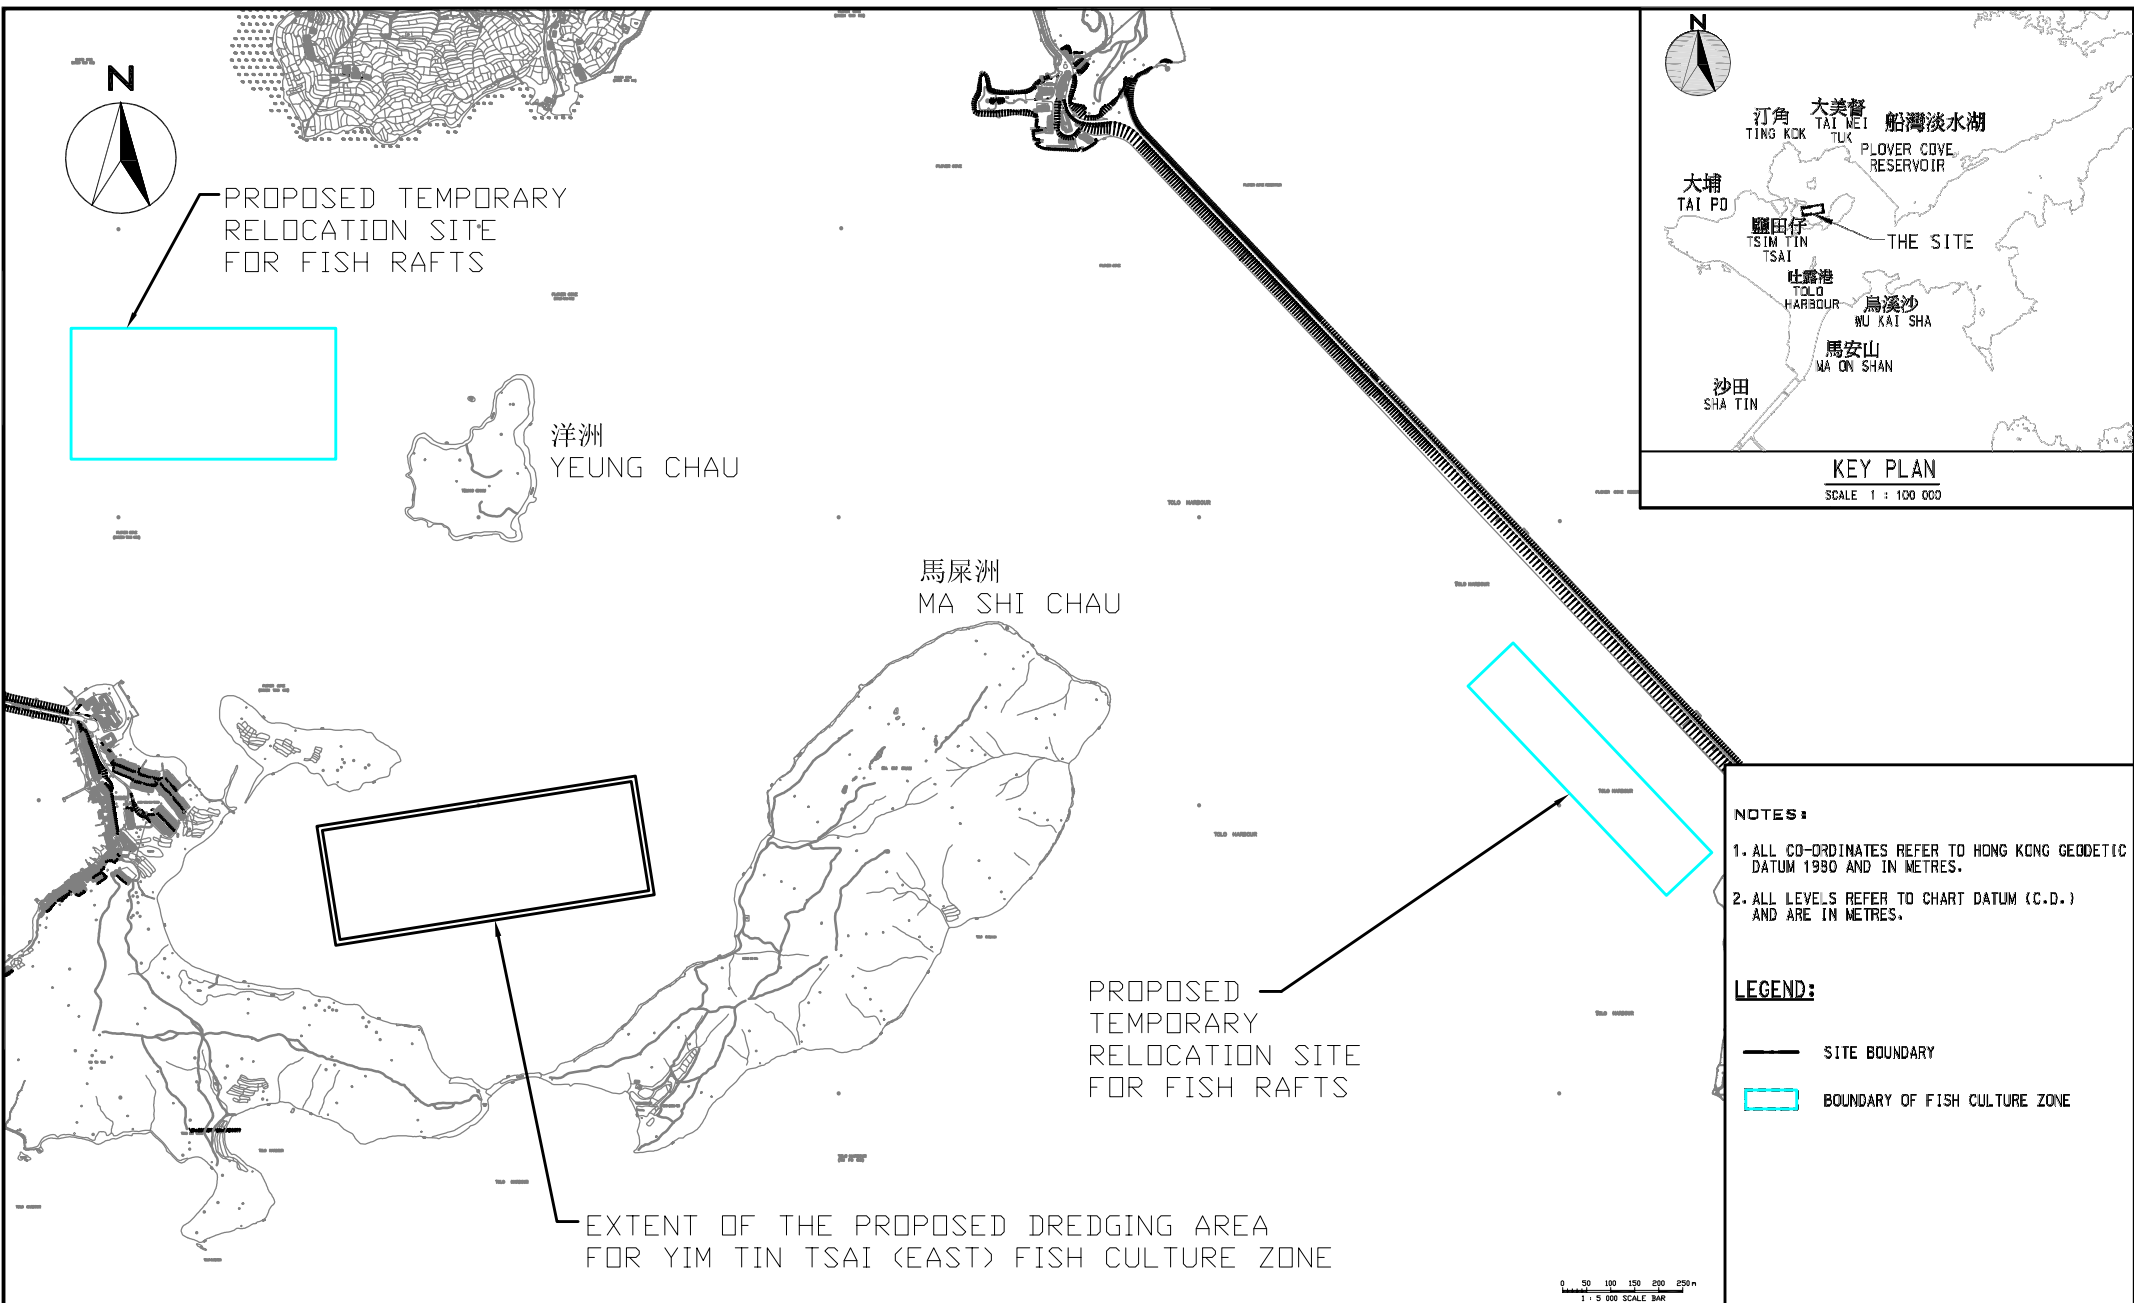
SCALE	1:400 @ A4	DATE	DEC 2013	
CHECK	IT	DRAWN	JW	
JOB No.	MA13027	FIGURE NO.	1	REV —

PROPOSED TEMPORARY  
RELOCATION SITE  
FOR FISH RAFTS

SITE LAYOUT PLAN

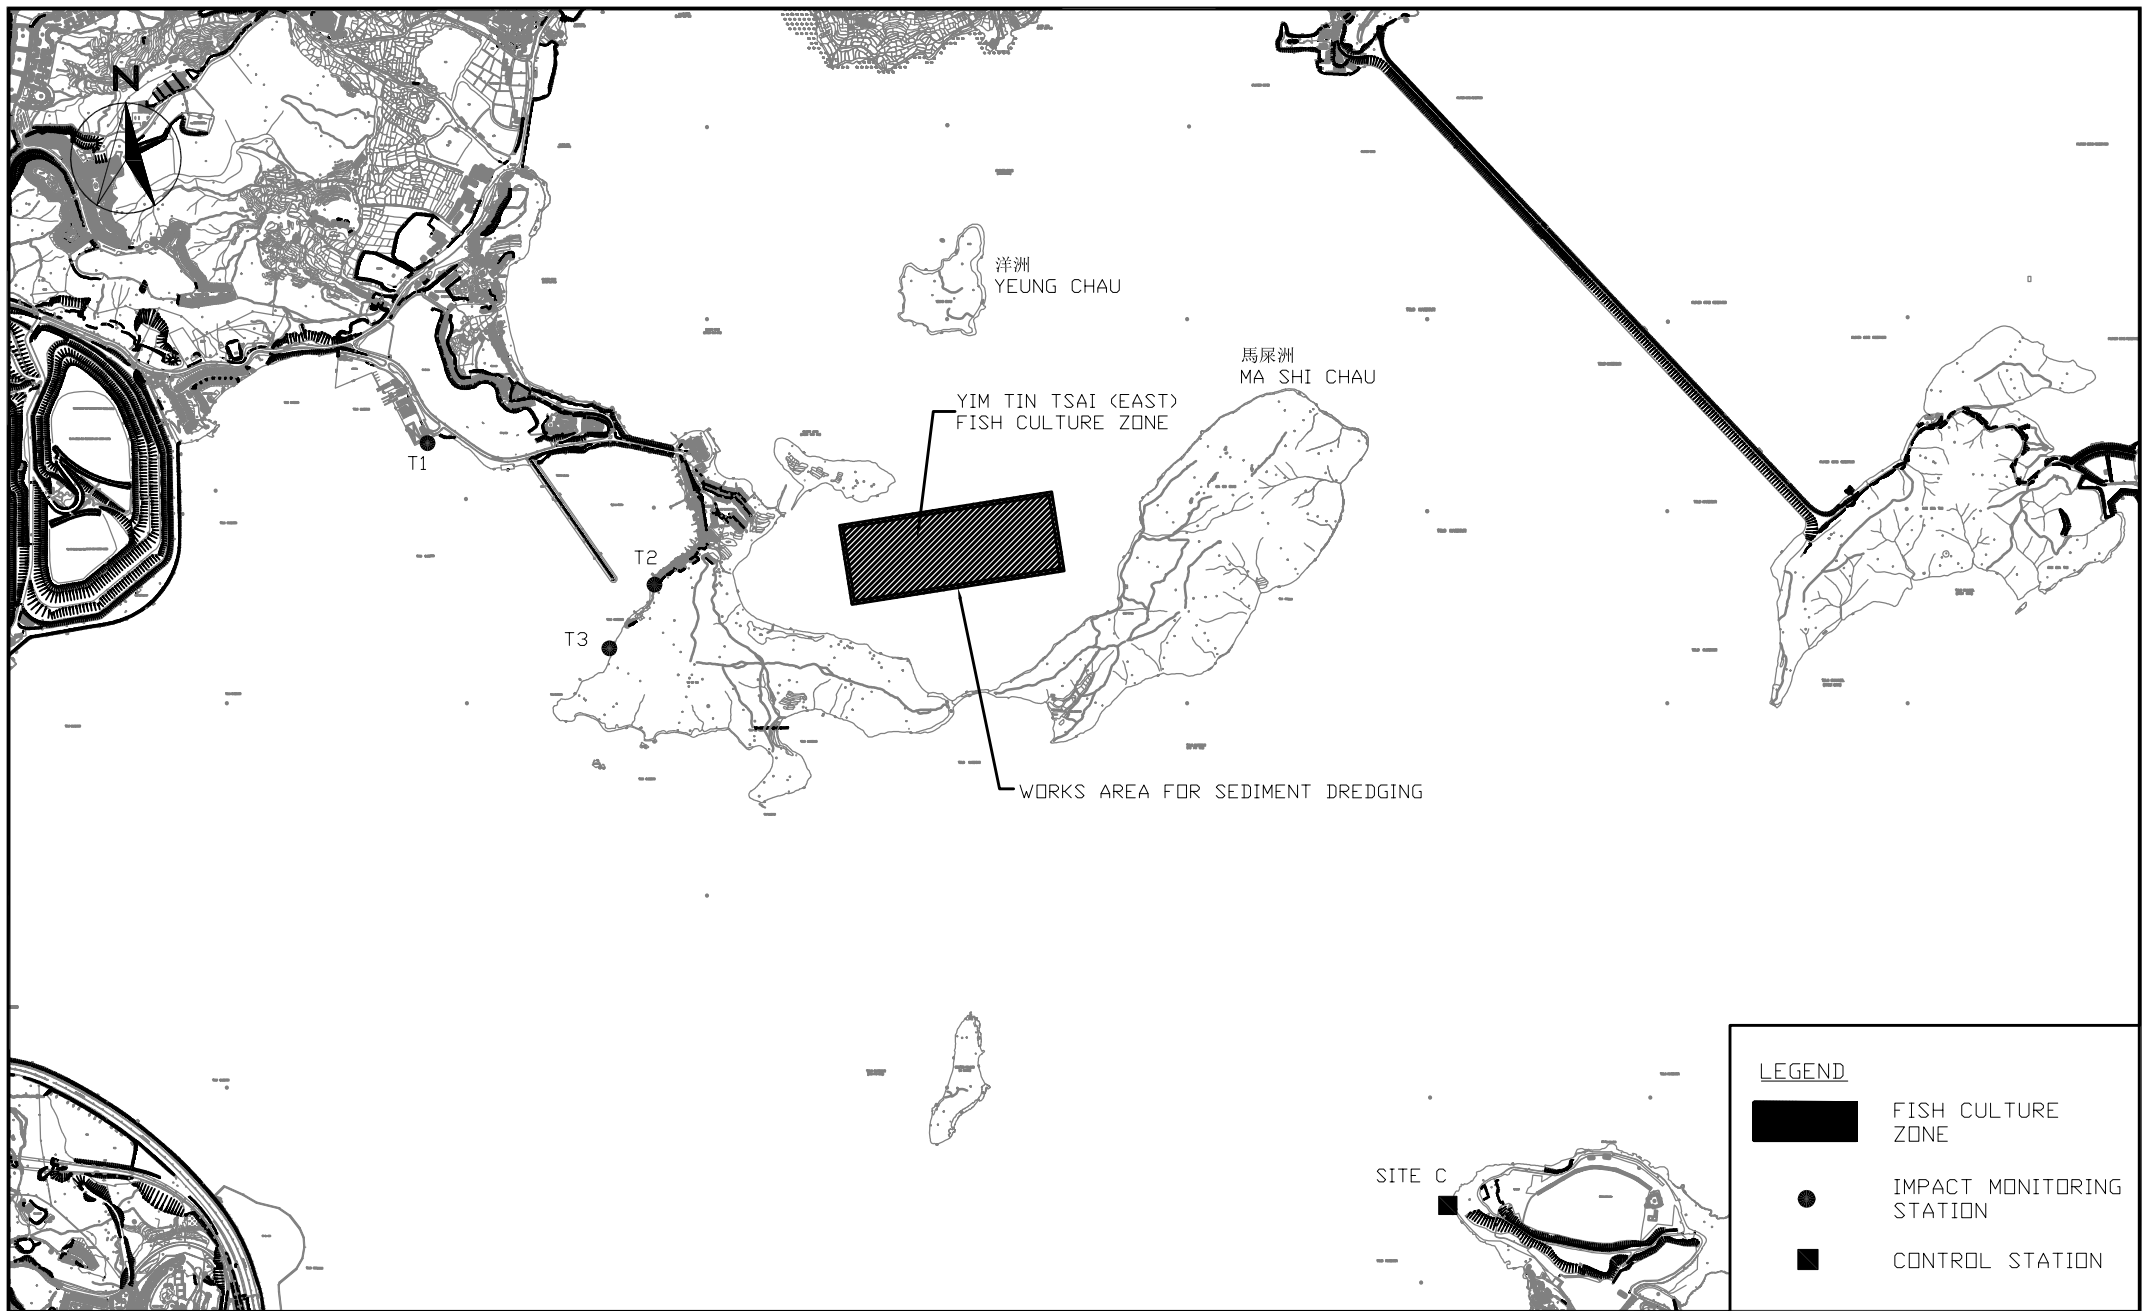
SCALE	1:600	DATE	JUN 2013	
CHECK	GL	DRAWN	JW	
JOB No.	MA13027	FIGURE NO.	3	REV —

- 3.4 The locations plan of the impact coral monitoring stations is shown in **Figure 3**. The summary for impact coral monitoring stations is shown in **Table 3.1**.

3.10 The locations of the survey sites are shown in **Figure 3**, and the coordinates of the start and end points and survey conditions are shown in **Table 3.2**.

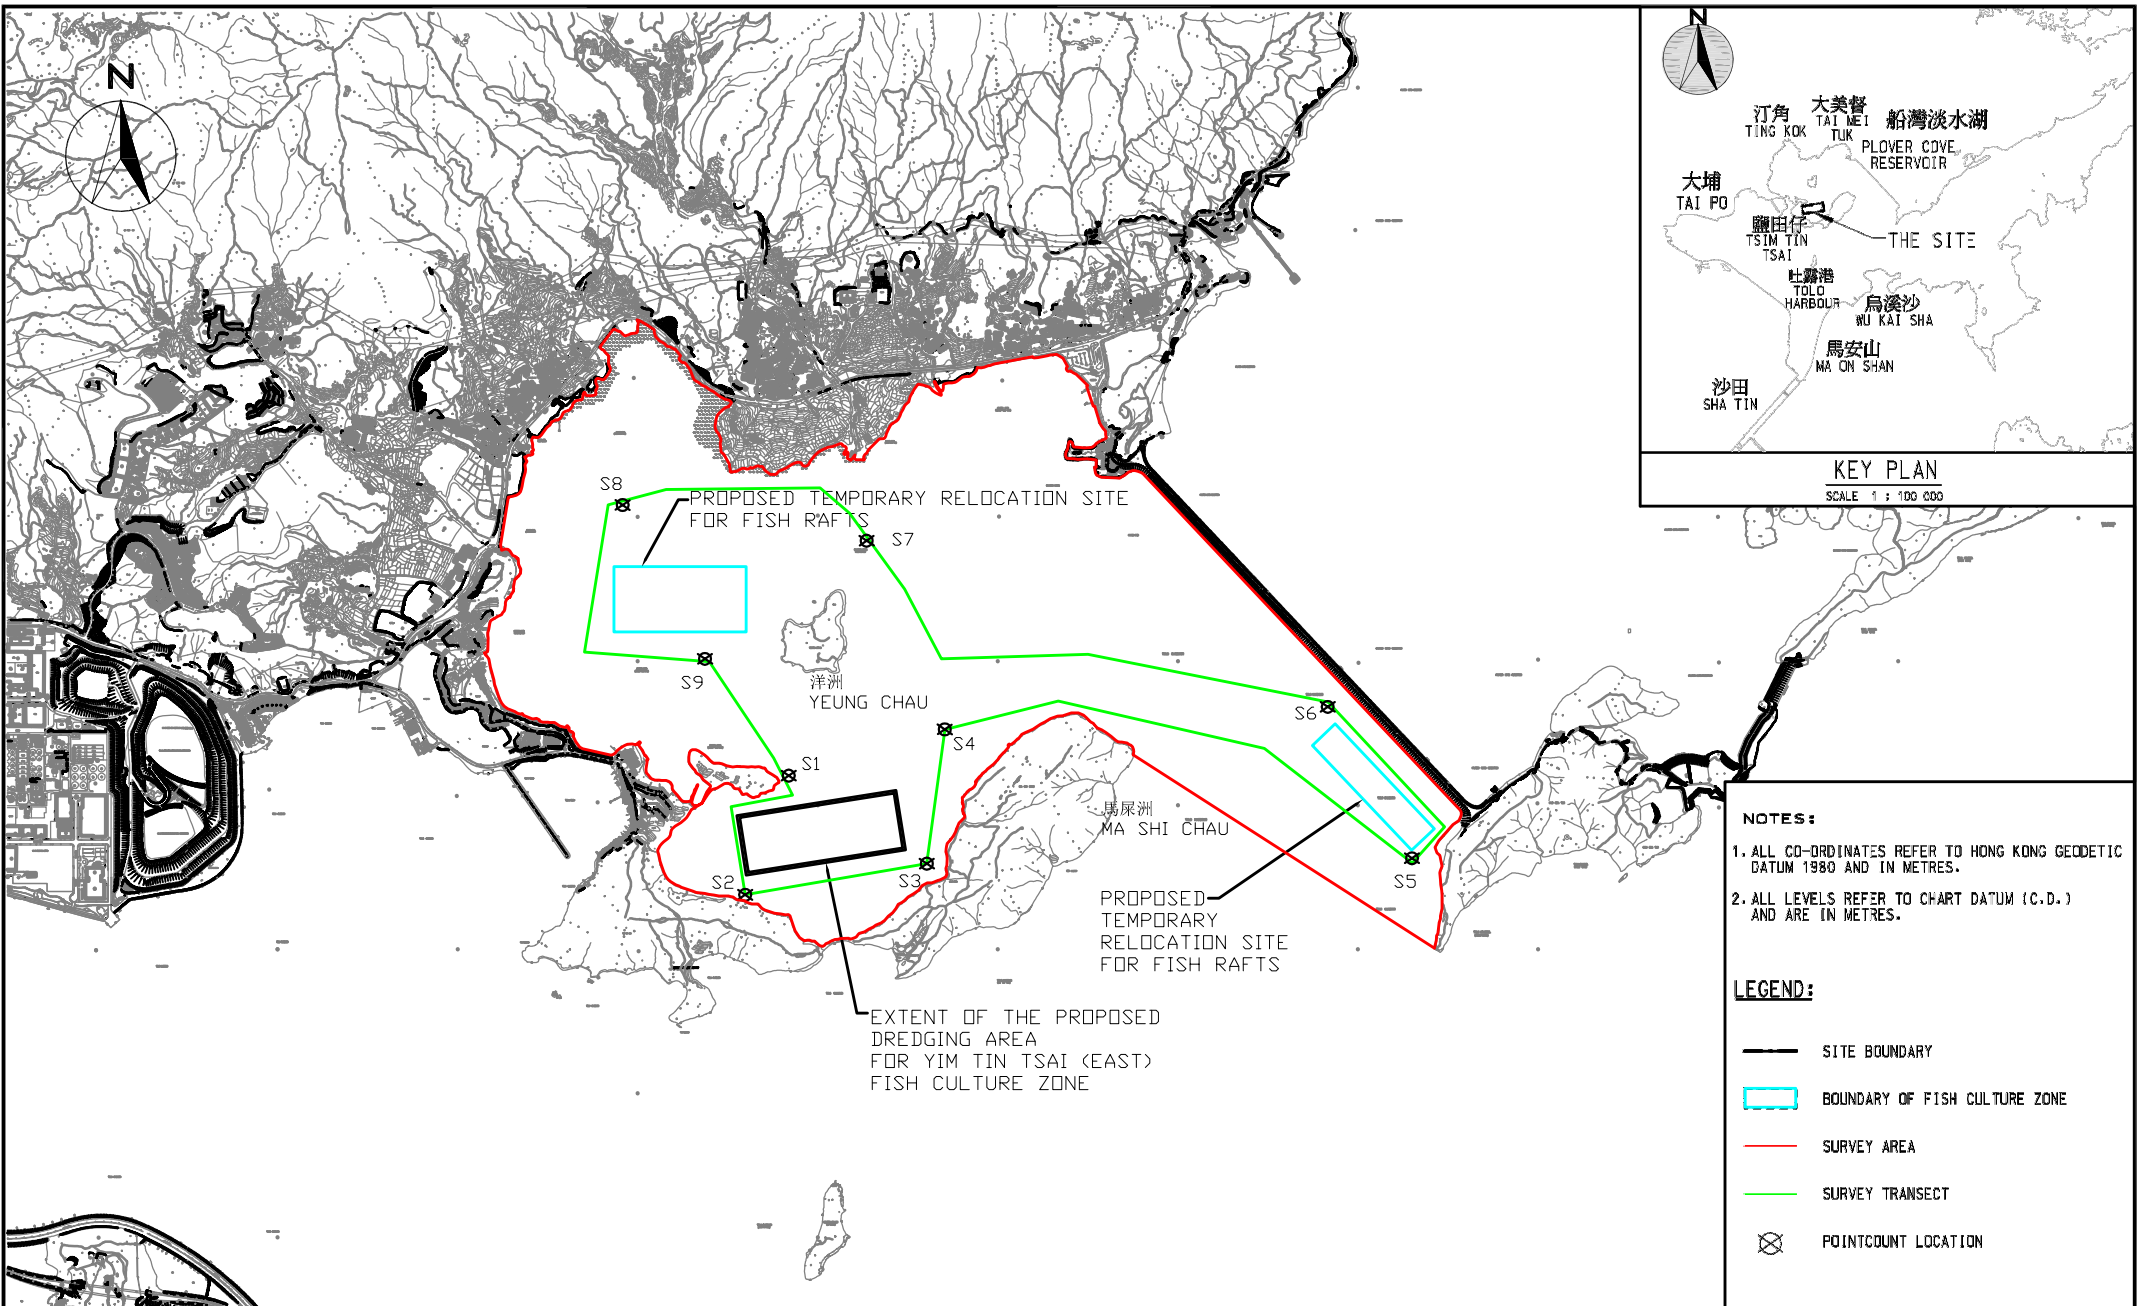
SCALE	1:800 @ A4	DATE	DEC 2013	
CHECK	IT	DRAWN	JW	
JOB No.	MA13027	FIGURE NO.	4	REV —

- 4.3 Transect route with some vantage points is shown in **Figure 4**. There are a total of 9 point count locations. The counting vantage points are selected with at least 500m distance with each other to avoid double-counting. The main focus areas of survey are the location of existing fish rafts before and after dredging works and Yeung Chau, where ardeids were observed in the past records.

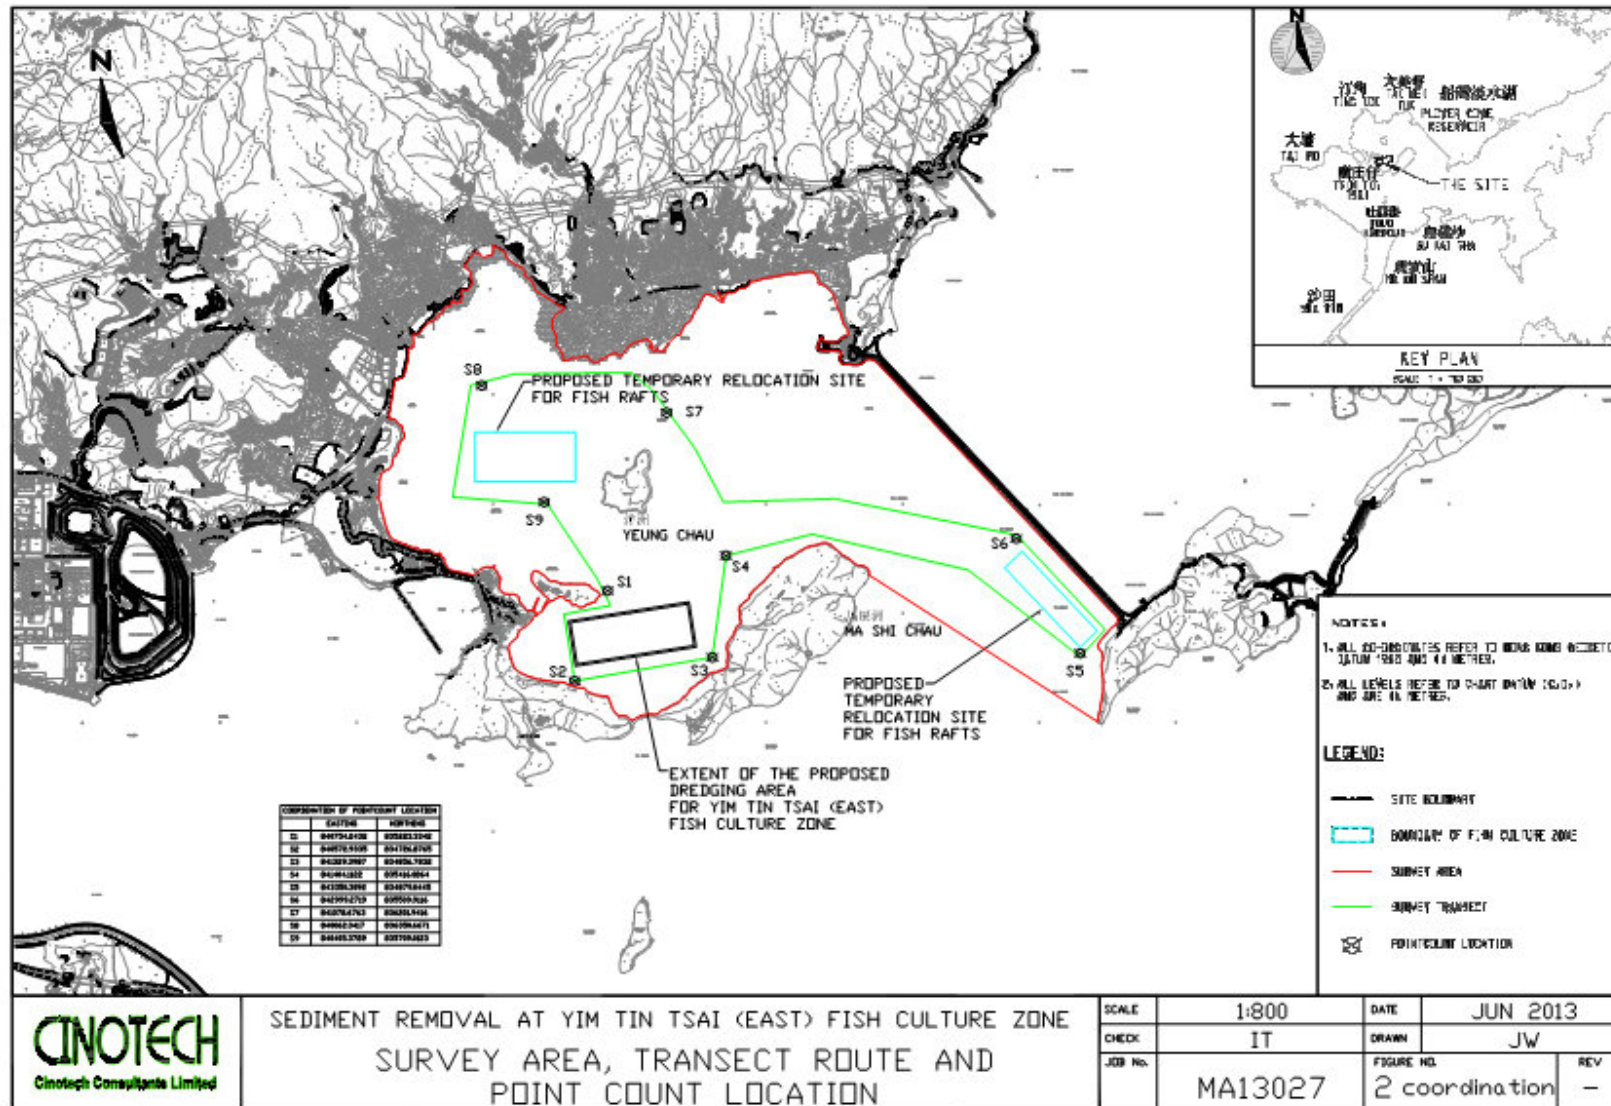
SEDIMENT REMOVAL AT YIM TIN TSAI (EAST) FISH CULTURE ZONE  
 SURVEY AREA, TRANSECT ROUTE AND  
 POINT COUNT LOCATION
