Sang Hing Civil Contractors Co. Ltd.

Contract No. CV/2010/05

**Temporary Construction Waste Sorting
Facilities, 2011 - 2013****Monthly EM&A Report No. 36
(for the month December 2013
at Tseung Kwan O Area 137)**

January 2014

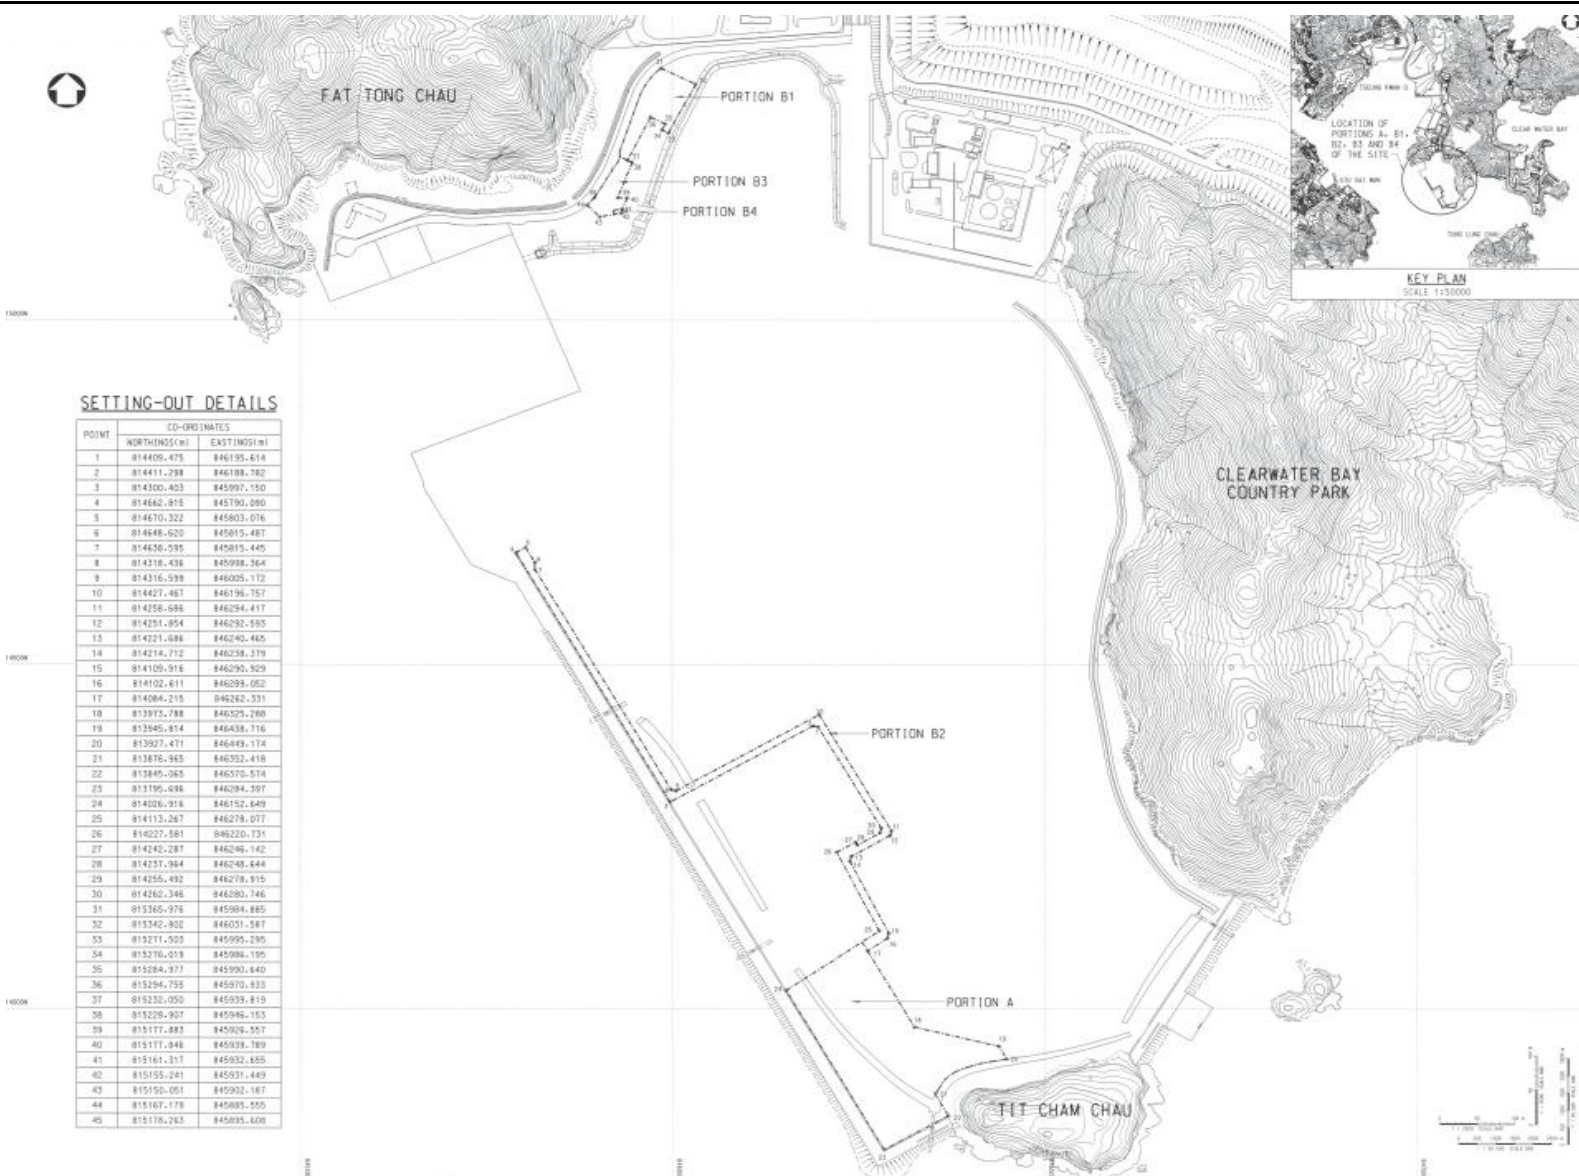
SCALE	N.T.S.	DATE	2011
CHECK	ENFL	DRAWN	PNWY
JOB NO.	60191018	FIGURE NO.	1.1
			Rev
			-

Site Layout of CWSF at TKO Area 137

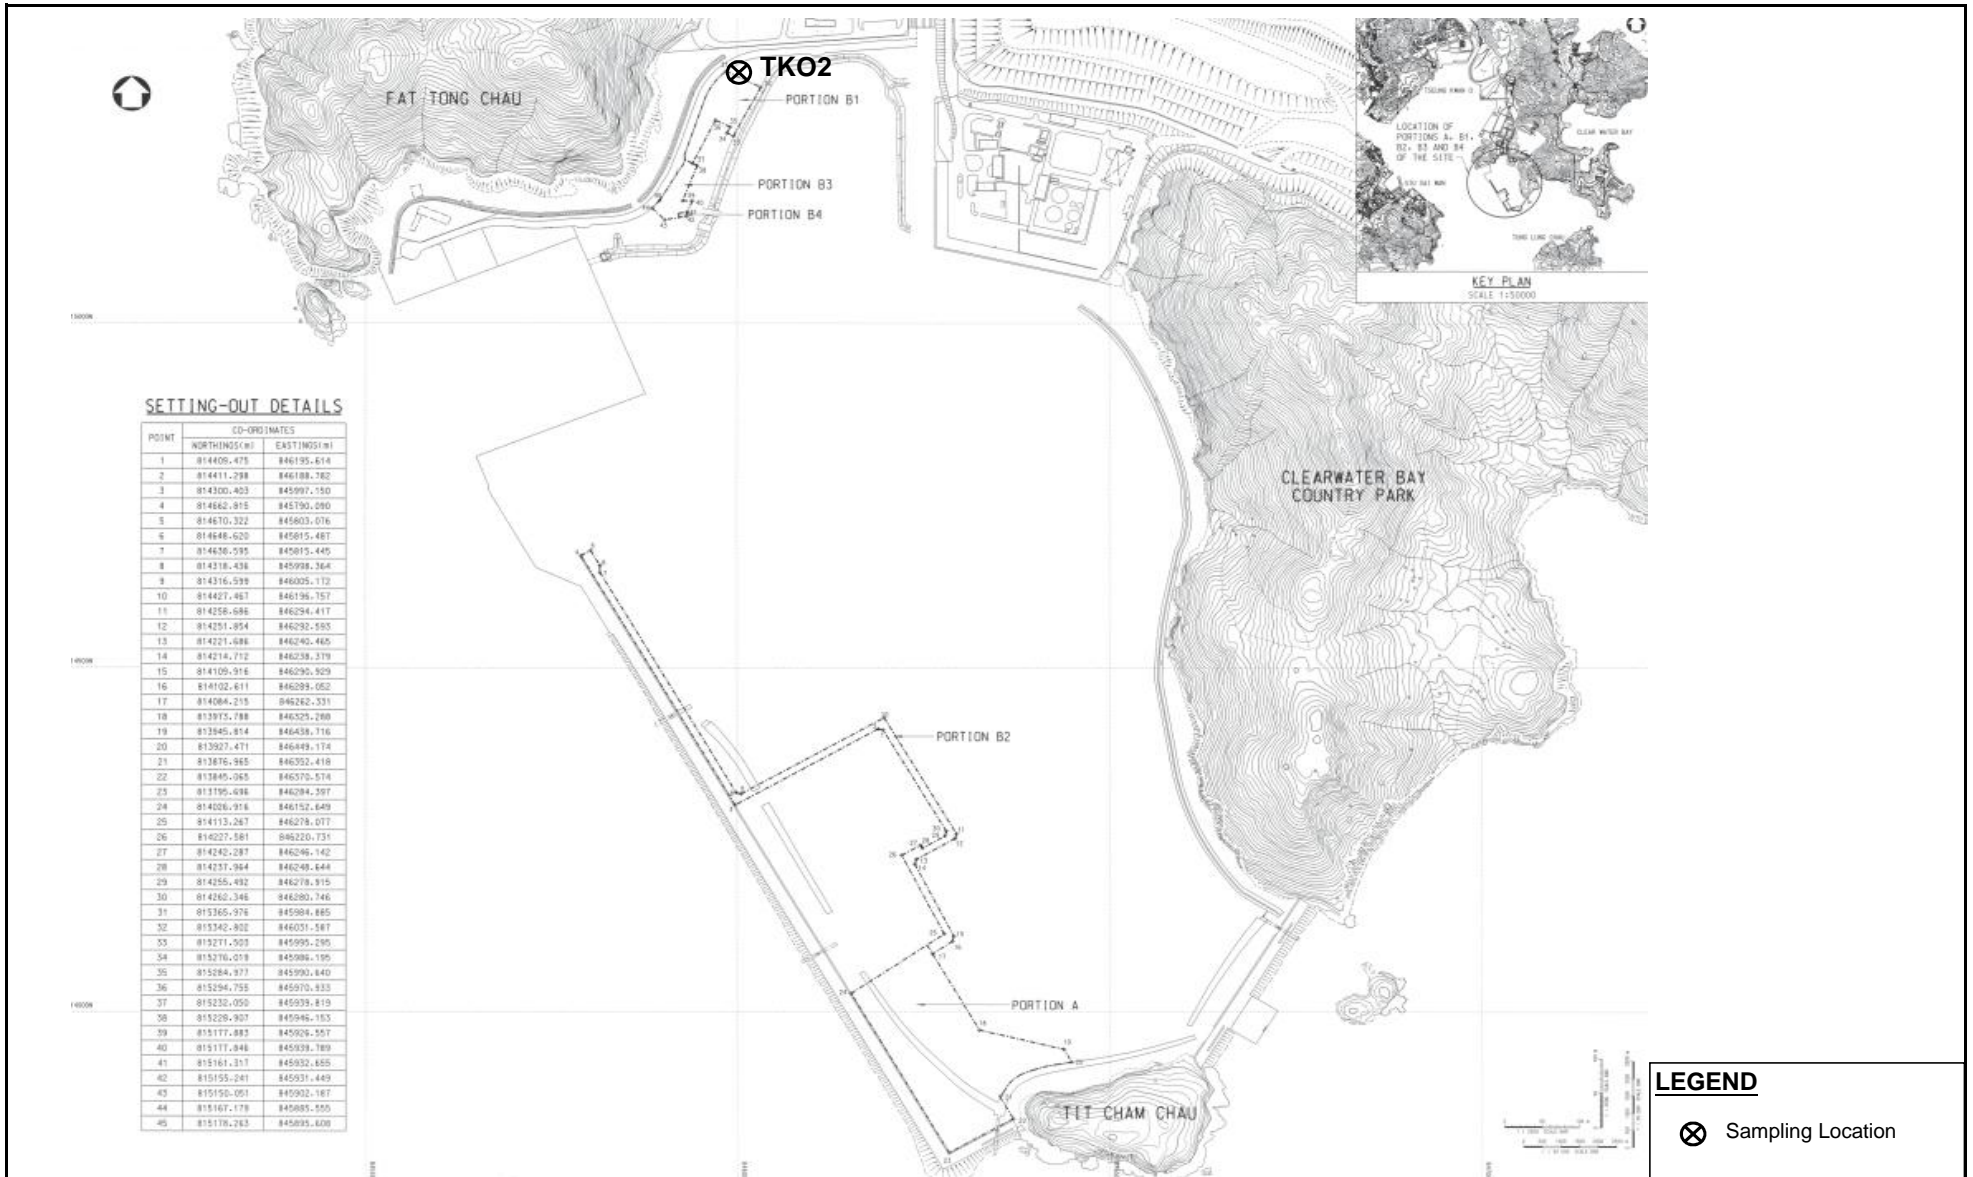
- 2.4 The location for the air quality monitoring station TKO2 is provided in Table 2.3 and depicted in Figure 2.1.

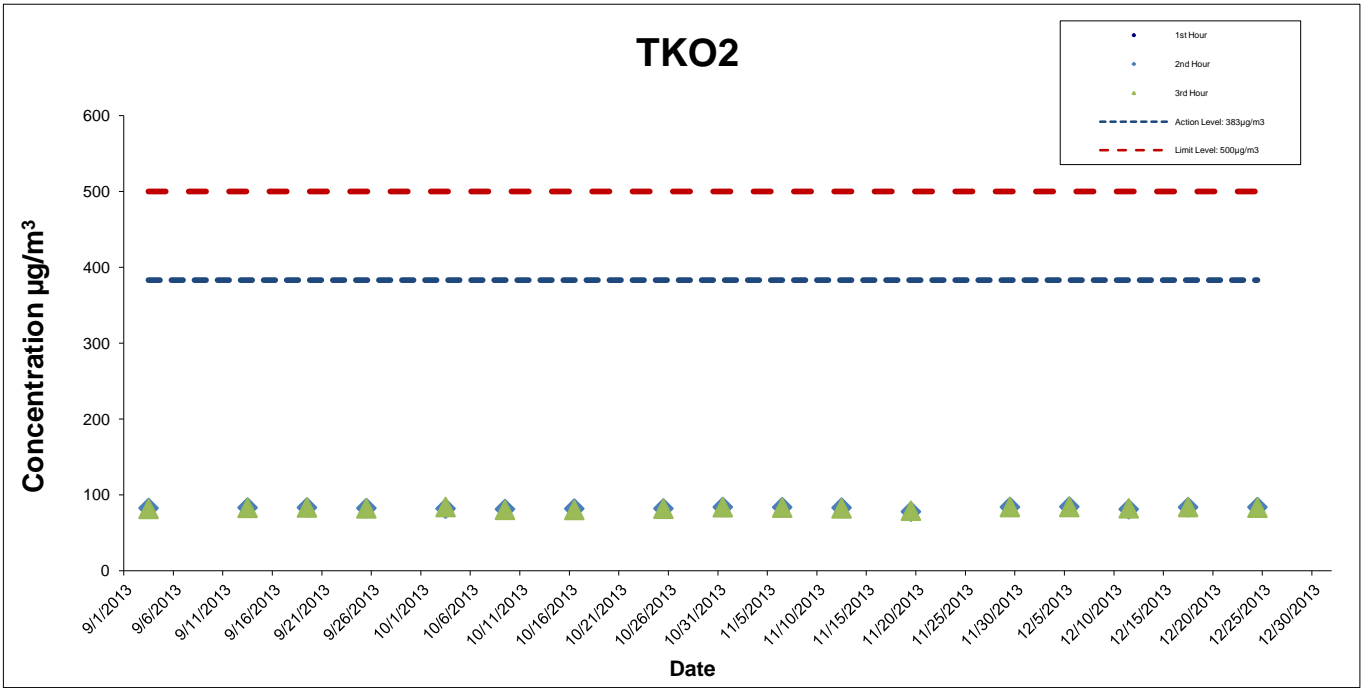
TKO2

AECOM	Contract No: CV/2010/05	SCALE	N.T.S.	DATE	2013
	Temporary CWSF, 2011 - 2013	CHECK	ENFL	DRAWN	JCYK
	Graphical Presentation of 1-hour TSP Monitoring Results	JOB NO.	60191018	APPENDIX No.	Rev.
			F		-

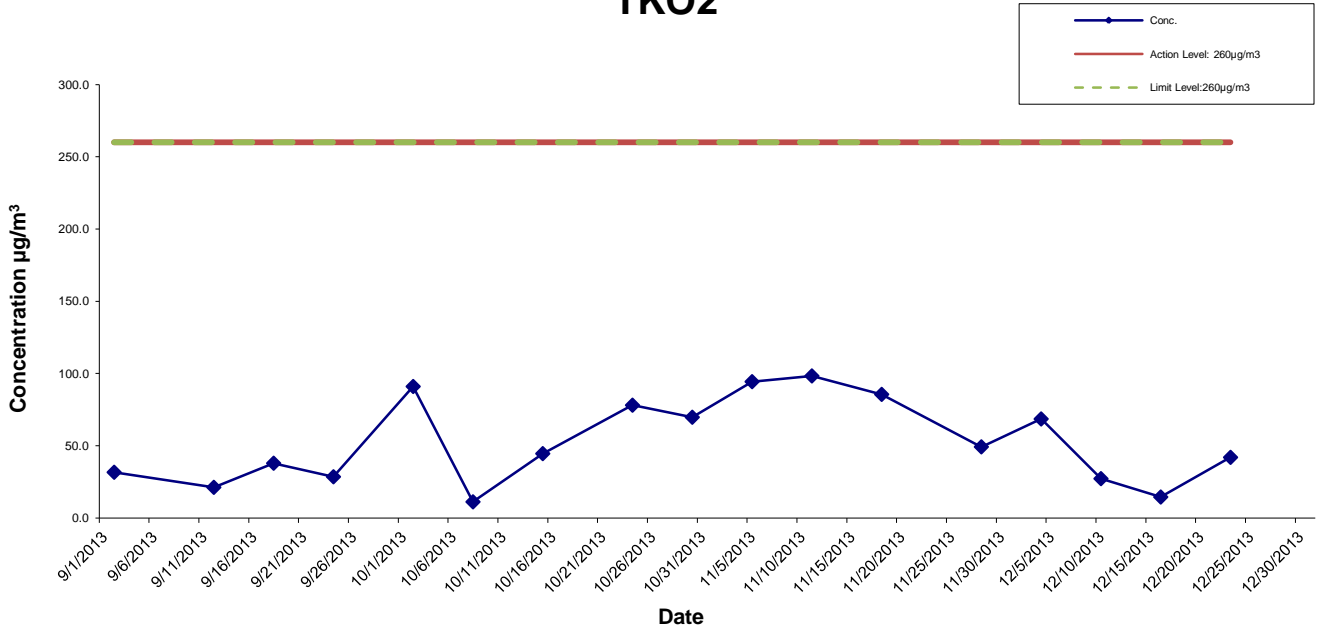
AECOM	Contract No: CV/2010/05	SCALE	N.T.S.	DATE	2013	
	Temporary CWSF, 2011 - 2013	CHECK	ENFL	DRAWN	JCYK	
	Graphical Presentation of 24-hour TSP Monitoring Results	JOB NO.	60191018	APPENDIX No.	F	Rev.
