## **China Harbour – China State Joint Venture**

**CONTRACT NO. CV/2009/02**  
**HANDLING OF SURPLUS PUBLIC FILL**  
**TSEUNG KWAN O AREA 137 FILL BANK**  
**MONTHLY EM&A REPORT NO.50**  
**(01 TO 20 JANUARY 2014)**

Report No.: ENA40185

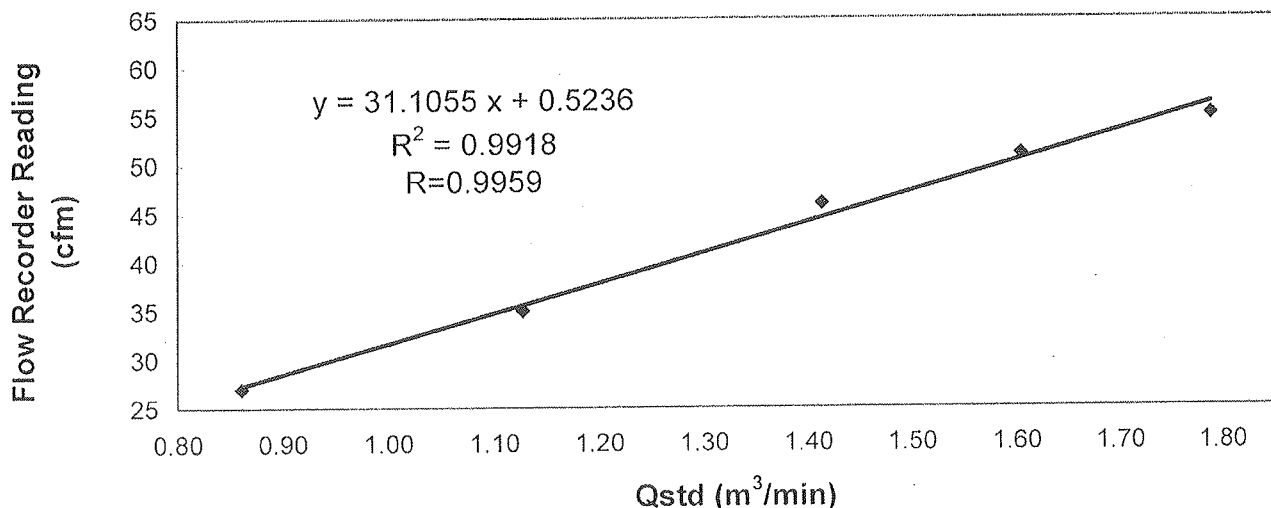
**Sampler 10581 Calibration Curve  
Site: Tseung Kwan O A-1**

Results	Flow recorder reading (cfm)	55	51	46	35	27
	Qstd (Actual flow rate, m <sup>3</sup> /min)	1.79	1.60	1.41	1.13	0.86
	Pressure : 763.56 mm Hg	Temp. : 298 K

Acceptance Criteria : Correlation coefficient (r) of the calibration curve greater than 0.990 after a 5-point calibration.

The high volume sampler complies\* / ~~does not comply\*~~ with the specified requirements and is deemed acceptable\* / unacceptable\* for use.

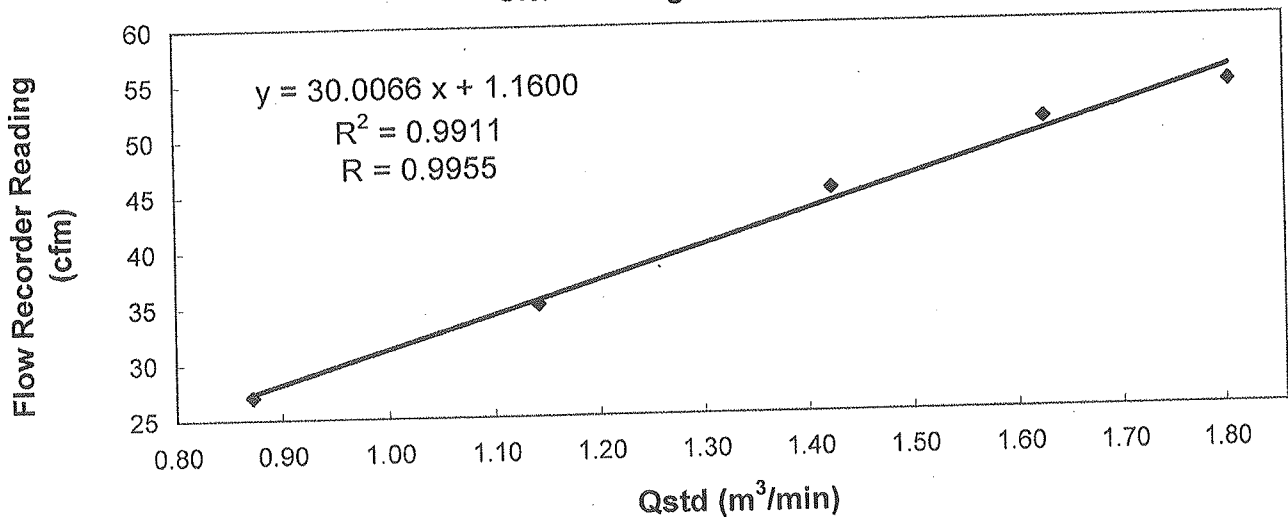
**Sampler 10581 Calibration Curve**  
Site: Tseung Kwan O A-1

Results :	Flow recorder reading (cfm)	54	51	45	35	27
	Qstd (Actual flow rate, m <sup>3</sup> /min)	1.81	1.63	1.42	1.14	0.87
	Pressure :	763.56	mm Hg	Temp. :	290	K

Acceptance Criteria : Correlation coefficient (r) of the calibration curve greater than 0.990 after a 5-point calibration.

The high volume sampler complies\* / does-not-comply\* with the specified requirements and is deemed acceptable\* / unacceptable\* for use.

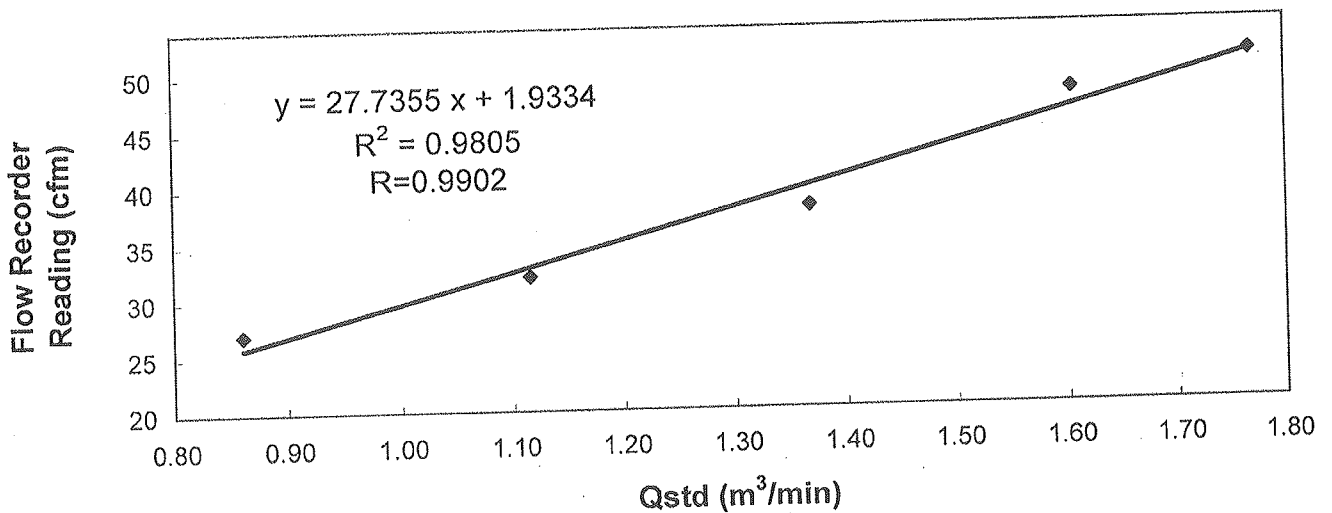
**Sampler 1172 Calibration Curve  
Site: Tseung Kwan O A-2**

Results	Flow recorder reading (cfm)	51	48	38	32	27
	Qstd (Actual flow rate, m <sup>3</sup> /min)	1.77	1.60	1.37	1.12	0.86
	Pressure :	763.56	mm Hg	Temp. :	298	K

Acceptance Criteria : Correlation coefficient (r) of the calibration curve greater than 0.990 after a 5-point calibration.

The high volume sampler complies\* / does-not-comply\* with the specified requirements and is deemed acceptable\* / unacceptable\* for use.

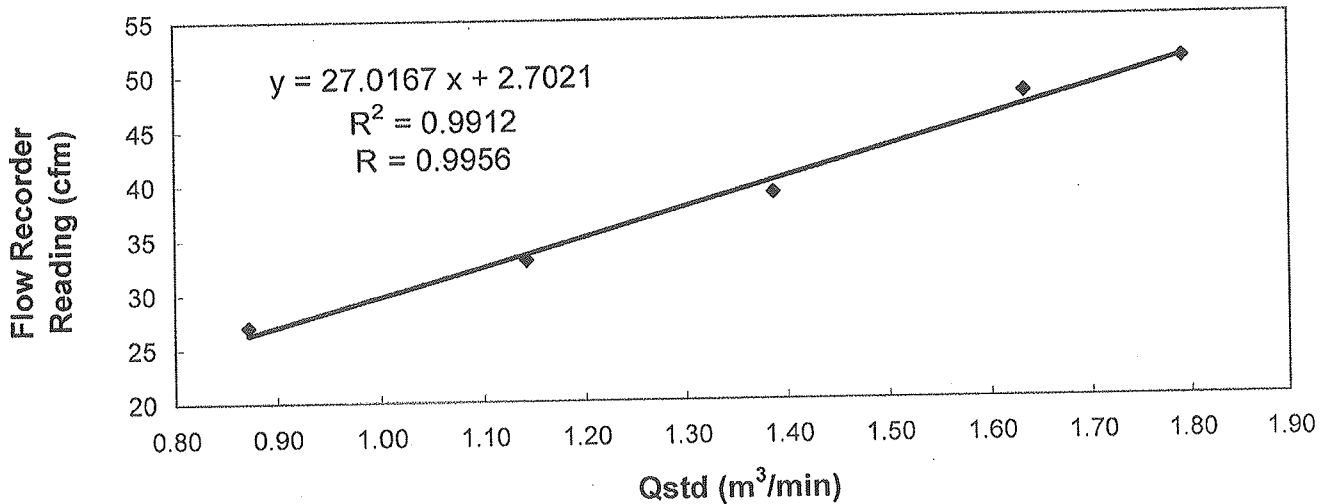
**Sampler 1172 Calibration Curve**  
Site: Tseung Kwan O A-2

Flow recorder reading (cfm)	51	48	39	33	27
Qstd (Actual flow rate, m <sup>3</sup> /min)	1.79	1.63	1.39	1.14	0.87
Pressure :	763.56	mm Hg	Temp. :	290	K

Acceptance Criteria : Correlation coefficient (r) of the calibration curve greater than 0.990 after a 5-point calibration.

The high volume sampler complies\* / does not comply\* with the specified requirements and is deemed acceptable\* / unacceptable\* for use.

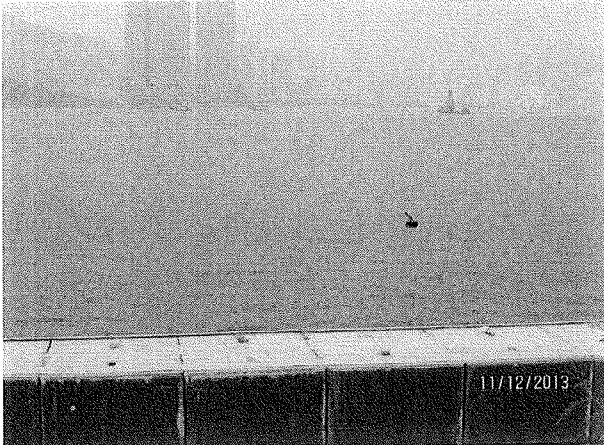
Photo 1

Silt Curtain

Silt curtain near the Tipping Hall No.1 is damaged.  
The Contractor is reminded to replace the damaged silt curtain as soon as possible.

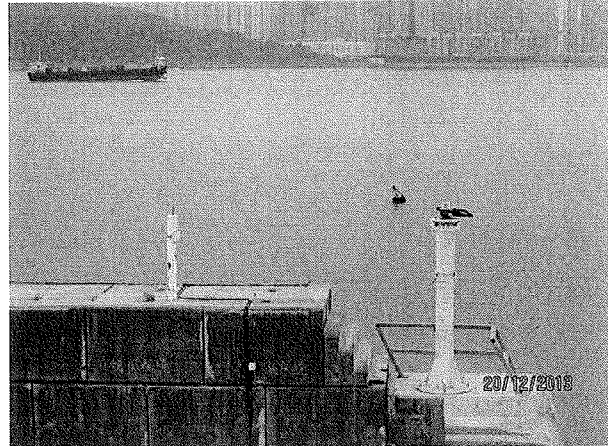
Photo 2

Silt Curtain

Silt curtain is still pending for rectification.  
**(Follow-up)**

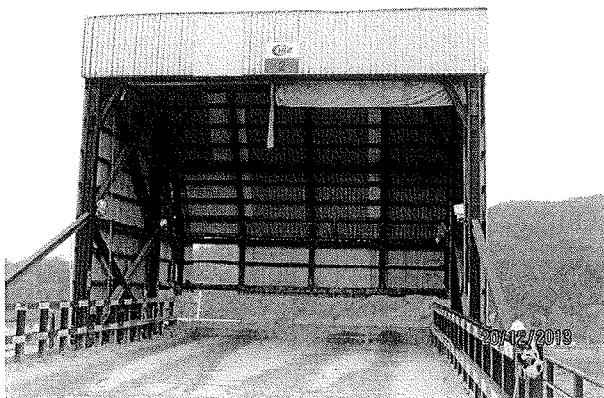
Photo 3

Tipping Hall No.2

Cladding of tipping hall is damaged.  
The Contractor is reminded to repair the damaged part of tipping hall.

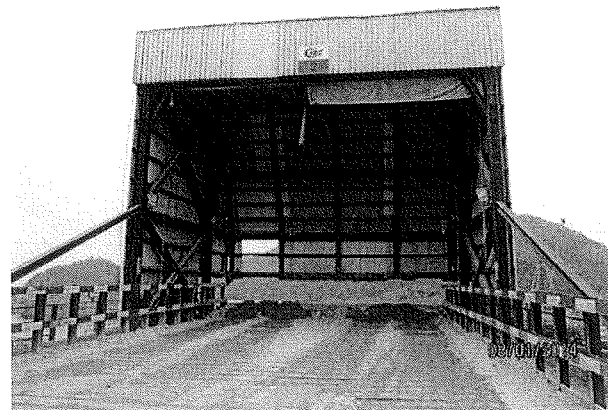
Photo 4

Tipping Hall No.2

Tipping hall is still pending for rectification.  
**(Follow-up)**

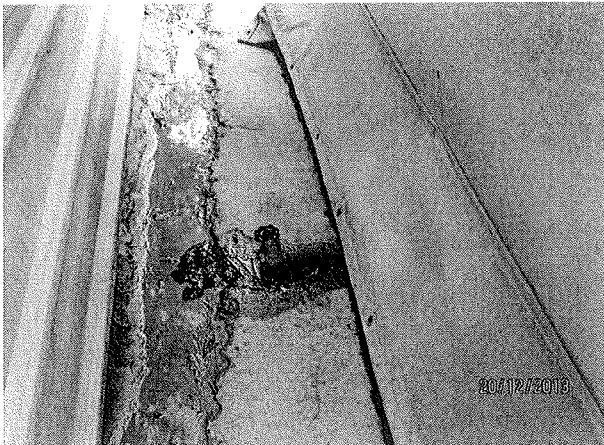
Photo 5

Chemical Waste Storage Area

Leakage of oil is observed from the chemical waste storage cabinet.

The Contractor is reminded to check/repair the cabinet and clear the oil stain as soon as possible.

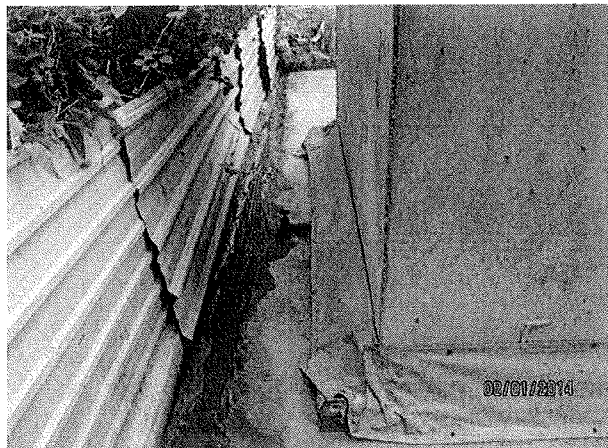
Photo 6

Chemical Waste Storage Area

Oil stain had been cleaned up and no leakage is observed. **(Closed)**

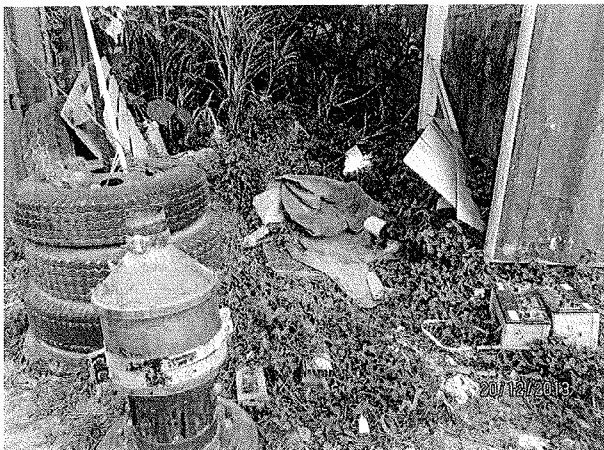
Photo 7

Portion A6

The Contractor is reminded to tidy up the area and dispose of the debris/wastes properly.

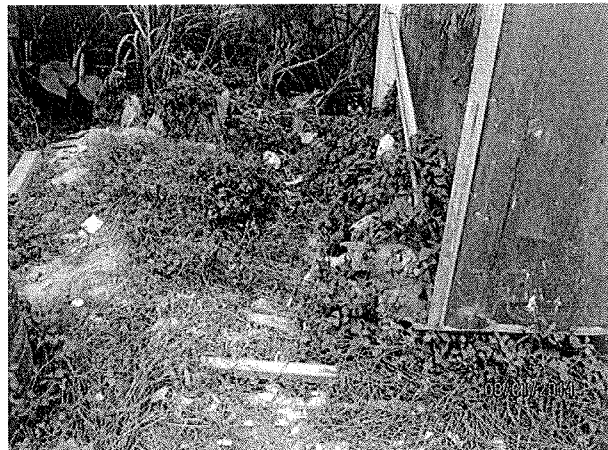
Photo 8

Portion A6

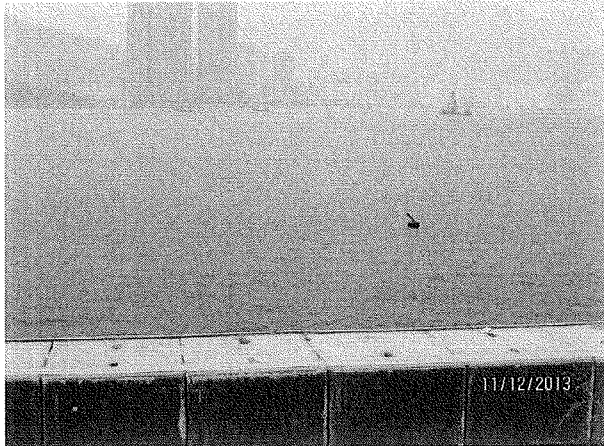
Photo 1

Silt Curtain

Silt curtain near the Tipping Hall No.1 is damaged. The Contractor is reminded to replace the damaged silt curtain as soon as possible.

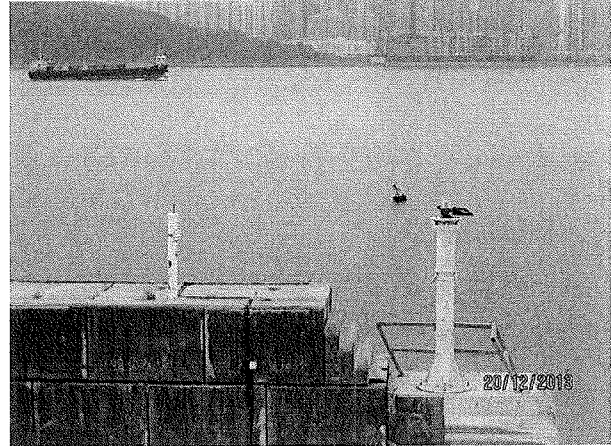
Photo 2

Silt Curtain

**(Follow-up)**

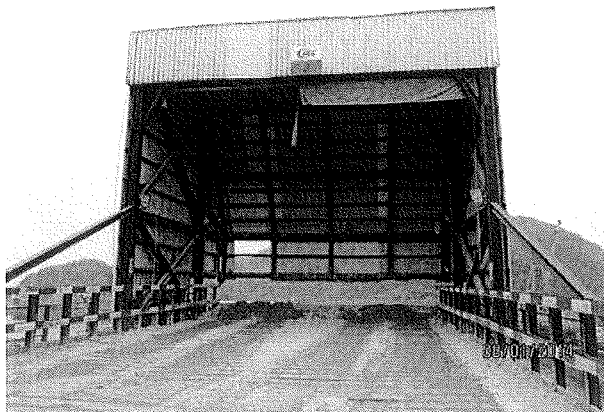
Photo 3

Tipping Hall No.2

Cladding of tipping hall is damaged. The Contractor is reminded to repair the damaged part of tipping hall.

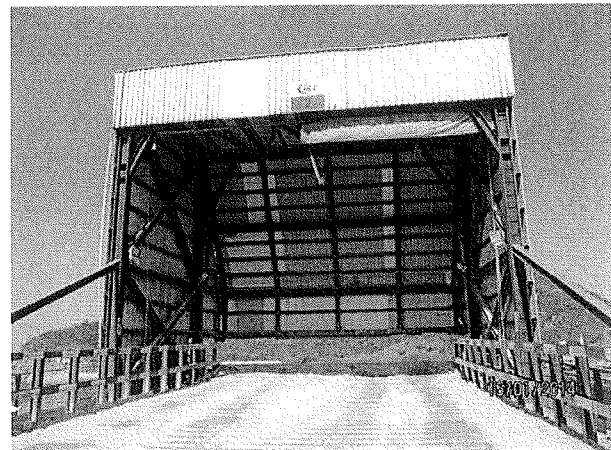
Photo 4

Tipping Hall No.2

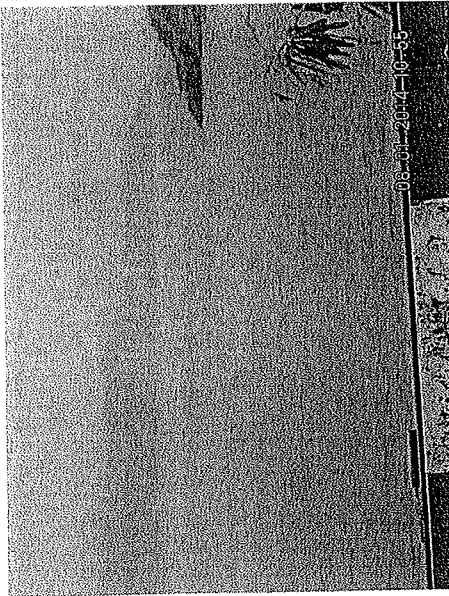
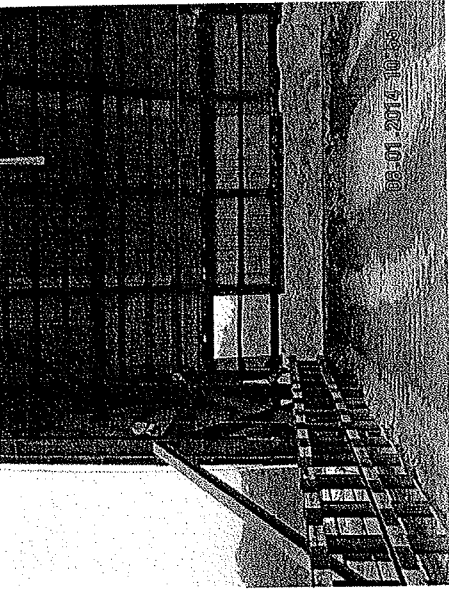
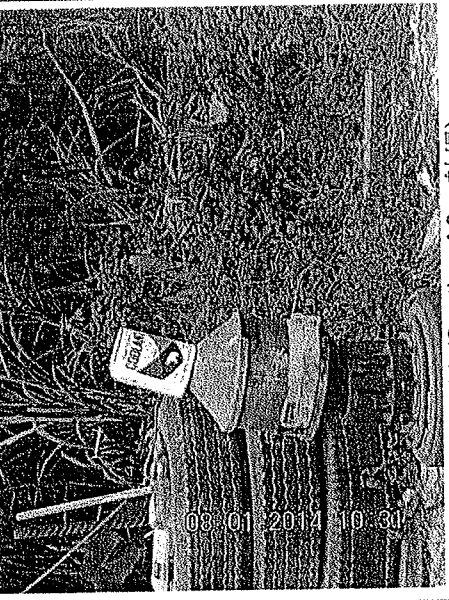
<p>08-01-2014 10:30</p>
<p>Photo 140108_001 (Silt curtain near tipping hall No.1)</p>	<p>Photo 140108_002 (Tipping hall No. 2)</p>	<p>Photo 140108_003 (Section A6 - 軟場) (Improved)</p>

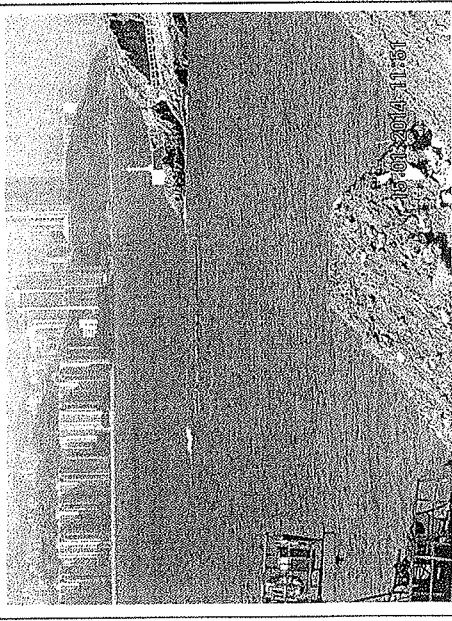
<p>Photo 140108_001 (Silt curtain near tipping hall No.1)</p>
