**CONTRACT NO. CV/2013/09
TEMPORARY CONSTRUCTION WASTE
SORTING FACILITIES, 2014-2016
AT TSEUNG KWAN O AREA 137
MONTHLY EM&A REPORT NO.2
(FEBRUARY 2014)**

Issue Date: 11 March 2014

Report No.: ENA40344

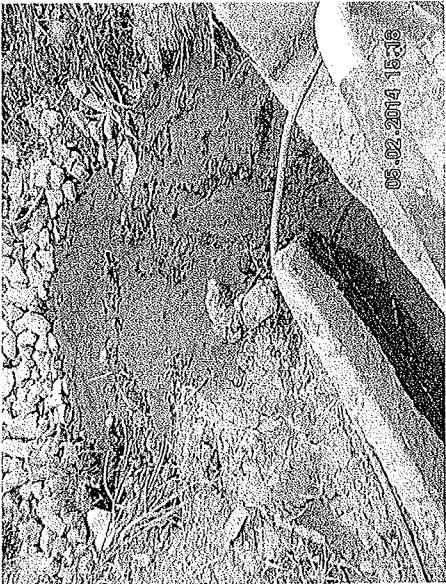
<p>Photo 140205_001 (Zone B2)</p>

Item	Details of defective works or observations	Proposed Follow Up Action	Photo Ref.	Further Action Required (Yes/No)	Target Completion Date
1	Mud and silt were accumulated at the drainage outlet at Zone B.	To clear the accumulated mud and silt in order to avoid any blockage.	140205_001	Yes	10/02/14

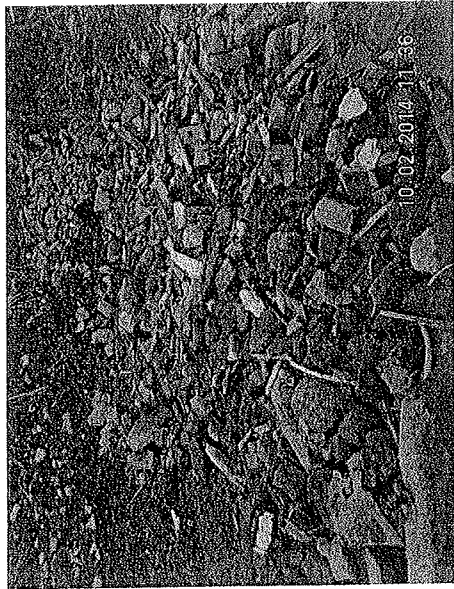
<p>Photo 140210_001 (Zone B2) (Improved)</p>

Item	Details of defective works or observations	Proposed Follow Up Action	Photo Ref.	Further Action Required (Yes/No)	Target Completion Date
1	Follow up action to item 1 on 05/02/14, mud and silt accumulated at the drainage outlet at Zone B were cleared.	--	140210_001	No	---

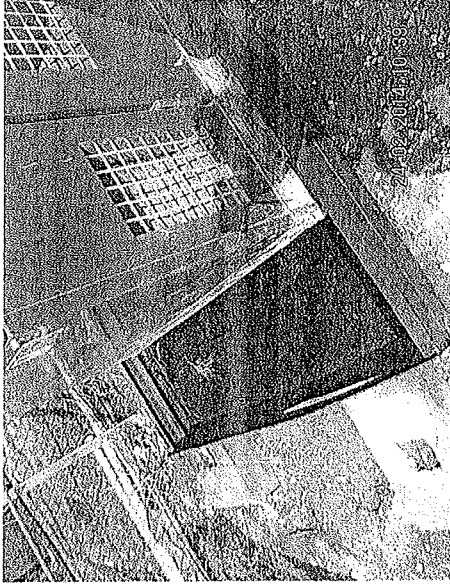
<p>Photo 140224_001 (Contractor's site office)</p>

Item	Details of defective works or observations	Proposed Follow Up Action	Photo Ref.	Further Action Required (Yes/No)	Target Completion Date
1	Drip tray for a generator at Contractor's site office was found without skirt curtain.	To provide skirt curtain to cover the drip tray properly.	140224_001	Yes	03/03/14
