**Contract No.: CV/2013/06  
Handling of Surplus Public Fill  
(2014-2016)**

**TSEUNG KWAN O AREA 137 FILL BANK**

**MONTHLY EM&A REPORT NO.8**

**(AUGUST 2014)**

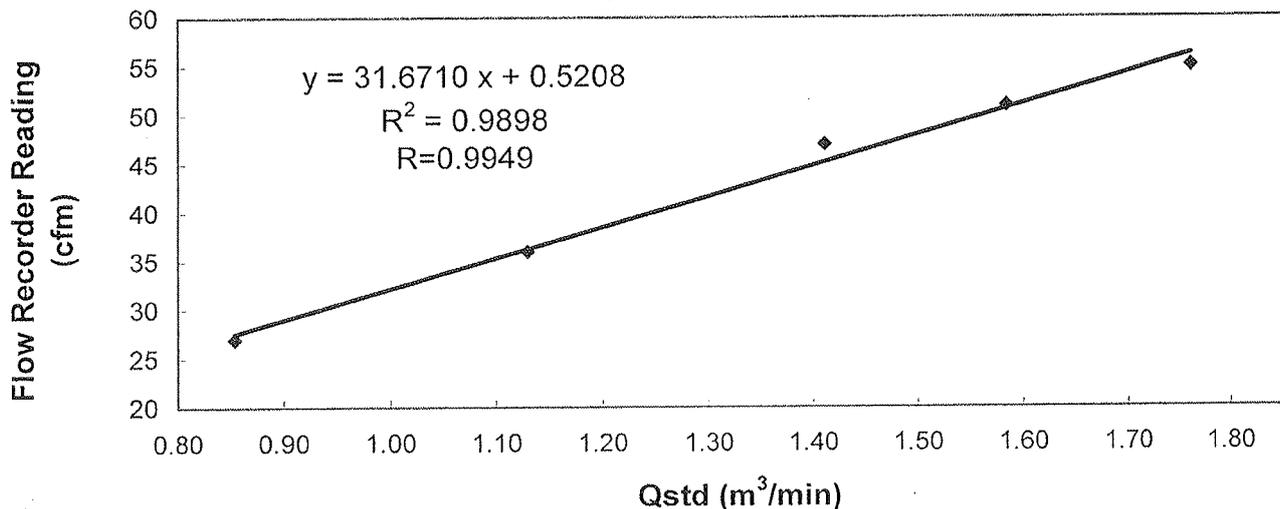
**Sampler 10581 Calibration Curve  
Site: Tseung Kwan O 137 (TKO-A1)**

Flow recorder reading (cfm)	55	51	47	36	27
Qstd (Actual flow rate, m <sup>3</sup> /min)	1.76	1.58	1.41	1.13	0.85
Pressure :	763.56	mm Hg	Temp. :	303	K

Acceptance Criteria : Correlation coefficient (r) of the calibration curve greater than 0.990 after a 5-point calibration.

The high volume sampler complies\* / ~~does not comply\*~~ with the specified requirements and is deemed acceptable\* / unacceptable\* for use.

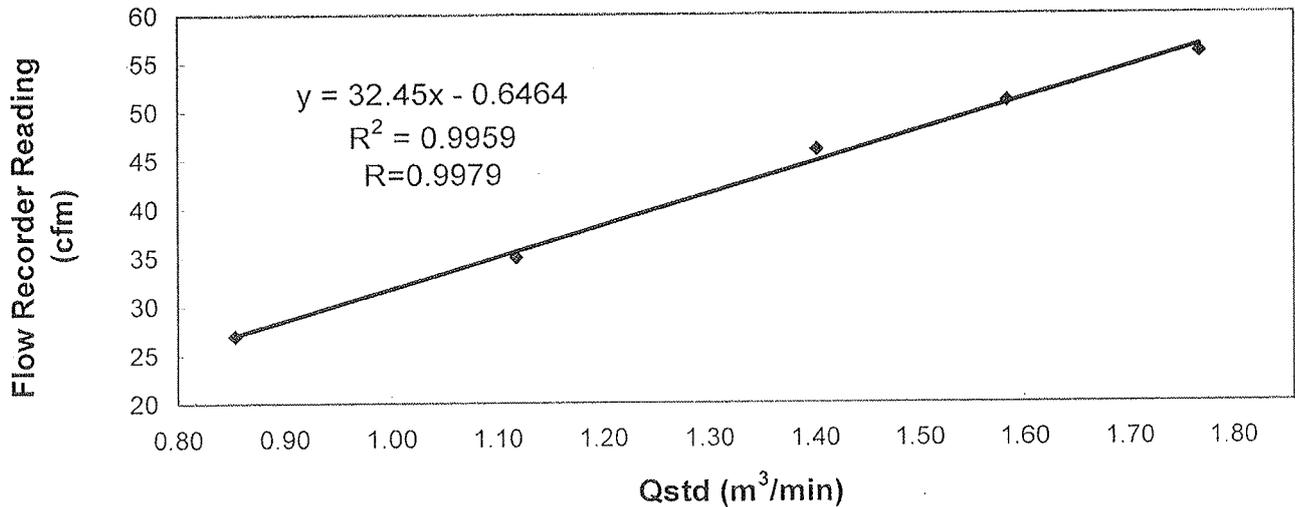
**Sampler 10581 Calibration Curve  
Site: Tseung Kwan O 137 (TKO-A1)**

Results	Flow recorder reading (cfm)	56	51	46	35	27
	Qstd (Actual flow rate, m <sup>3</sup> /min)	1.77	1.58	1.40	1.12	0.85
	Pressure : 763.56 mm Hg	Temp. : 303 K

Acceptance Criteria : Correlation coefficient (r) of the calibration curve greater than 0.990 after a 5-point calibration.

The high volume sampler complies\* / does not comply\* with the specified requirements and is deemed acceptable\* / unacceptable\* for use.

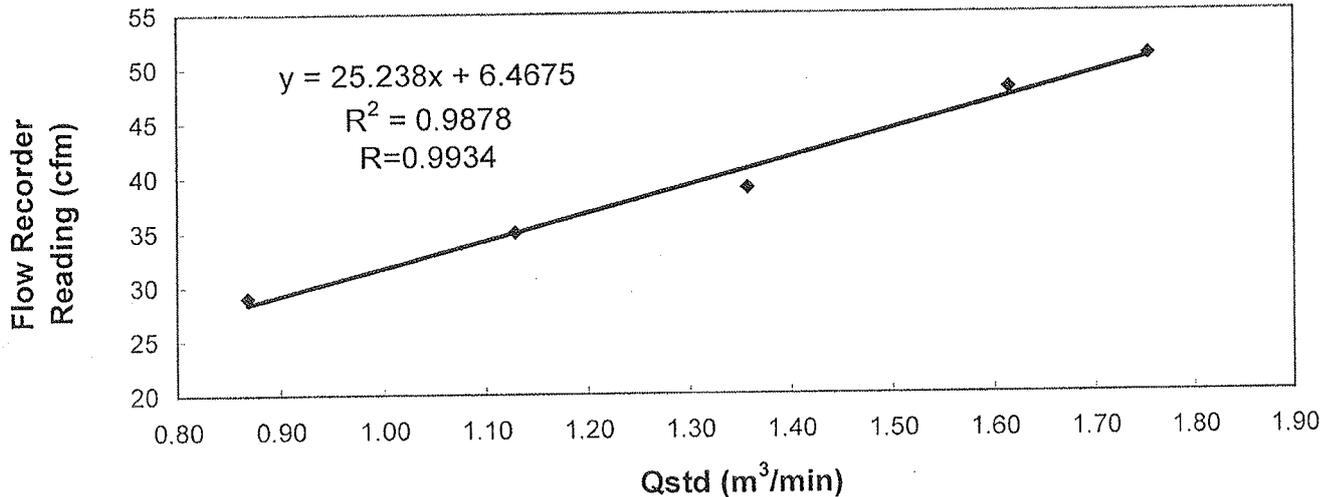
**Sampler 1172 Calibration Curve**  
Site: Tseung Kwan O 137 (TKO-A2a)

Flow recorder reading (cfm)	51	48	39	35	29
Qstd (Actual flow rate, m <sup>3</sup> /min)	1.75	1.61	1.36	1.13	0.87
Pressure :	763.56	mm Hg	Temp. :	303	K

Acceptance Criteria : Correlation coefficient (r) of the calibration curve greater than 0.990 after a 5-point calibration.

The high volume sampler complies\* / ~~does not comply\*~~ with the specified requirements and is deemed acceptable\* / unacceptable\* for use.

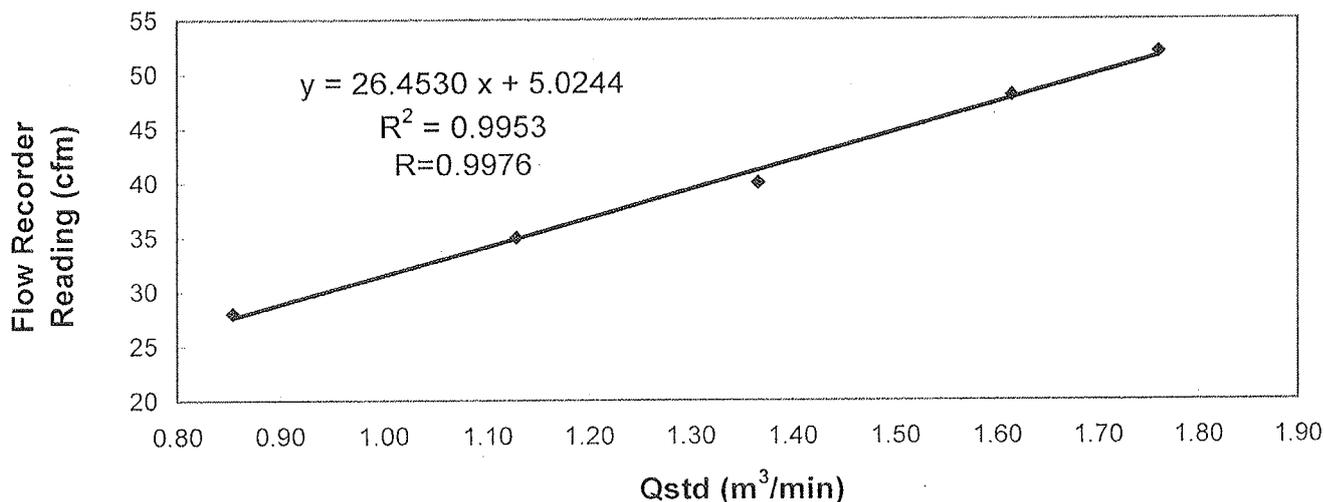
**Sampler 1172 Calibration Curve  
Site: Tseung Kwan O 137 (TKO-A2a)**

Results	Flow recorder reading (cfm)	52	48	40	35	28
	Qstd (Actual flow rate, m <sup>3</sup> /min)	1.76	1.61	1.37	1.13	0.85
	Pressure : 763.56 mm Hg	Temp. :		303 K

Acceptance Criteria : Correlation coefficient (r) of the calibration curve greater than 0.990 after a 5-point calibration.

The high volume sampler complies\* / does not comply\* with the specified requirements and is deemed acceptable\* / unacceptable\* for use.

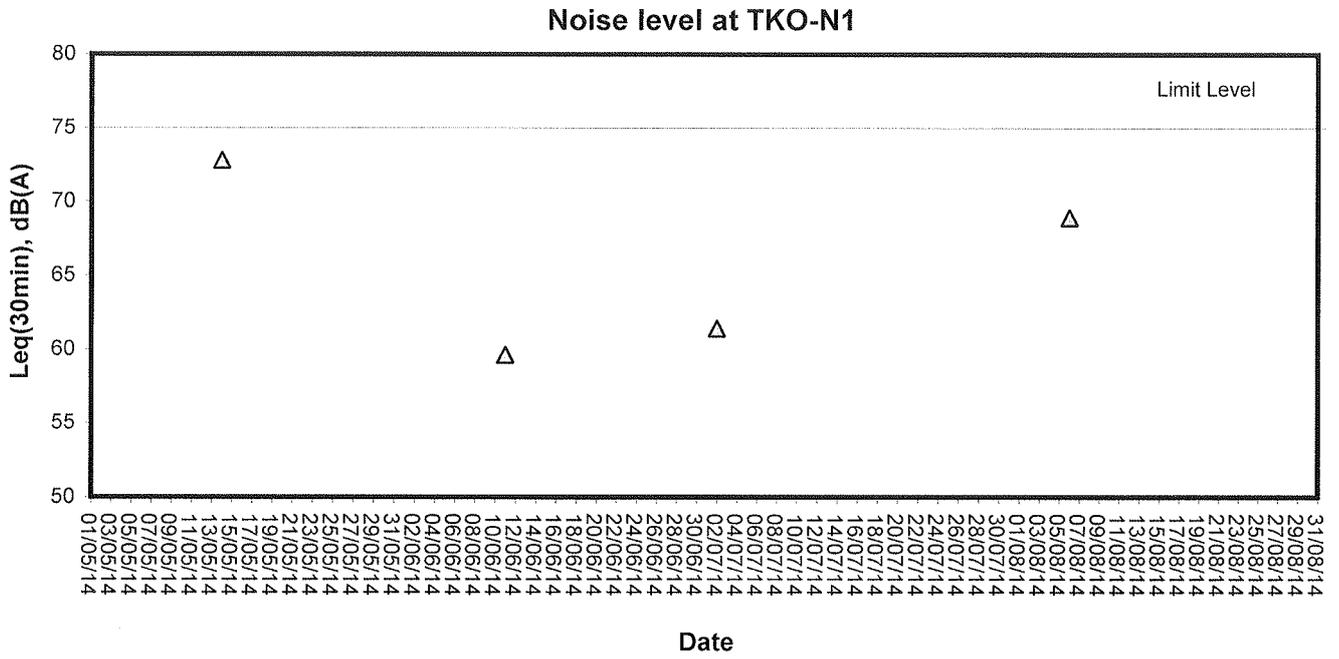
## Noise Monitoring (Day-time)

Date	Start Sampling Time (hh:mm)	Noise Level dB (A)			Wind Speed (m/s)	Weather Condition
		L <sub>eq</sub> (30min)	L <sub>10</sub>	L <sub>90</sub>		
06/08/14	08:45	68.9	71.4	65.3	0.3	Fine

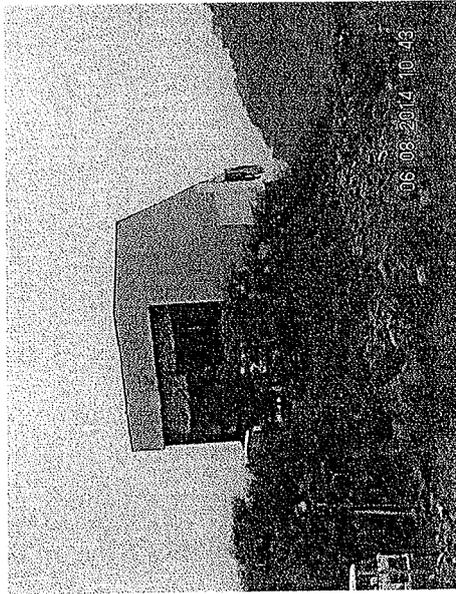
Photo 140806\_001 (Tipping Hall No.2)

Date	Key Findings	Action(s) Taken recommended by ET	Action(s) Taken by the Contractor during the ET weekly site audit	Rectification Status by ET
06 August 2014	The enclosure of tipping hall No.2 was damaged. (Previous item)	To repair the damaged part of tipping hall properly.	---	Follow-up
	The enclosure of tipping hall No.3 was damaged. (Previous item)	To repair the damaged part of tipping hall properly.	---	Follow-up
	Desilting set-up at catchpit CP5 and CP8 were found insufficient to treat the site surface runoff. (Previous item)	To enhance the desilting set-up at catchpit CP5 and CP8 to improve the desilting capacity.	---	Follow-up
13 August 2014	The enclosure of tipping hall No.2 was damaged. (Previous item)	To repair the damaged part of tipping hall properly.	The enclosure of tipping hall No.2 was repaired.	Closed
	The enclosure of tipping hall No.3 was damaged. (Previous item)	To repair the damaged part of tipping hall properly.	The enclosure of tipping hall No.3 was repaired.	Closed

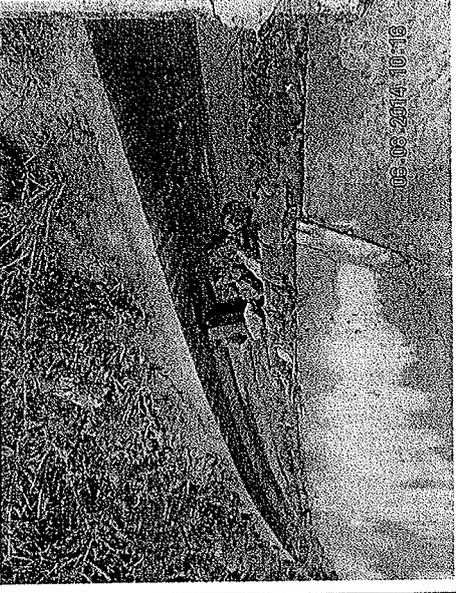
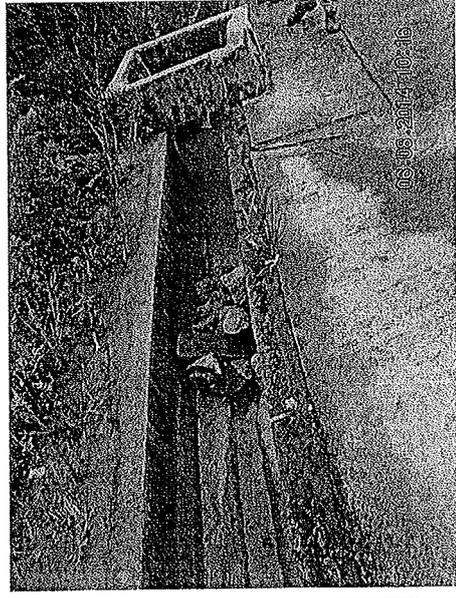
Photo 140806\_003 (Catchpit CP5 and CP8)

Desilting set-up at catchpit CP5 and CP8 were found insufficient to treat the site surface runoff. (Previous item)	To enhance the desilting set-up at catchpit CP5 and CP8 to improve the desilting capacity.	Desilting set-up at catchpit CP5 and CP8 were still found improved to treat the site surface runoff.	Closed
19 August 2014	Mud and silt were found accumulated inside the drainage channel from Catchpit CP5 to CP8. (New item)	To clear the accumulated mud and silt properly.	---	Follow-up
27 August 2014	Mud and silt were found accumulated inside the drainage channel from Catchpit CP5 to CP8. (Previous item)	To clear the accumulated mud and silt properly.	---	Follow-up
	Water leakage was noted from the air conditioner at CEDD site office. (New item)	To repair the defect part of the air conditioner or provide appropriate container to collect the leaked water.	---	Follow-up
	Oil leakage was found from a generator without coving with skirt curtain at A4 zone. (New item)	To clean up the oil strain and contaminated material as chemical waste, and provide appropriate skirt curtain for the generator.	---	Follow-up
