Contract No.: CV/2013/06
Handling of Surplus Public Fill
(2014-2016)

TSEUNG KWAN O AREA 137 FILL BANK

MONTHLY EM&A REPORT NO.21

(SEPTEMBER 2015)

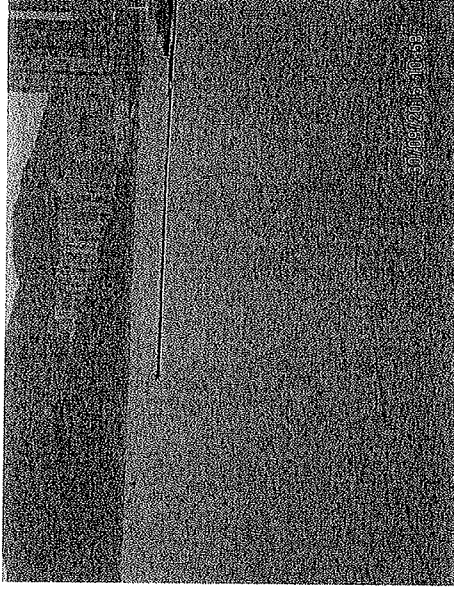
| Date | Key Findings | Action(s) Taken recommended by ET | Action(s) Taken by the Contractor during the ET weekly site audit | Rectification Status by ET |
|---|--|--|---|---|
| 30 September 2015 | Both sides of the silt curtain were found damaged. (Previous item) | To repair the silt curtain as soon as possible | Both sides of the silt curtain were repaired. | Closed |

Photo 150930_001 (Silt curtain) (Improved)

Photo 150930_002 (Silt curtain) (Improved)

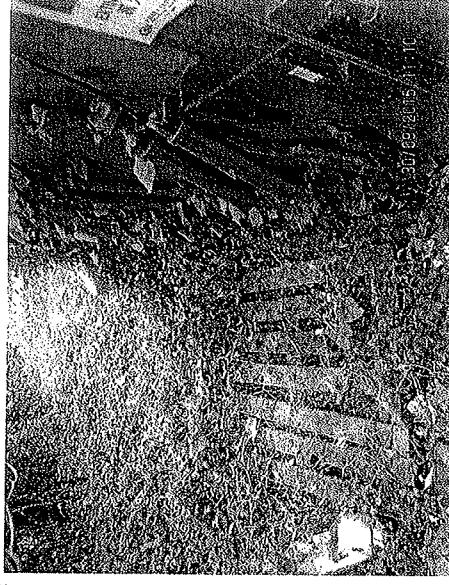
Photo 150930_003 (Area A6) (Improved)

| Date | Key Findings | Action(s) Taken recommended by ET | Action(s) Taken by the Contractor during the ET weekly site audit | Rectification Status by ET |
|---|--|--|---|---|
| | Idle chemical buckets were found discarded at Area A6. (Previous item) | To collect and dispose of / store the chemical buckets properly. | The chemical buckets were discarded at Area A6 were collected. | Closed |
