**Contract No.: CV/2013/06
Handling of Surplus Public Fill
(2014-2016)**

TSEUNG KWAN O AREA 137 FILL BANK

MONTHLY EM&A REPORT NO.29

(MAY 2016)

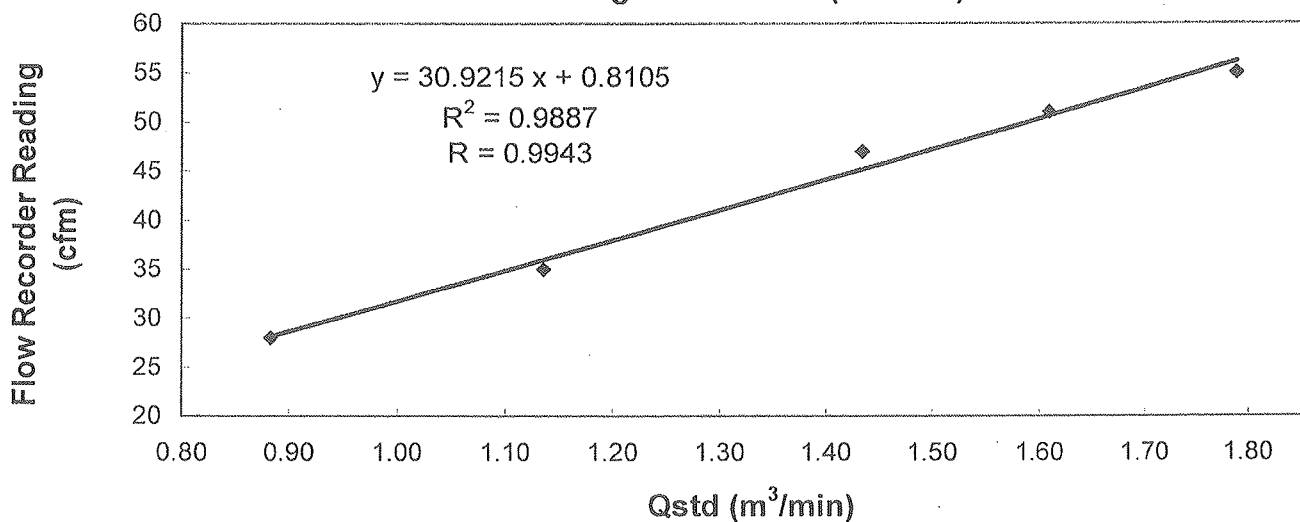
Sampler 10581 Calibration Curve
Site: Tseung Kwan O 137 (TKO-A1)

Results	Flow recorder reading (cfm)	55	51	47	35	28
	Qstd (Actual flow rate, m ³ /min)	1.79	1.61	1.43	1.14	0.88
	Pressure : 763.56	Temp. : 293		K

Acceptance Criteria : Correlation coefficient (r) of the calibration curve greater than 0.990 after a 5-point calibration.

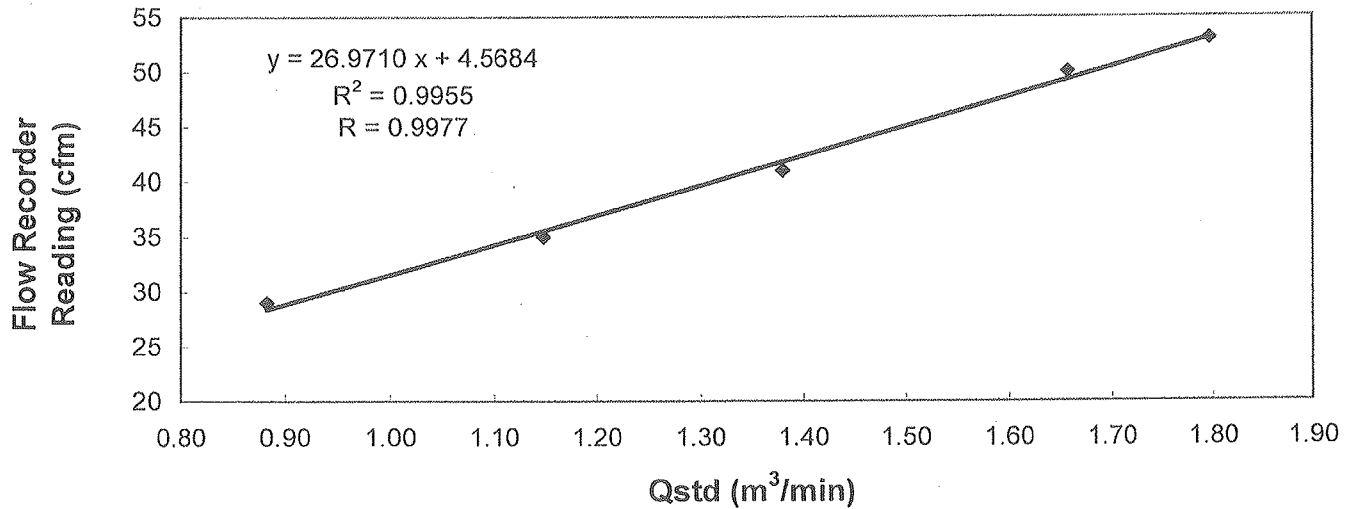
Sampler 1172 Calibration Curve
Site: Tseung Kwan O 137 (TKO-A2a)

Results	Flow recorder reading (cfm)	53	50	41	35	29
	Qstd (Actual flow rate, m ³ /min)	1.80	1.66	1.38	1.15	0.88
	Pressure : 763.56 mm Hg	Temp. : 293 K

Acceptance Criteria : Correlation coefficient (r) of the calibration curve greater than 0.990 after a 5-point calibration.

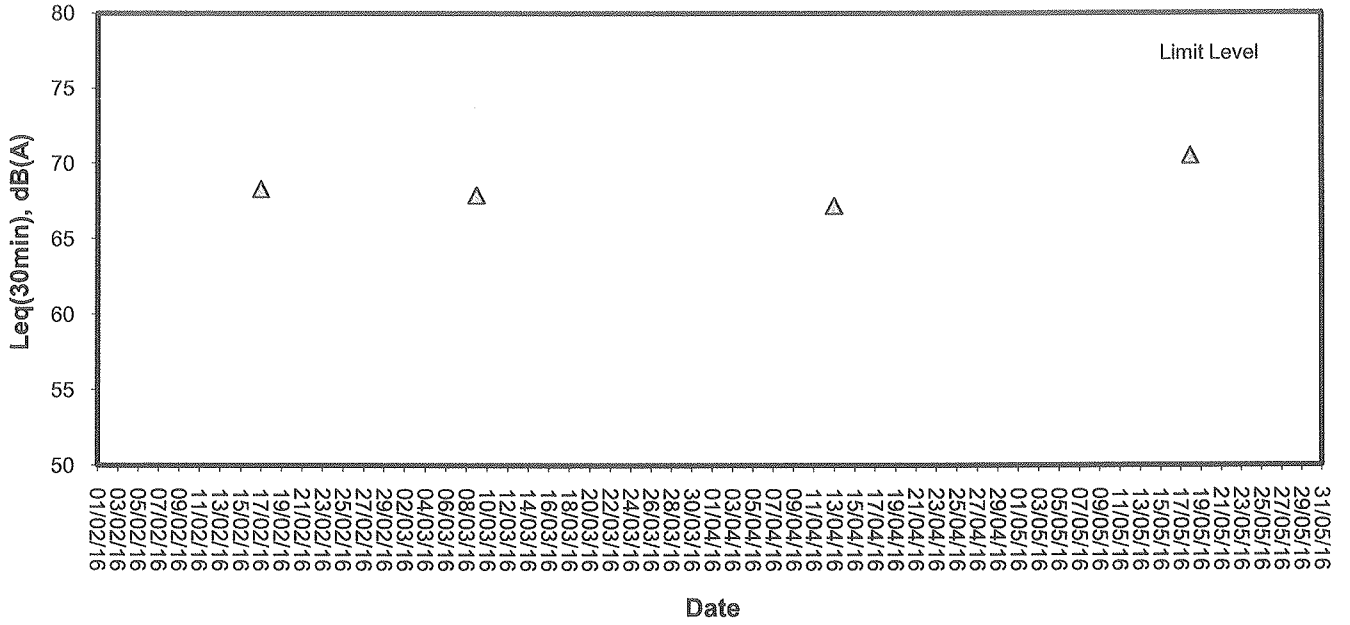
Noise level at TKO-N1

Date	Start Sampling Time (hh:mm)	Noise Level dB (A)			Wind Speed (m/s)	Weather Condition
		L _{eq} (30min)	L ₁₀	L ₉₀		
18/05/16	14:15	70.5	74.2	69.3	0.2	Fine

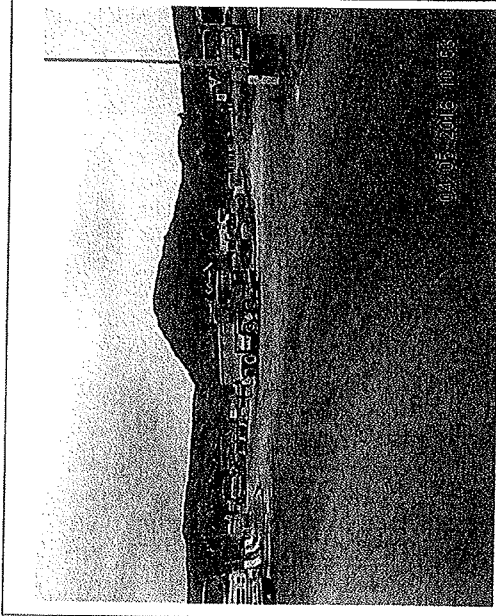
Photo 160504_001 (Zone A1) (Improved)

Item	Details of defective works or observations	Proposed Follow Up Action	Photo Ref.	Further Action Required (Yes/No)	Target Completion Date
1	Follow up action to item 2 on 27/04/2016, no stagnant water was found on the road near Zone A1.	--	160504_001	No	--
2	Mud was noted on the ground near wheel maintenance area.	To clear the mud as soon as possible.	160504_002	Yes	11/05/16
3	Rubbish, such as plastic bag and paper box, were found discarded inside and beside the drainage channel near site entrance.	To collect and dispose of the rubbish properly.	160504_003	Yes	11/05/16

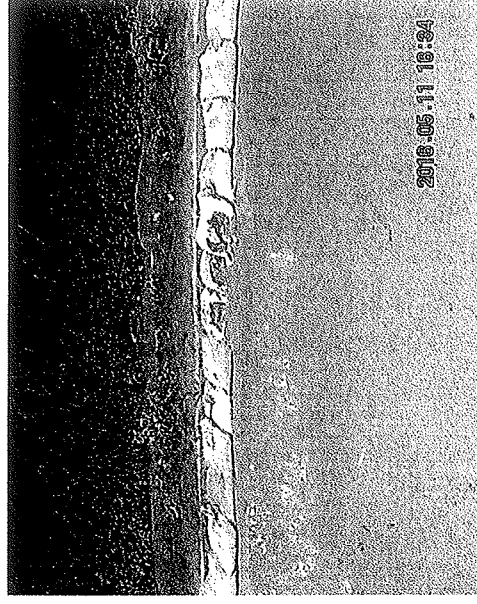
Photo 160511_003 (Near CP5)

Muddy water was found accumulated besides the drainage channel near CP5. (New item)	To clear the accumulated muddy water properly.	---	Follow-up
	Some sand bags provided along the drainage channel near CP5 were broken. (New item)	To replace the broken sand bags by new ones.	---	Follow-up
18 May 2016	Muddy water was found accumulated besides the drainage channel near CP5. (Previous item)	To clear the accumulated muddy water properly.	Muddy water accumulated besides the drainage channel near CP5 was cleared.	Closed
	Some sand bags provided along the drainage channel near CP5 were broken. (Previous item)	To replace the broken sand bags by new ones.	Broken sand bags provided along the drainage channel near CP5 were replaced by new ones.	Closed
	The silt curtain near the tipping hall No.1 was found damaged. (New item)	To repair the damaged silt curtain properly.	---	Follow-up
25 May 2016	The silt curtain near the tipping hall No.1 was found damaged. (Previous item)	To repair the damaged silt curtain properly.	---	Follow-up

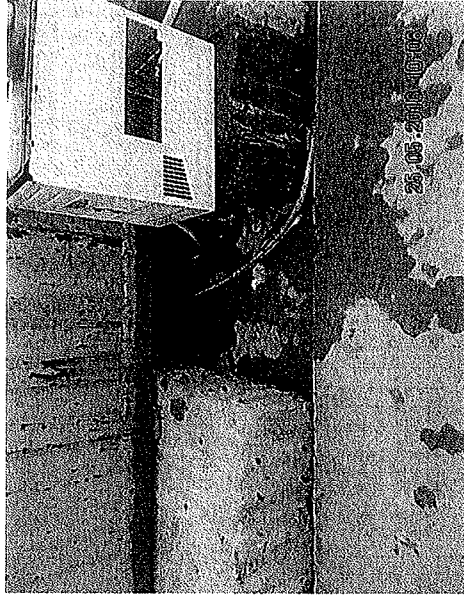
Photo 160525_002 (Near wheel repairing area)

Stagnant water was found under the container near wheel repairing area. (New item)	To clear the stagnant water to avoid mosquito breeding.	---	Follow-up

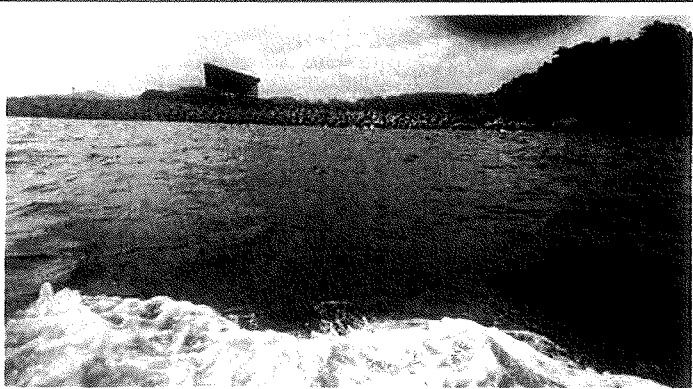
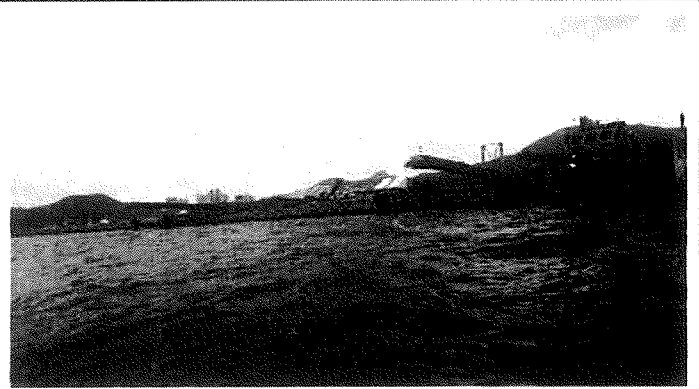
Barging Point at TKO137

- Two complaints received on 25 and 27 May 2016, which were forwarded to ET on 01 June 2016, from EPD (Ref. NCF-N08/RE/000012768-16 and NCF-N08/RE/000013040-16) against the dust emission from barging points at TKO137 Fill Bank. The complainant complained that dust generated caused an environmental nuisance;

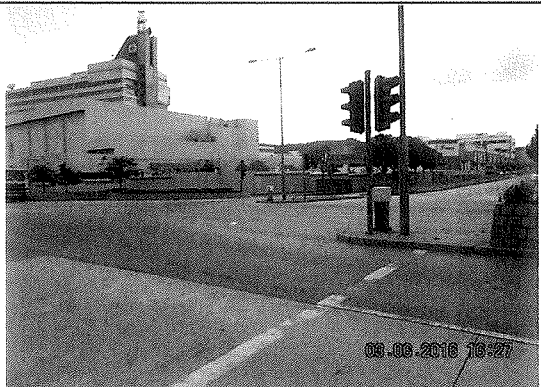
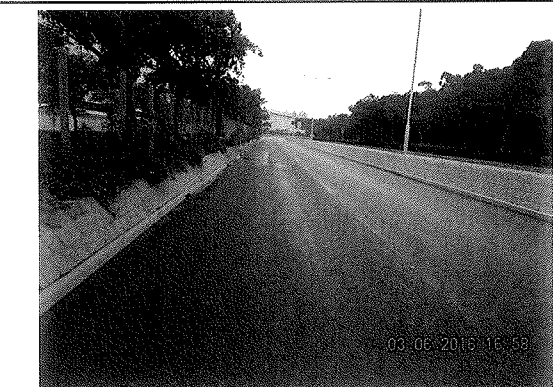
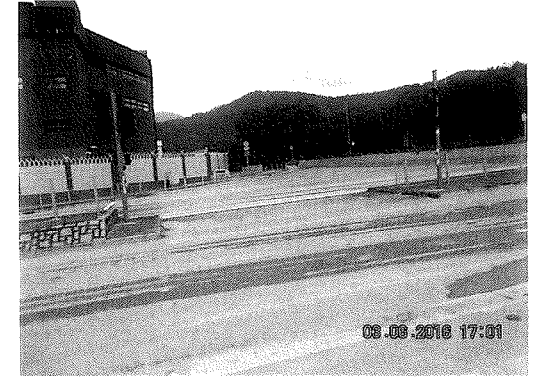
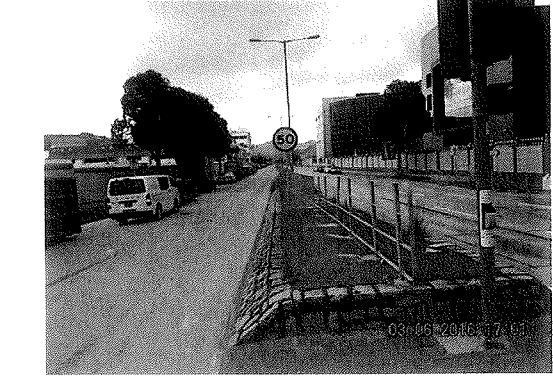
Wan Po Road near TVB

- Two complaints received on 22 and 26 May 2016, which were forwarded to ET on 02 June 2016, from 1823 (Case#2-2257302039) & EPD (Ref: NCF-N08/RE/000012545-16) and EPD (Ref. NCF-N08/RE/000013106-16) against the muddy water noted at Wan Po Road near Tseung Kwan O Industrial Estate. The complainant complained that water and waste generated caused an environmental nuisance.
