**Contract No.: CV/2013/06
Handling of Surplus Public Fill
(2014-2016)**

**TSEUNG KWAN O AREA 137 FILL BANK
MONTHLY EM&A REPORT NO.31
(JULY 2016)**

Report No.: ENA63396

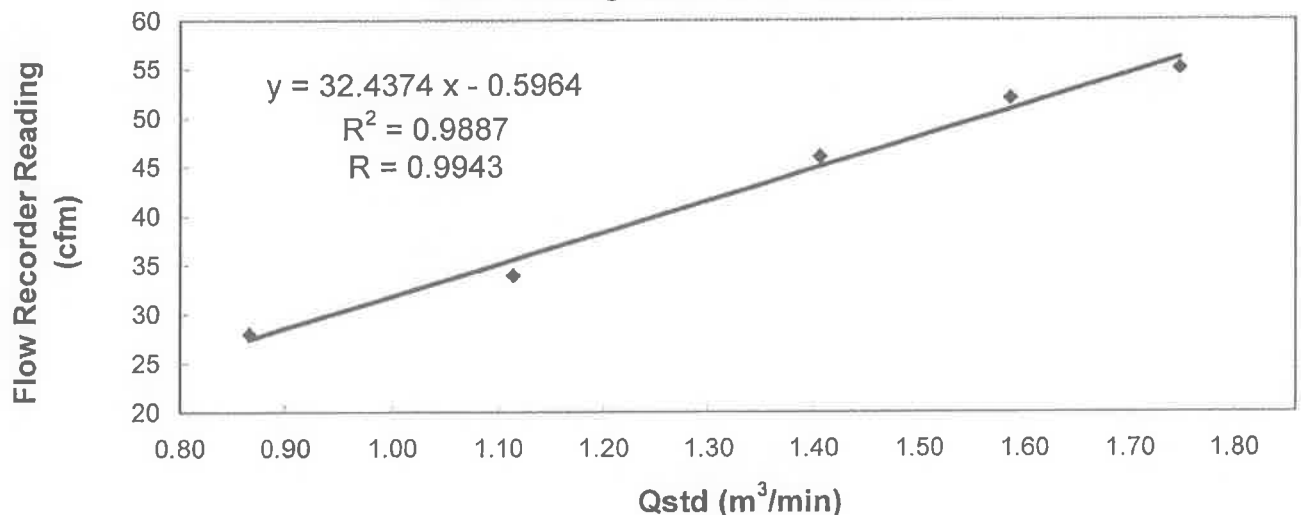
Sampler 10581 Calibration Curve
Site: Tseung Kwan O 137 (TKO-A1)

Flow recorder reading (cfm)	55	52	46	34	28
Qstd (Actual flow rate, m ³ /min)	1.75	1.59	1.41	1.11	0.87
Pressure :	763.56		Temp. :	305 K

Acceptance Criteria : Correlation coefficient (r) of the calibration curve greater than 0.990 after a 5-point calibration.

The high volume sampler complies* / ~~does not comply*~~ with the specified requirements and is deemed acceptable* / unacceptable* for use.

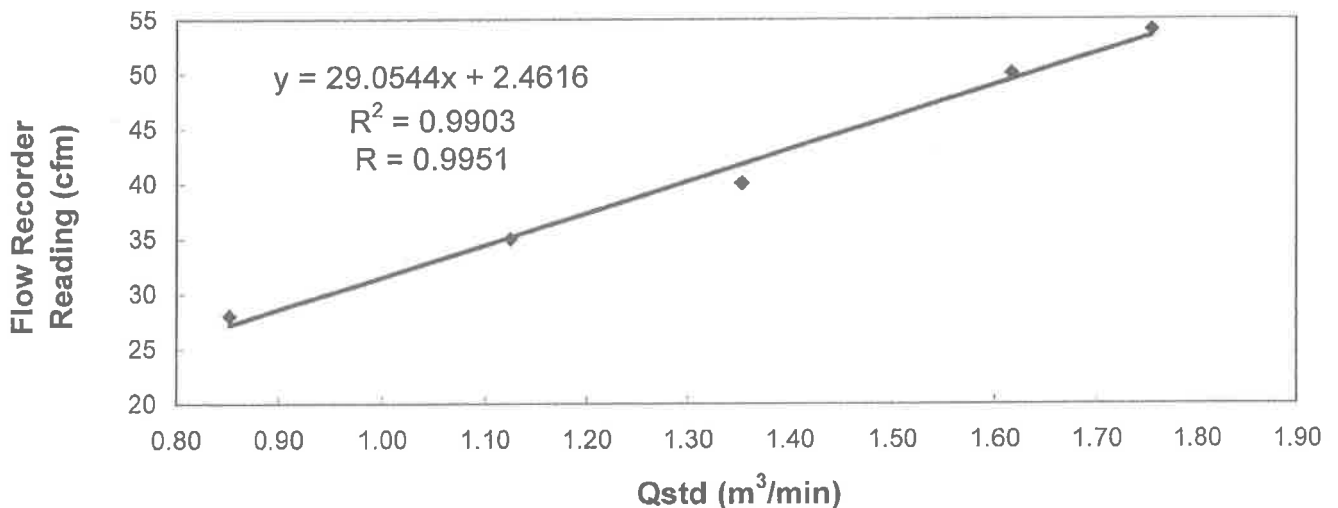
Sampler 1172 Calibration Curve
Site: Tseung Kwan O 137 (TKO-A2a)

Results	Flow recorder reading (cfm)	54	50	40	35	28
	Qstd (Actual flow rate, m ³ /min)	1.75	1.62	1.35	1.13	0.85
	Pressure : 763.56 mm Hg	Temp. : 305 K

Acceptance Criteria : Correlation coefficient (r) of the calibration curve greater than 0.990 after a 5-point calibration.

The high volume sampler complies* / ~~does not comply*~~ with the specified requirements and is deemed acceptable* / ~~unacceptable*~~ for use.

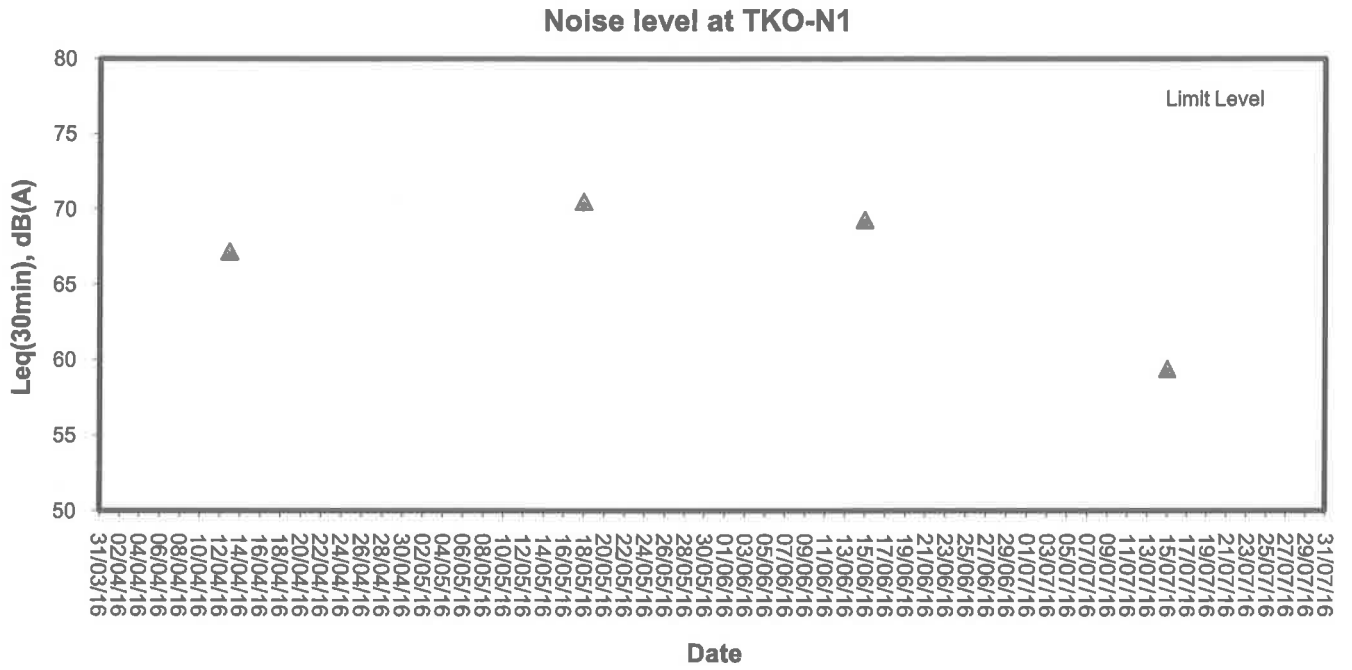
Noise Monitoring (Day-time)

Date	Start Sampling Time (hh:mm)	Noise Level dB (A)			Wind Speed (m/s)	Weather Condition
		L _{eq} (30min)	L ₁₀	L ₉₀		
15/07/16	08:30	59.4	62.8	53.9	0.2	Fine

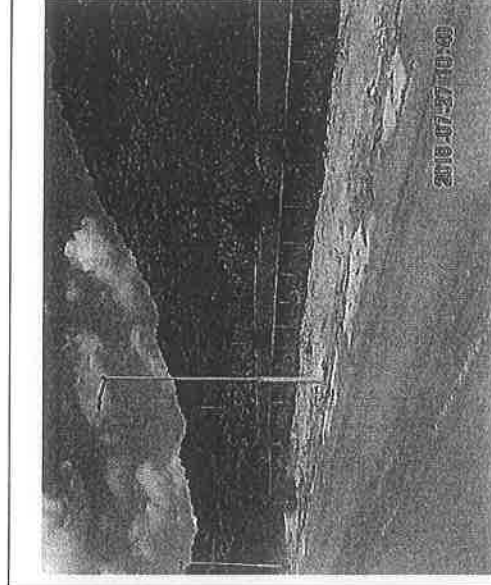
Photo 160727_001 (Wheel repairing area near the Contractor's site office)

Silt curtain near the tipping hall No.1 was found damaged. (New item)	To repair the damaged silt curtain properly.	---	Follow-up
27 July 2016	Standing water was noted at wheel repairing area near the Contractor's site office. (Previous item)	To clear the standing water to avoid mosquito breeding.	---	Follow-up
	Rocks and mud was found accumulated beside the haul road near barge handling area (BHA). (Previous item)	To clear the rocks and mud properly.	Rocks and mud accumulated beside the haul road near barge handling area (BHA) were cleared.	Closed
	Silt curtain near the tipping hall No.1 was found damaged. (Previous item)	To repair the damaged silt curtain properly.	---	Follow-up
