HKPFH Joint Venture

**Contract No.: CV/2013/06
Handling of Surplus Public Fill
(2014-2016)**

**TSEUNG KWAN O AREA 137 FILL BANK
MONTHLY EM&A REPORT NO.32
(AUGUST 2016)**

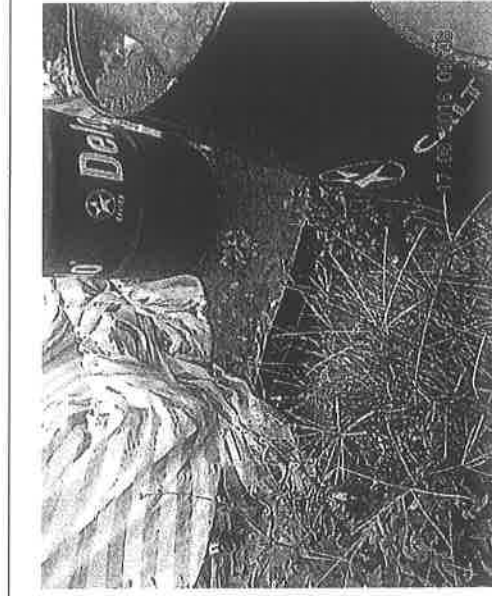
Stagnant water was found inside the drip tray at truck maintenance workshop near the Contractor's site office. (New item)	To drain out the stagnant water to avoid mosquito breeding.	---	Follow-up
	Stagnant water was found inside the bucket of an excavator at truck maintenance workshop near the Contractor's site office. (New item)	To clear the stagnant water to avoid mosquito breeding.	---	Follow-up

Photo 160817_003 (Truck maintenance workshop near the Contractor's site office)

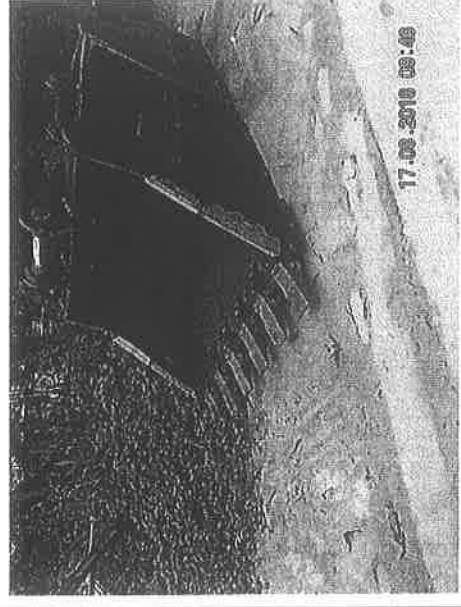
Photo 160817_004 (Truck maintenance workshop near the Contractor's site office)

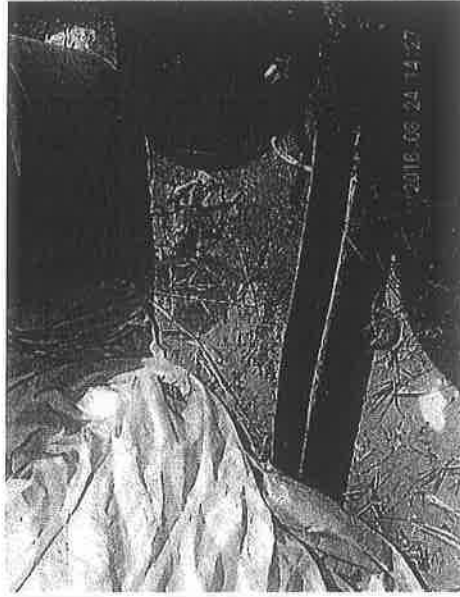
<p>Photo 160824_002 (Truck maintenance workshop near the Contractor's site office)(Improved)</p>
