**Contract No.: CV/2013/06  
Handling of Surplus Public Fill  
(2014-2016)**

**TSEUNG KWAN O AREA 137 FILL BANK**

**MONTHLY EM&A REPORT NO.33**

**(SEPTEMBER 2016)**

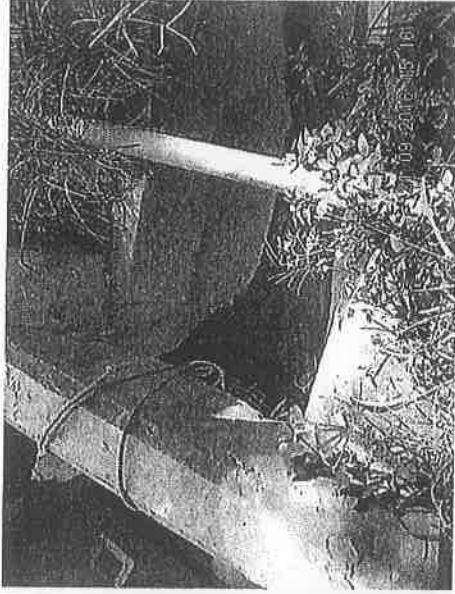
Photo 160921\_002 (CP5)

Desilting screen at CP5 was dilapidated. (New item)	To replace the desilting screen properly.	---	Follow-up
	Standing water was accumulated inside the bucket of an excavator near chemical waste storage area. (New item)	To clear the standing water or apply pesticide to avoid mosquito breeding.	---	Follow-up
28 September 2016	Silt curtain near Fat Tong Chau was damaged. (Previous item)	To repair the damaged silt curtain properly.	Silt curtain near Fat Tong Chau was repaired.	Closed
	Desilting screen at CP5 was dilapidated. (Previous item)	To replace the desilting screen properly.	Desilting screen at CP5 was replaced properly.	Closed
	Standing water was accumulated inside the bucket of an excavator near chemical waste storage area. (Previous item)	To clear the standing water or apply pesticide to avoid mosquito breeding.	Standing water was noted inside the bucket of an excavator near chemical waste storage area was cleared.	Closed
