**Contract No.: CV/2013/06
Handling of Surplus Public Fill
(2014-2016)**

TSEUNG KWAN O AREA 137 FILL BANK

MONTHLY EM&A REPORT NO.36

(DECEMBER 2016)

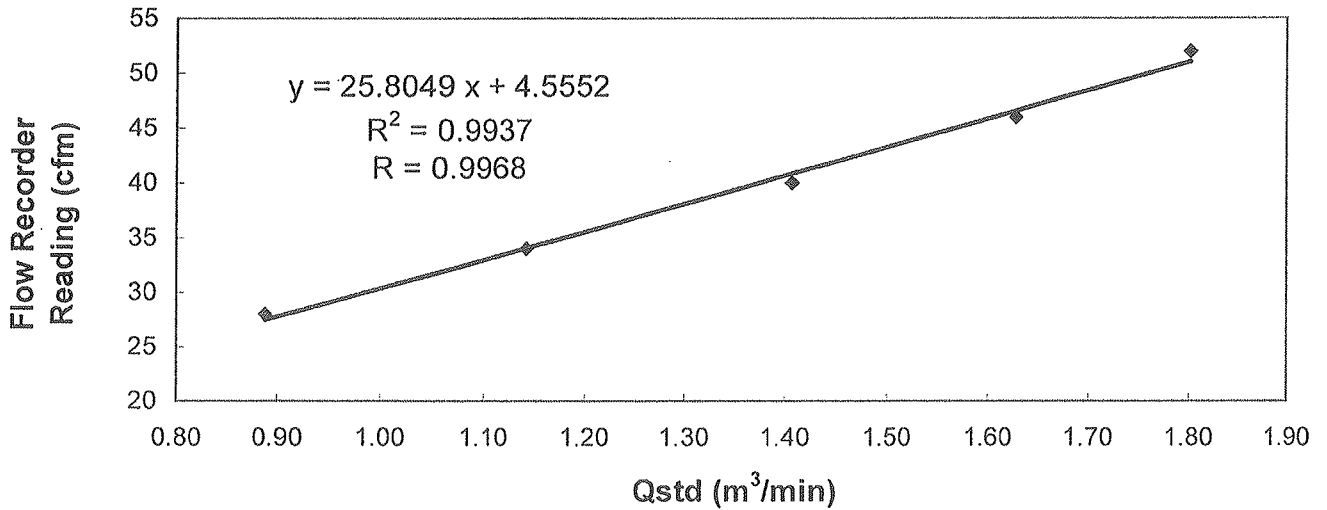
Sampler 1172 Calibration Curve
Site: Tseung Kwan O 137 (TKO-A2a)

Results	Flow recorder reading (cfm)	52	46	40	34	28
	Qstd (Actual flow rate, m ³ /min)	1.80	1.63	1.41	1.14	0.89
	Pressure : 765.06 mm Hg	Temp. : 290 K

Acceptance Criteria : Correlation coefficient (r) of the calibration curve greater than 0.990 after a 5-point calibration.

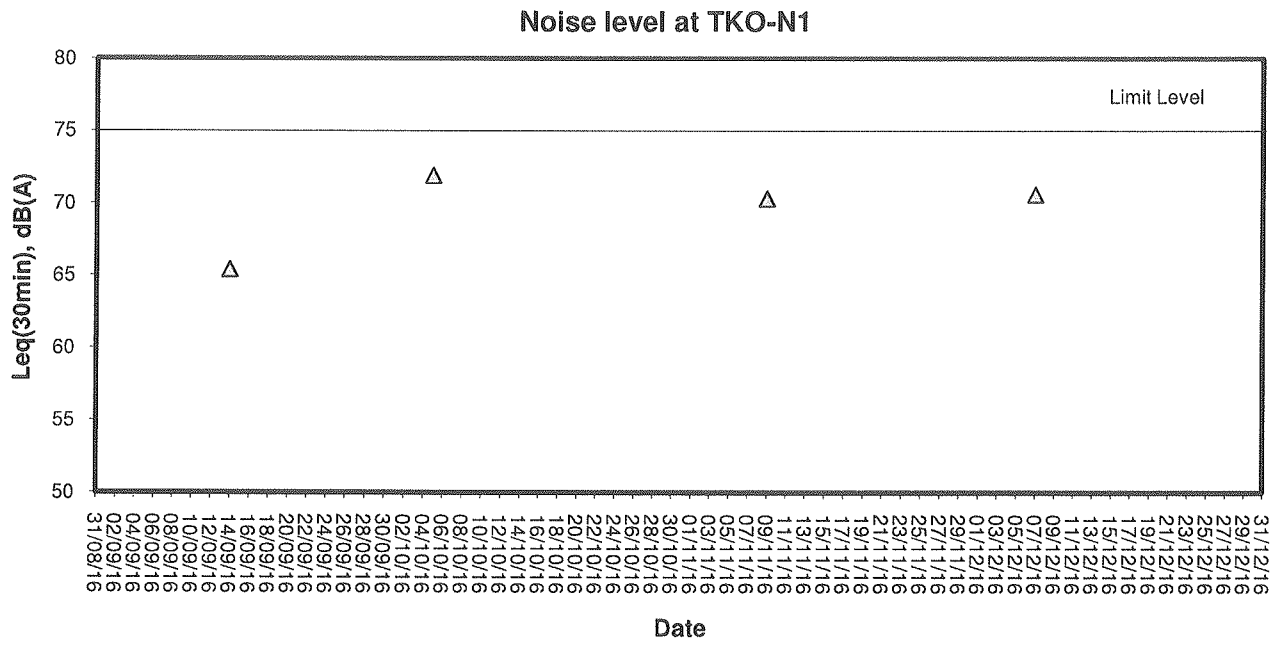
Noise Monitoring (Day-time)

Date	Start Sampling Time (hh:mm)	Noise Level dB (A)			Wind Speed (m/s)	Weather Condition
		L _{eq} (30min)	L ₁₀	L ₉₀		
07/12/16	09:00	70.6	72.9	67.8	0.2	Cloudy

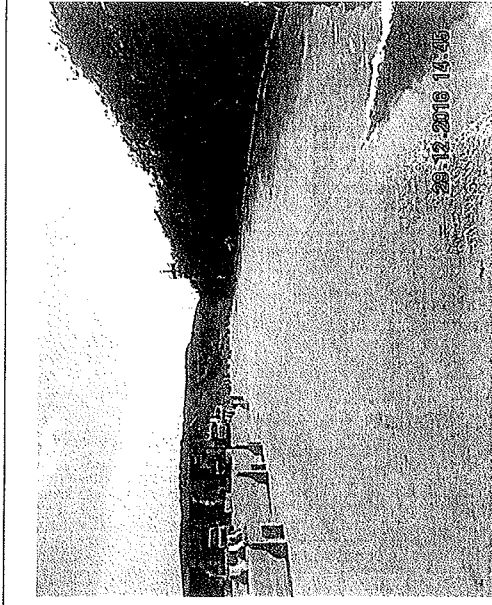
Photo 161229_001 (CP5)

Item	Details of defective works or observations	Proposed Follow Up Action	Photo Ref.	Further Action Required (Yes/No)	Follow up Date
1	Follow up action to item 1 on 21/12/16, mud on the haul road near CP5 was cleaned up.	--	161229_001	No	--
