**Contract No.: CV/2013/06
Handling of Surplus Public Fill
(2014-2016)**

TSEUNG KWAN O AREA 137 FILL BANK

MONTHLY EM&A REPORT NO.38

(FEBRUARY 2017)

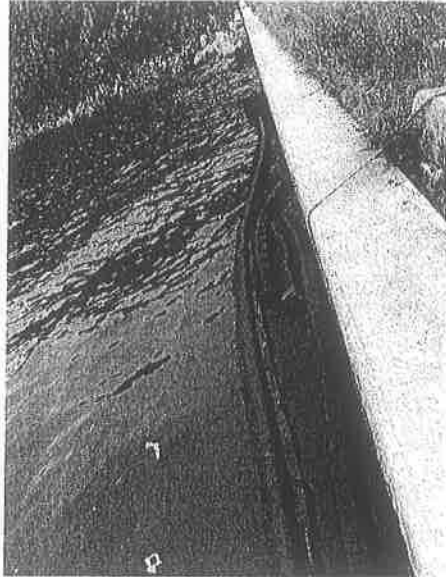
<p>Photo 170222_001 (Near Fat Tong Chau)</p>		
---	--	--

Item	Details of defective works or observations	Proposed Follow Up Action	Photo Ref.	Further Action Required (Yes/No)	Follow up Date
1	Silt curtain near Fat Tong Chau was damaged.	To repair the damaged silt curtain property.	170222_001	Yes	01/03/17

Date	Key Findings	Action(s) Taken recommended by ET	Action(s) Taken by the Contractor during the ET weekly site audit	Rectification Status by ET
03 February 2017	No defective work or observation was recorded during the weekly ET site inspection.			
08 February 2017	No defective work or observation was recorded during the weekly ET site inspection.			
17 February 2017	No defective work or observation was recorded during the weekly ET site inspection.			
22 February 2017	Silt curtain near Fat Tong Chau was damaged. (New item)	To repair the damaged silt curtain properly.	---	Follow-up
