**Contract No.: CV/2013/06
Handling of Surplus Public Fill
(2014-2016)**

TSEUNG KWAN O AREA 137 FILL BANK

MONTHLY EM&A REPORT NO.41

(01 TO 11 MAY 2017)

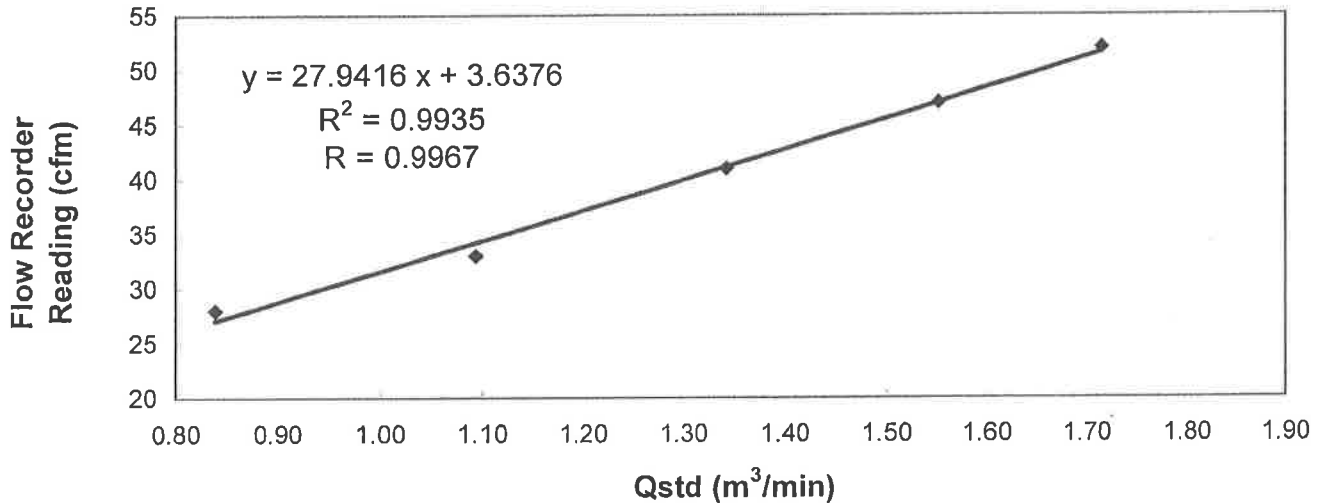
Sampler 1172 Calibration Curve
Site: Tseung Kwan O 137 (TKO-A2a)

Flow recorder reading (cfm)	52	47	41	33	28
Qstd (Actual flow rate, m ³ /min)	1.72	1.55	1.34	1.09	0.84
Pressure :	765.81	mm Hg	Temp. :	295	K

Acceptance Criteria : Correlation coefficient (r) of the calibration curve greater than 0.990 after a 5-point calibration.

The high volume sampler complies* / ~~does not comply*~~ with the specified requirements and is deemed acceptable* / unacceptable* for use.

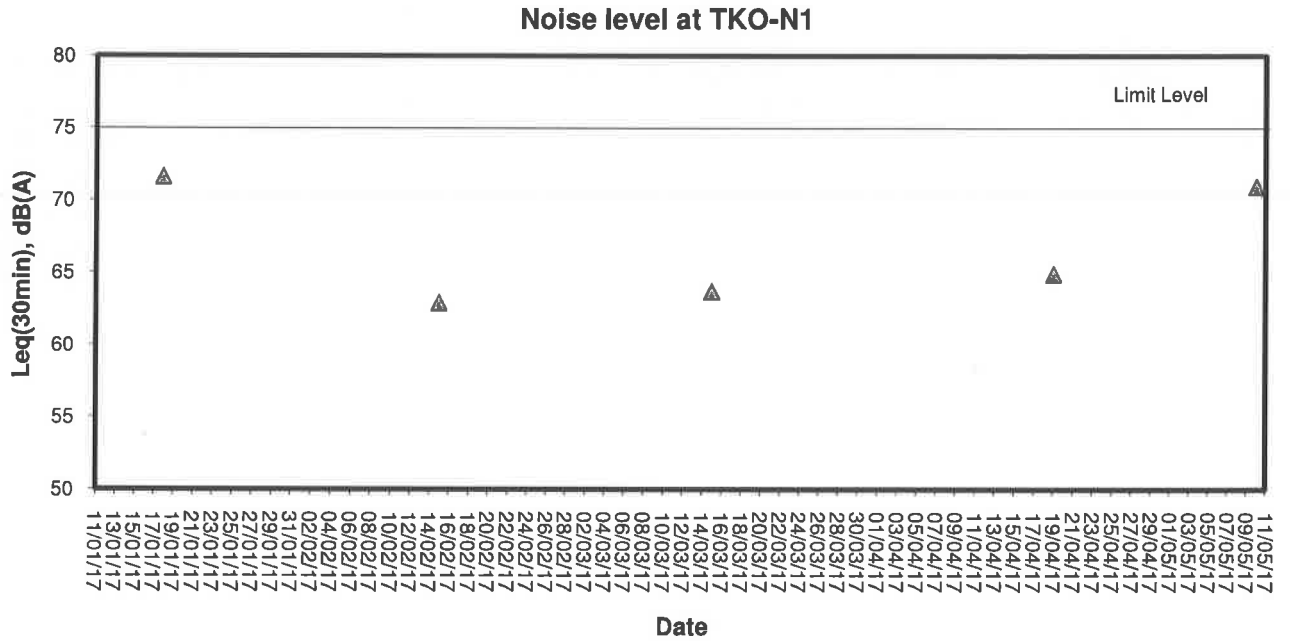
Noise Monitoring (Day-time)

Date	Start Sampling Time (hh:mm)	Noise Level dB (A)			Wind Speed (m/s)	Weather Condition
		L _{eq} (30min)	L ₁₀	L ₉₀		
10/05/17	13:30	70.9	72.4	69.3	0.2	Cloudy
