## ***China Harbour – Zhen Hua Joint Venture***

**Contract No.: CV/2015/07  
Handling of Surplus Public Fill  
(2016-2018)**

**TSEUNG KWAN O AREA 137 FILL BANK  
QUARTERLY EM&A SUMMARY REPORT  
NO.1**

**(FROM 12 MAY 2017 TO 31 JULY 2017)**

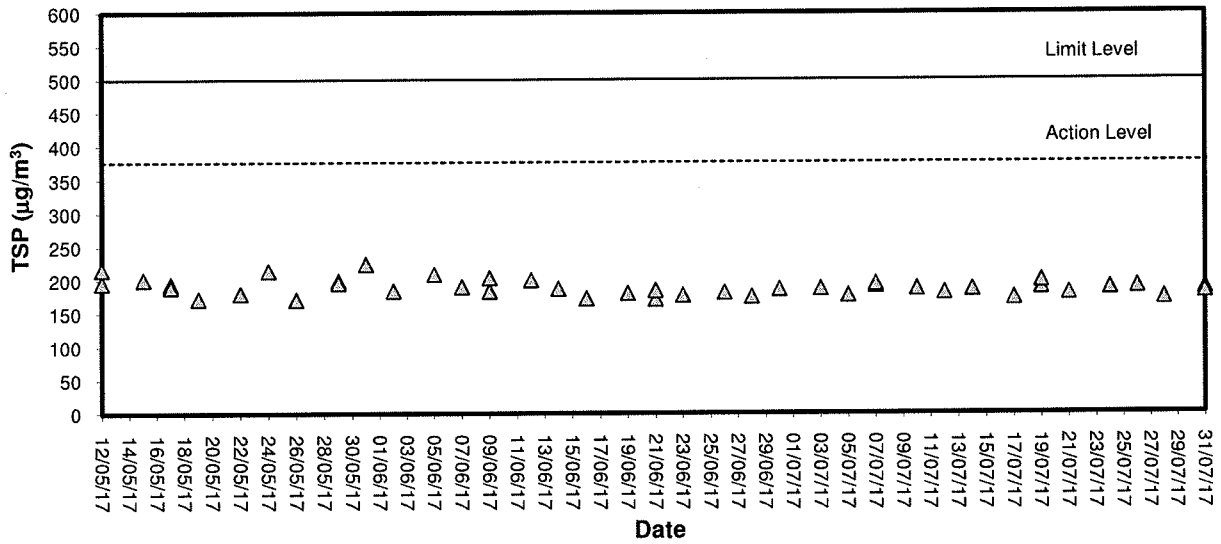
### 1-hour TSP level at TKO-A1

No exceedance of Action and Limit levels was recorded for 1-hr and 24-hr TSP monitoring in this quarter. The trend of air quality during the reporting quarter is present in Appendix B. Wind data included wind speed and wind direction were extracted from Tseung Kwan O Station of Hong Kong Observatory and presented in Appendix K.

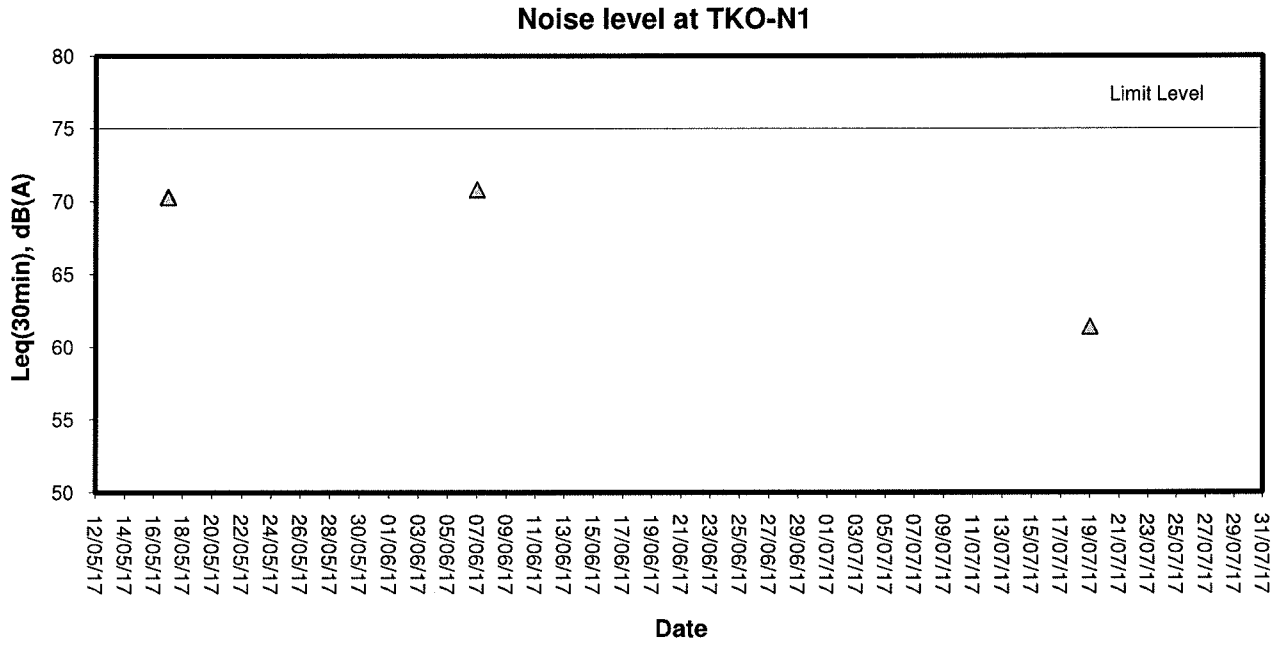
## Noise Monitoring (Day-time)

All recorded noise levels complied with the AL Levels. The registered noise levels in the past three months are plotted in Appendices C. Table 4.3 presents the limited level and average impact noise monitoring results during the reporting quarter.

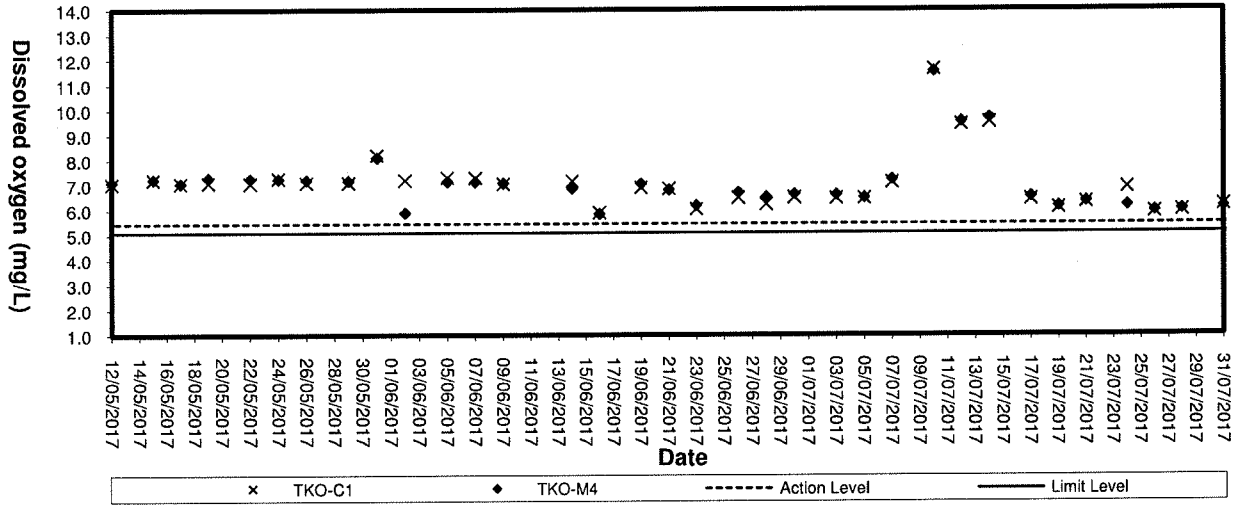
**Dissolved Oxygen (Surface & Middle) at Mid-Flood Tide**

Table 4.4 presents the total number of marine water quality exceedances in the reporting quarter. The trend of marine water quality in the past three months is depicted in Appendix D.

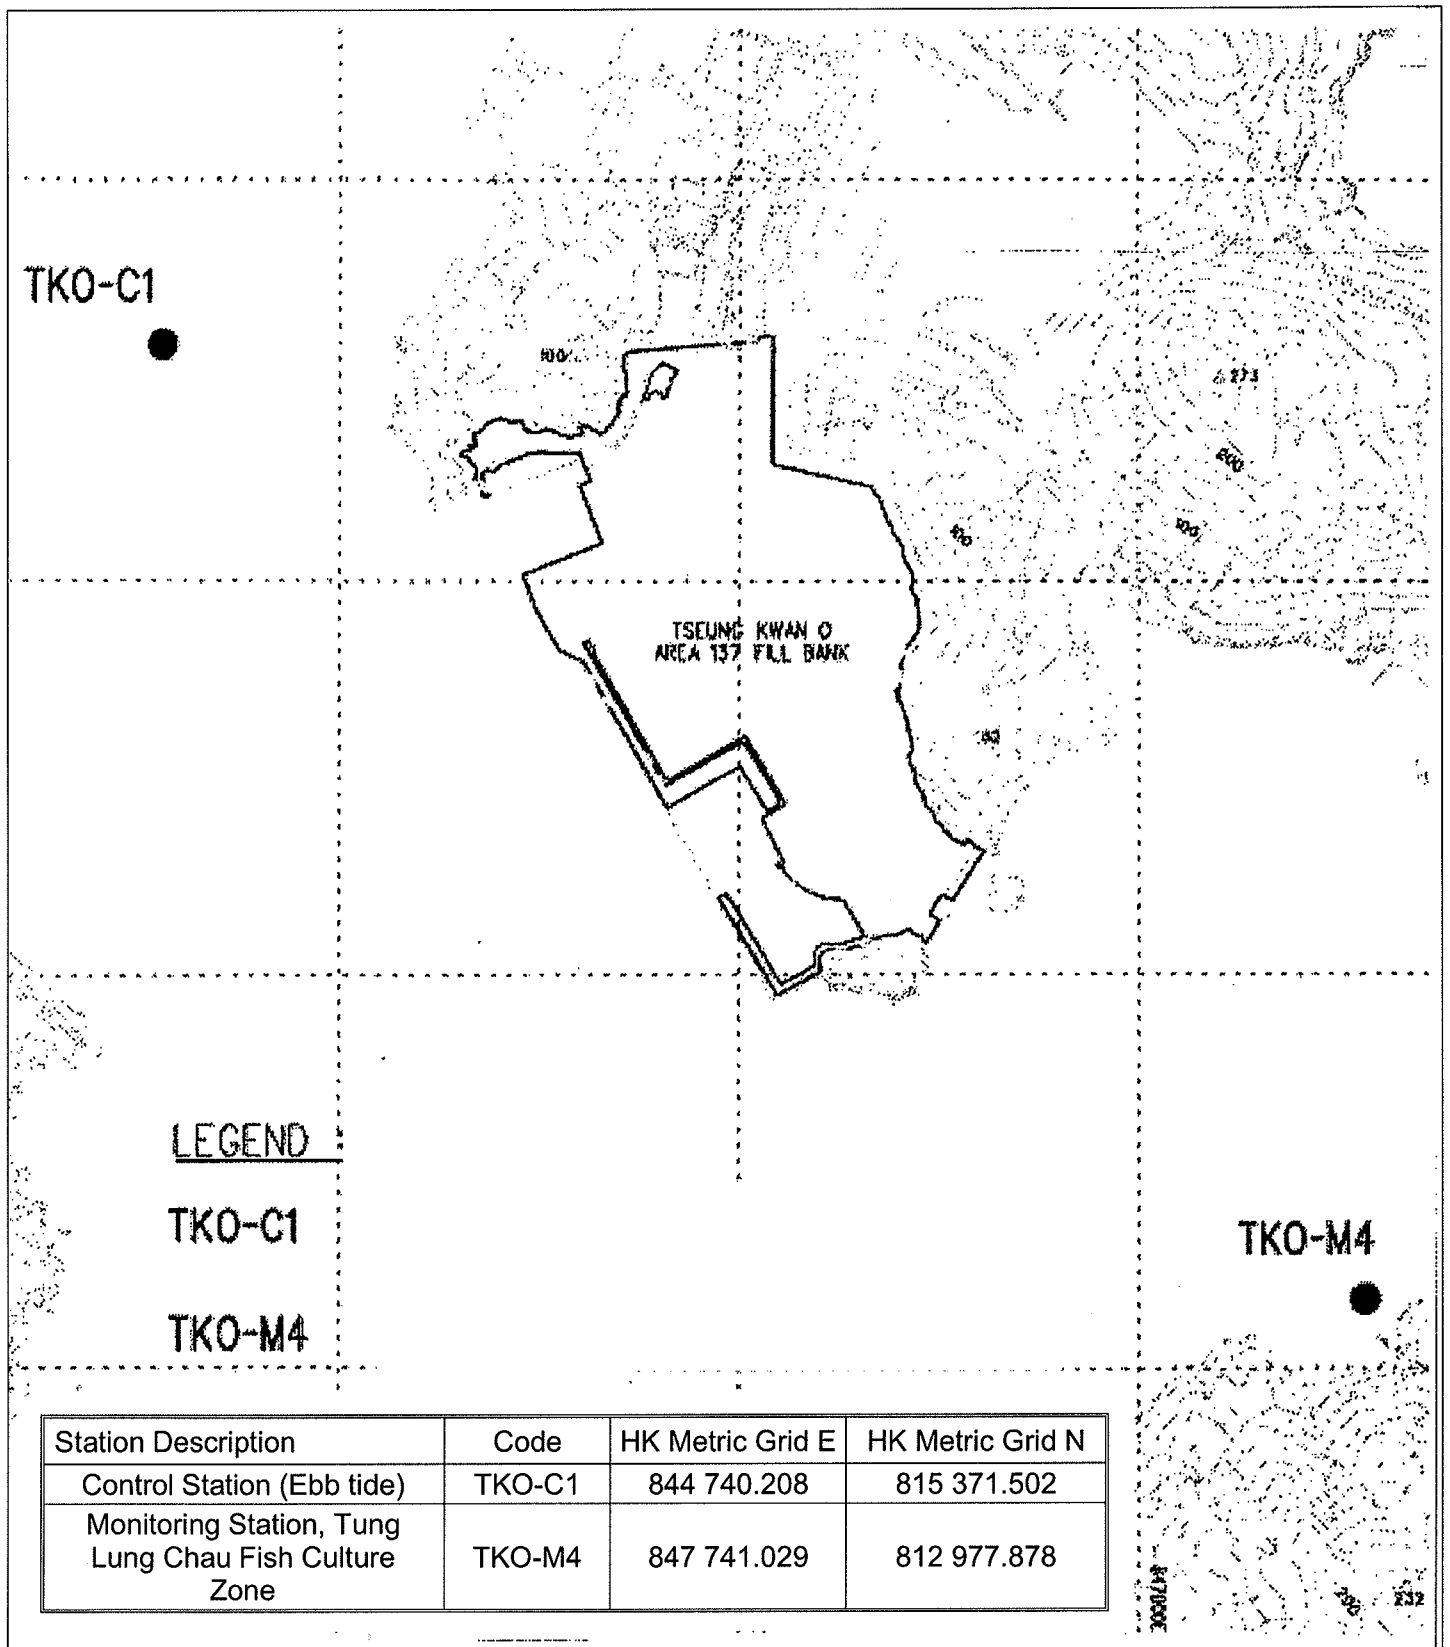
Figure 1  
 Locations of Water Quality Monitoring Stations –  
 Tseung Kwan O Area 137 Fill Bank

In accordance with the EM&A Manual, the marine water quality monitoring was conducted at the monitoring station (M4) and the control station (C1) in the reporting quarter.

The EM&A Manual designates several locations to monitor environmental impacts in terms of air quality, noise and water quality due to the Project. The description and detailed locations of monitoring stations for air quality, noise and marine water quality are shown in Figures 1, 2 and 3 and relevant sections of this Report.

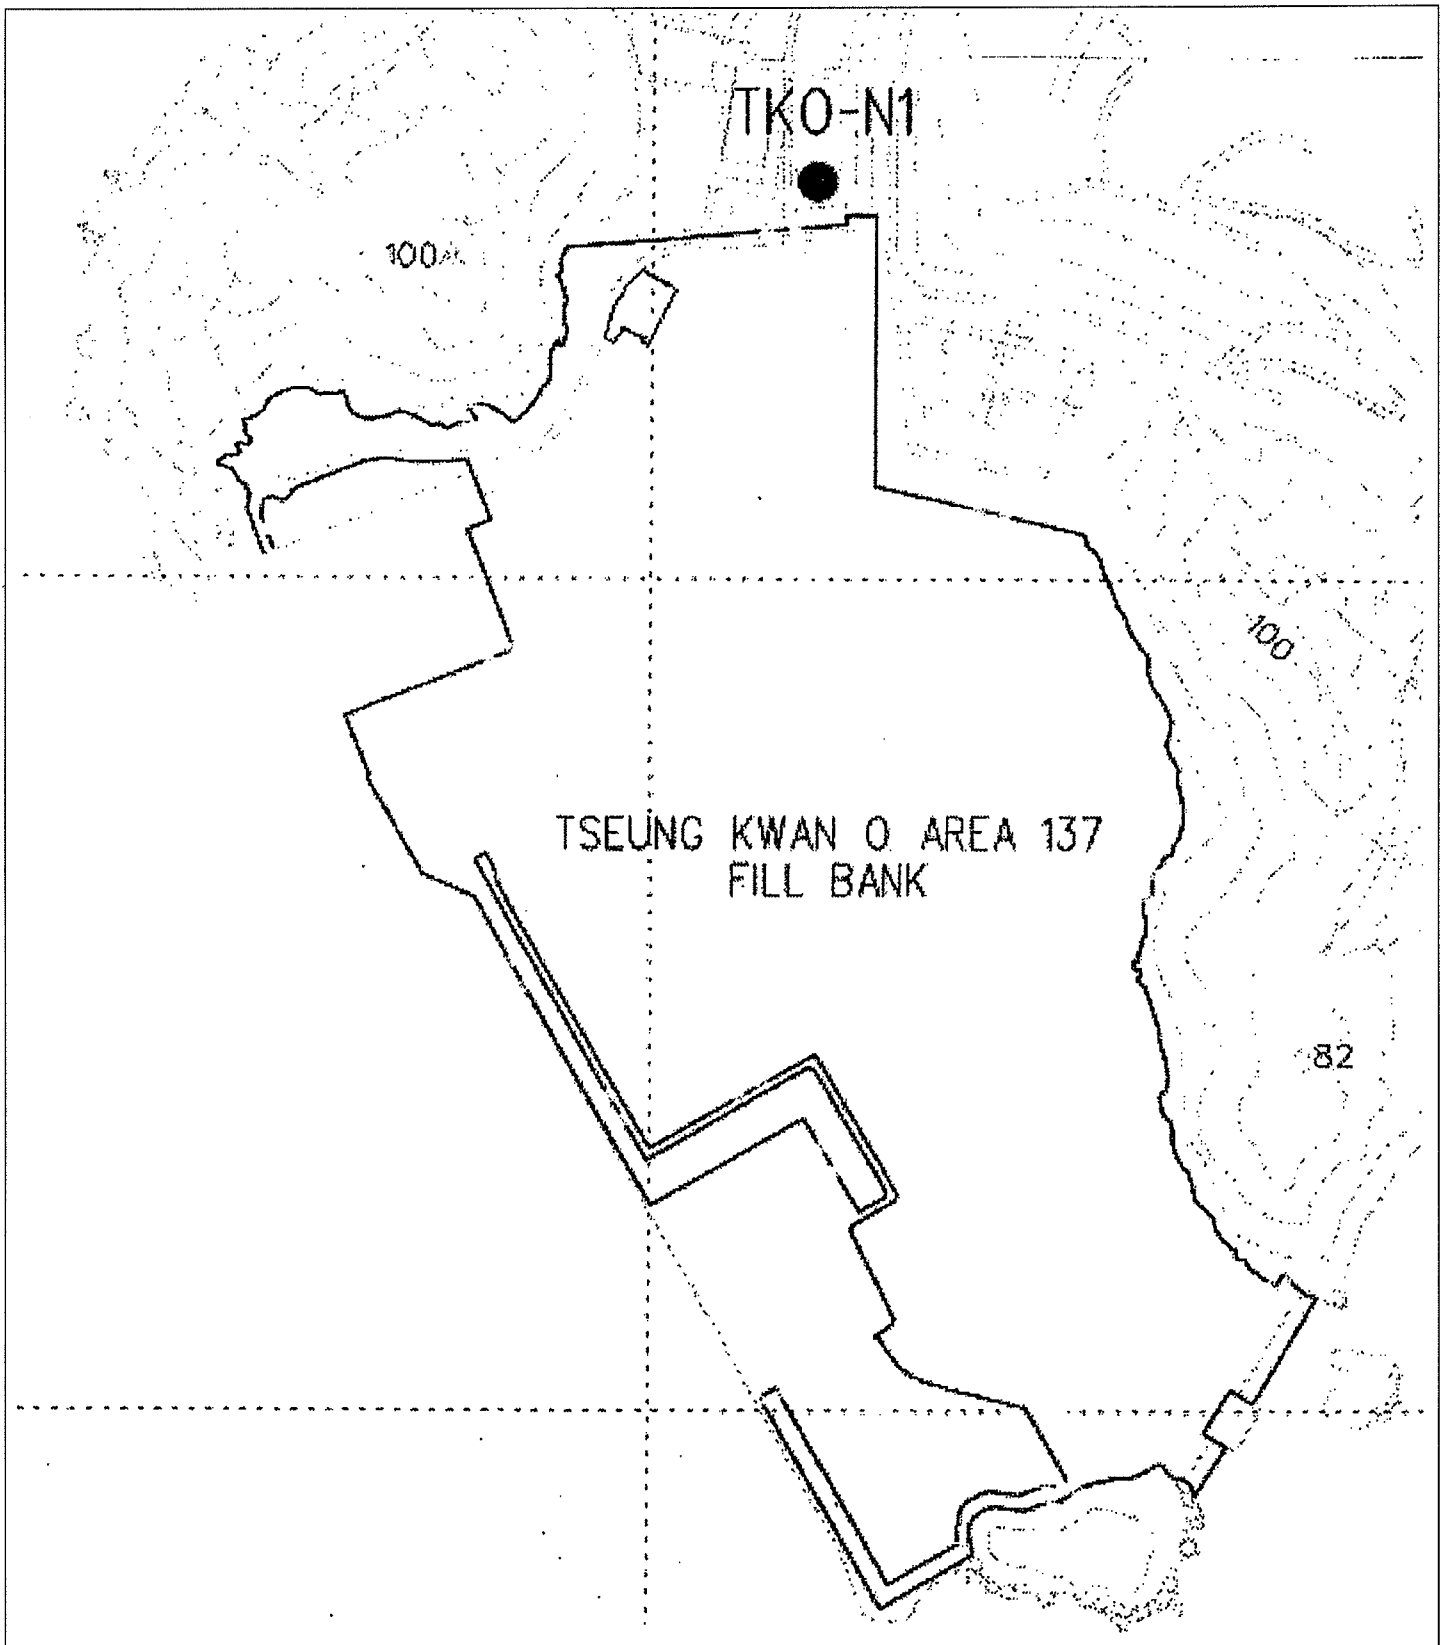
Figure 2  
Location of Noise Monitoring Station –  
Tseung Kwan O Area 137 Fill Bank

Monitoring Location	Limit Level	12 to 31 May 2017	June 2017	July 2017
		Leq, dB(A)		
TKO-N1	75	70.3	70.8	61.4

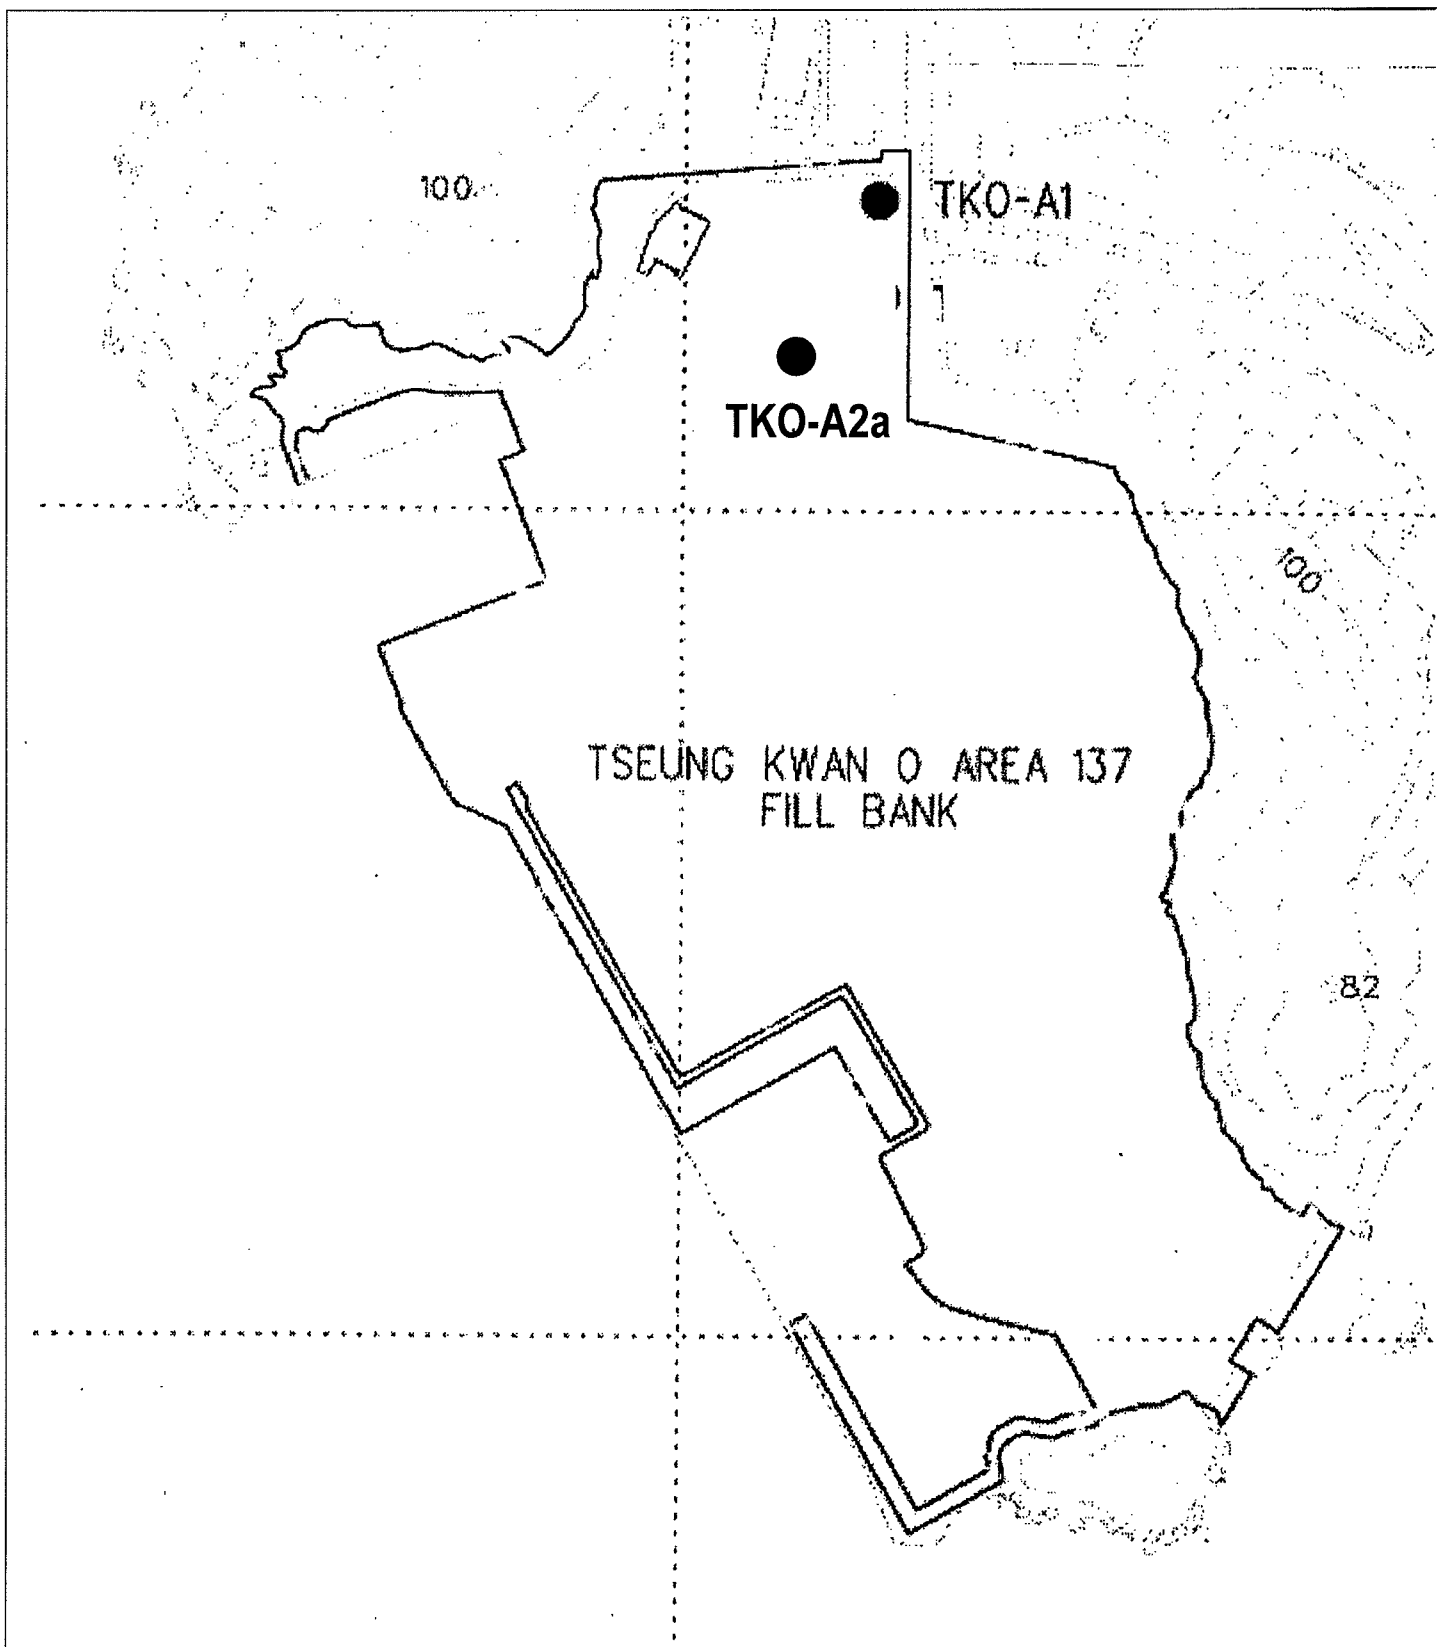
Figure 3  
 Locations of Air Quality Monitoring Stations –  
 Tseung Kwan O Area 137 Fill Bank

Period	1-hr TSP ( $\mu\text{g}/\text{m}^3$ )		24-hr TSP ( $\mu\text{g}/\text{m}^3$ )	
	TKO-A1	TKO-A2a	TKO-A1	TKO-A2a
Baseline (29/08 – 13/09)	195		123	
12 to 31 May 2017	70	78	196	225
June 2017	69	75	185	212
July 2017	69	77	185	214
