**Contract No.: CV/2015/07
Handling of Surplus Public Fill
(2016-2018)**

TSEUNG KWAN O AREA 137 FILL BANK

MONTHLY EM&A REPORT NO.5

(SEPTEMBER 2017)

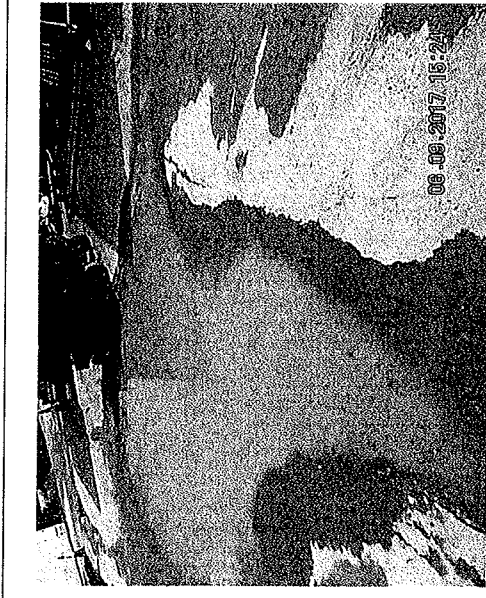
Photo 170906_001 (Near Sheung Moon office)

| Date | Key Findings | Action(s) Taken recommended by ET | Action(s) Taken by the Contractor during the ET weekly site audit | Rectification Status by ET |
|---|--|---|--|---|
| 06 September 2017 | Muddy water was found near Sheung Moon office. (New item) | To clear the unnecessary water properly. | --- | Follow-up |

| Item | Details of defective works or observations | Proposed Follow Up Action | Photo Ref. | Further Action Required (Yes/No) | Follow up Date |
|---|--|---|---|---|---|
| 1 | Muddy water was found near Sheung Moon office. | To clear the unnecessary water properly. | 170906_001 | Yes | 13/09/17 |

| Date | Key Findings | Action(s) Taken recommended by ET | Action(s) Taken by the Contractor during the ET weekly site audit | Rectification Status by ET |
|---|--|---|--|---|
| 13 September 2017 | Muddy water was found near Sheung Moon office. (Previous item) | To clear the unnecessary water properly. | No muddy water was found near Sheung Moon office. | Closed |

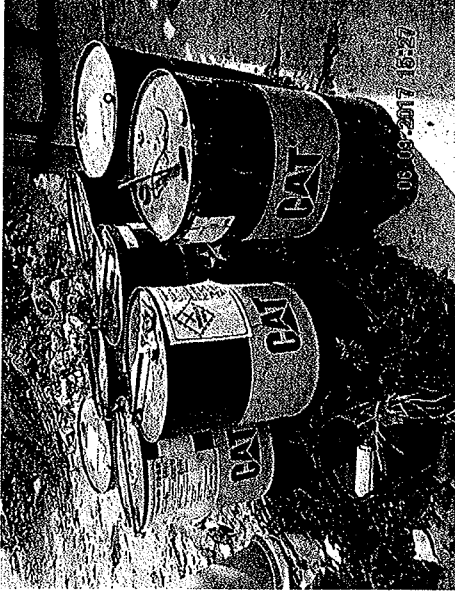
Photo 170906_002 (Near Sheung Moon office)

| Date | Key Findings | Action(s) Taken recommended by ET | Action(s) Taken by the Contractor during the ET weekly site audit | Rectification Status by ET |
|---|--|---|--|---|
| | Idle oil drums were found without drip tray near Sheung Moon office. (New item) | To stall / dispose of the oil drums properly. | --- | Follow-up |

| Item | Details of defective works or observations | Proposed Follow Up Action | Photo Ref. | Further Action Required (Yes/No) | Follow up Date |
|---|--|---|---|---|---|
| 2 | Idle oil drums were found without drip tray near Sheung Moon office. | To stall / dispose of the oil drums properly. | 170906_002 | Yes | 13/09/17 |

| Date | Key Findings | Action(s) Taken recommended by ET | Action(s) Taken by the Contractor during the ET weekly site audit | Rectification Status by ET |
|---|--|---|--|---|
| | Idle oil drums were found without drip tray near Sheung Moon office. (Previous item) | To stall / dispose of the oil drums properly. | Idle oil drums found without drip tray near Sheung Moon office were collected. | Closed |

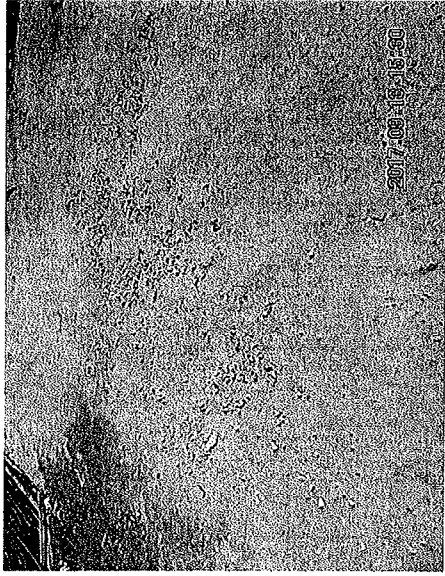
Photo 170913_001 (Near Sheung Moon office)
(Improved)

| Item | Details of defective works or observations | Proposed Follow Up Action | Photo Ref. | Further Action Required (Yes/No) | Follow up Date |
|---|--|---|---|---|---|
| 1 | Follow up action to item 1 on 06/09/17, no muddy water was found near Sheung Moon office. | --- | 170913_001 | No | --- |
