**Contract No.: CV/2015/07
Handling of Surplus Public Fill
(2016-2018)**

TSEUNG KWAN O AREA 137 FILL BANK

MONTHLY EM&A REPORT NO.11

(MARCH 2018)

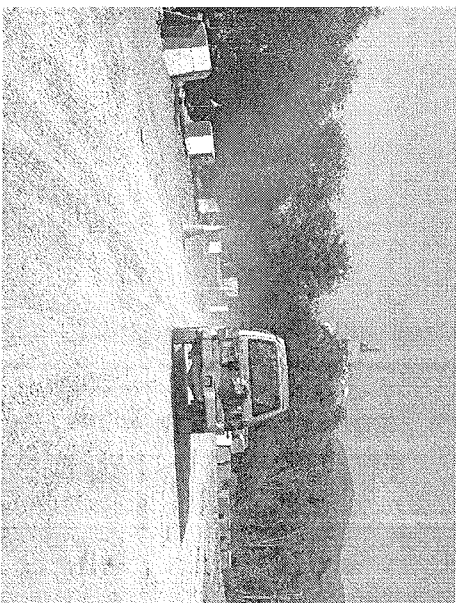
Photo 180327_002 (Haul Road)

Haul road was found fugitive dust emission (New item)	Provide watering to avoid dust emission.	---	<i>Follow-up</i>
