**Contract No.: CV/2015/07  
Handling of Surplus Public Fill  
(2016-2018)**

**TSEUNG KWAN O AREA 137 FILL BANK  
MONTHLY EM&A REPORT NO.13**

**(MAY 2018)**

Report No.: ENA83703

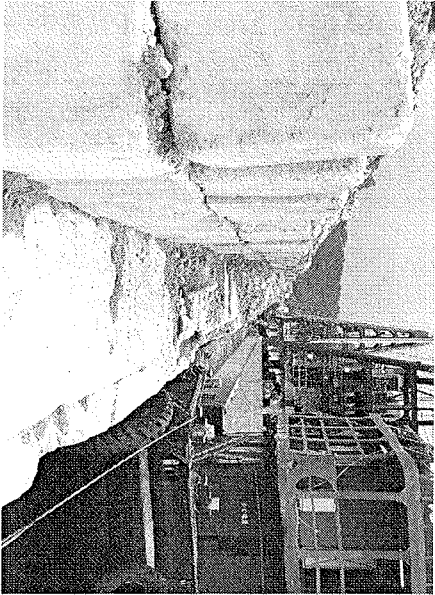
Photo 180502\_001 (Area A9) (Improved)

Date	Key Findings	Action(s) Taken recommended by ET	Action(s) Taken by the Contractor during the ET weekly site audit	Rectification Status by ET
02 May 2018	Fill materials were found accumulated along the concrete pavement near the pier at Area A9.. ( Previous item)	To clean up the fill materials properly.	<b>Accumulated fill materials near the pier at Area A9 were cleaned.</b>	Closed
	Fugitive dust emission was observed near soil platform (New item)	To provide watering to avoid dust emission.		Follow-up
09 May	Fugitive dust emission was observed near soil platform ( Previous item)	To provide watering to avoid dust emission.	Soil platform provided watering to avoid dust emission.	Closed

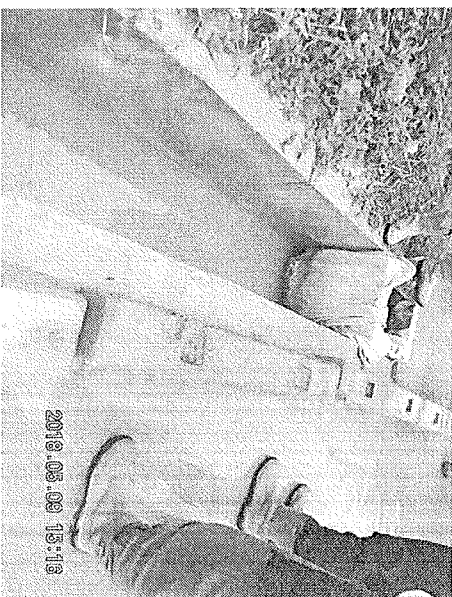
Photo 180509\_002 (CP5)

2018	Mud was found accumulated near CP5 (New item)	To clean the accumulated mud properly.		Follow-up
16 May 2018	Mud was found accumulated near CP5 ( Previous item)	To clean the accumulated mud properly.	Mud accumulated near CP5 was cleaned.	Closed
	Fugitive dust emission was observed near soil platform (New item)	To provide watering to avoid dust emission.		Follow-up
23 May 2018	Fugitive dust emission was observed near soil platform ( Previous item)	To provide watering to avoid dust emission.	Soil platform provided watering to avoid dust emission.	Closed
29 May 2018	Fugitive dust emission was observed near soil platform(New item)	To provide watering to avoid dust emission.		Follow-up
