**Contract No.: CV/2015/07
Handling of Surplus Public Fill
(2016-2018)**

TSEUNG KWAN O AREA 137 FILL BANK

MONTHLY EM&A REPORT NO.15

(JULY 2018)

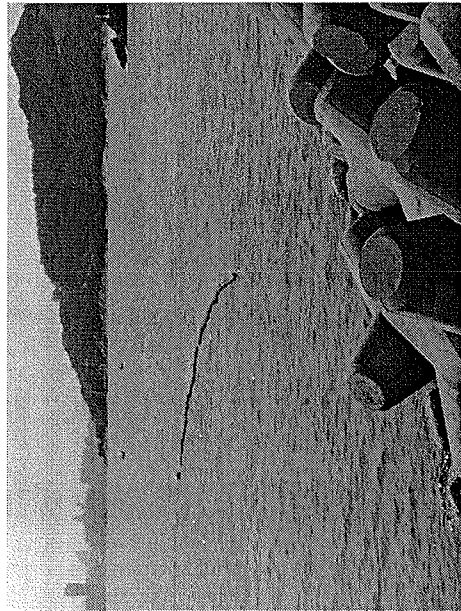
Photo 180704_001 (BHA Area)

Item	Details of defective works or observations	Proposed Follow Up Action	Photo Ref.	Further Action Required (Yes/No)	Follow up Date
1	Follow up to item no.2 on 27/06/18, Silt curtain was found still damaged near Area BHA.	Replace the silt curtain as soon as possible.	180704_001	Yes	11/07/18
