Contract No. DC/2008/03
Design, Build and Operate Pillar
Point Sewage Treatment Works:
Thirty-third Monthly EM&A Report

August 2013

Monthly EM&A Report for July 2013

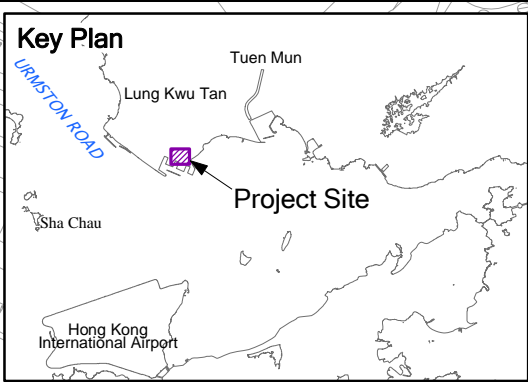
Location of Works Areas

P1 & P3 - Works Areas within Existing PPSTW Facilities
P2 - Open Area for Construction of New Facilities at PPSTW

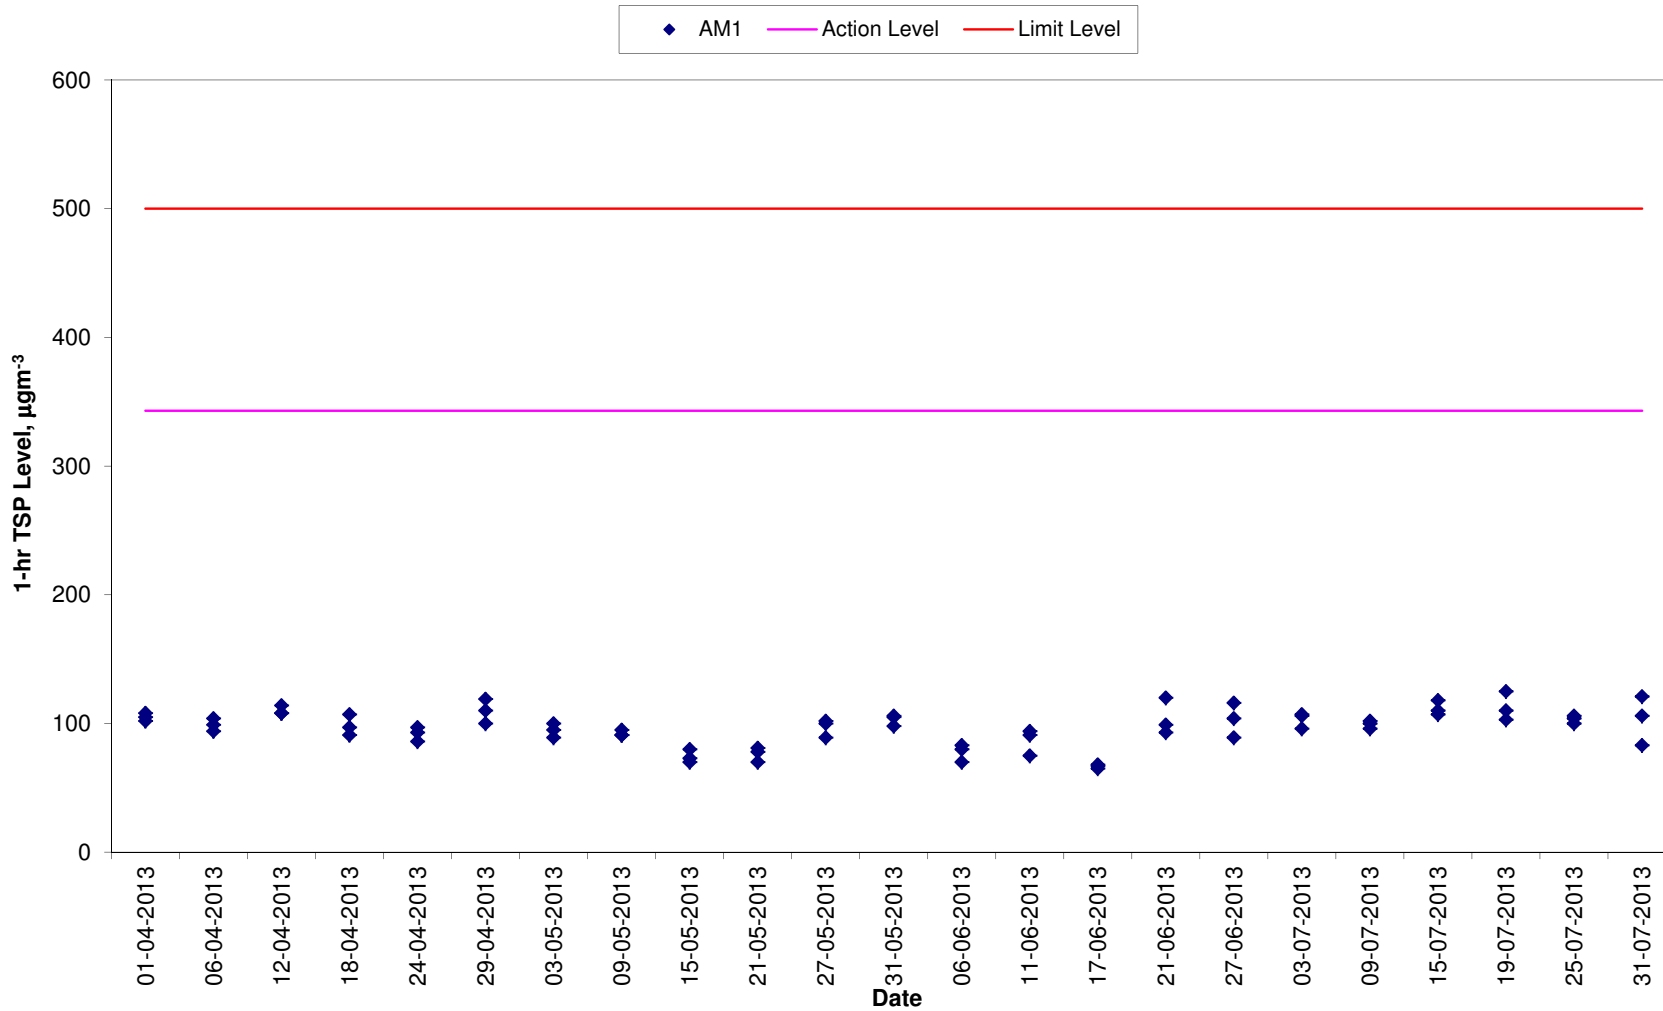
1-hr TSP Levels for the Past 4 Months AM1 (Tuen Mun EMSD Vehicle Servicing Station)

A total of 6 sets of 24-hour and 18 sets of 1-hour TSP measurements were taken at each of the monitoring stations (AM1 and AM2) during the reporting period. The monitoring data for 24-hour and 1-hour TSP together with the wind data and graphical presentations for the past 4 months are presented in *Annex G*. The weather conditions during the monitoring period ranged from sunny to rainy. The local impacts near the monitoring stations of AM1 and AM2 were mainly associated with vehicular emissions. No exceedance of Action and Limit Level of the 1-hr and 24-hr TSP was recorded during the reporting period.

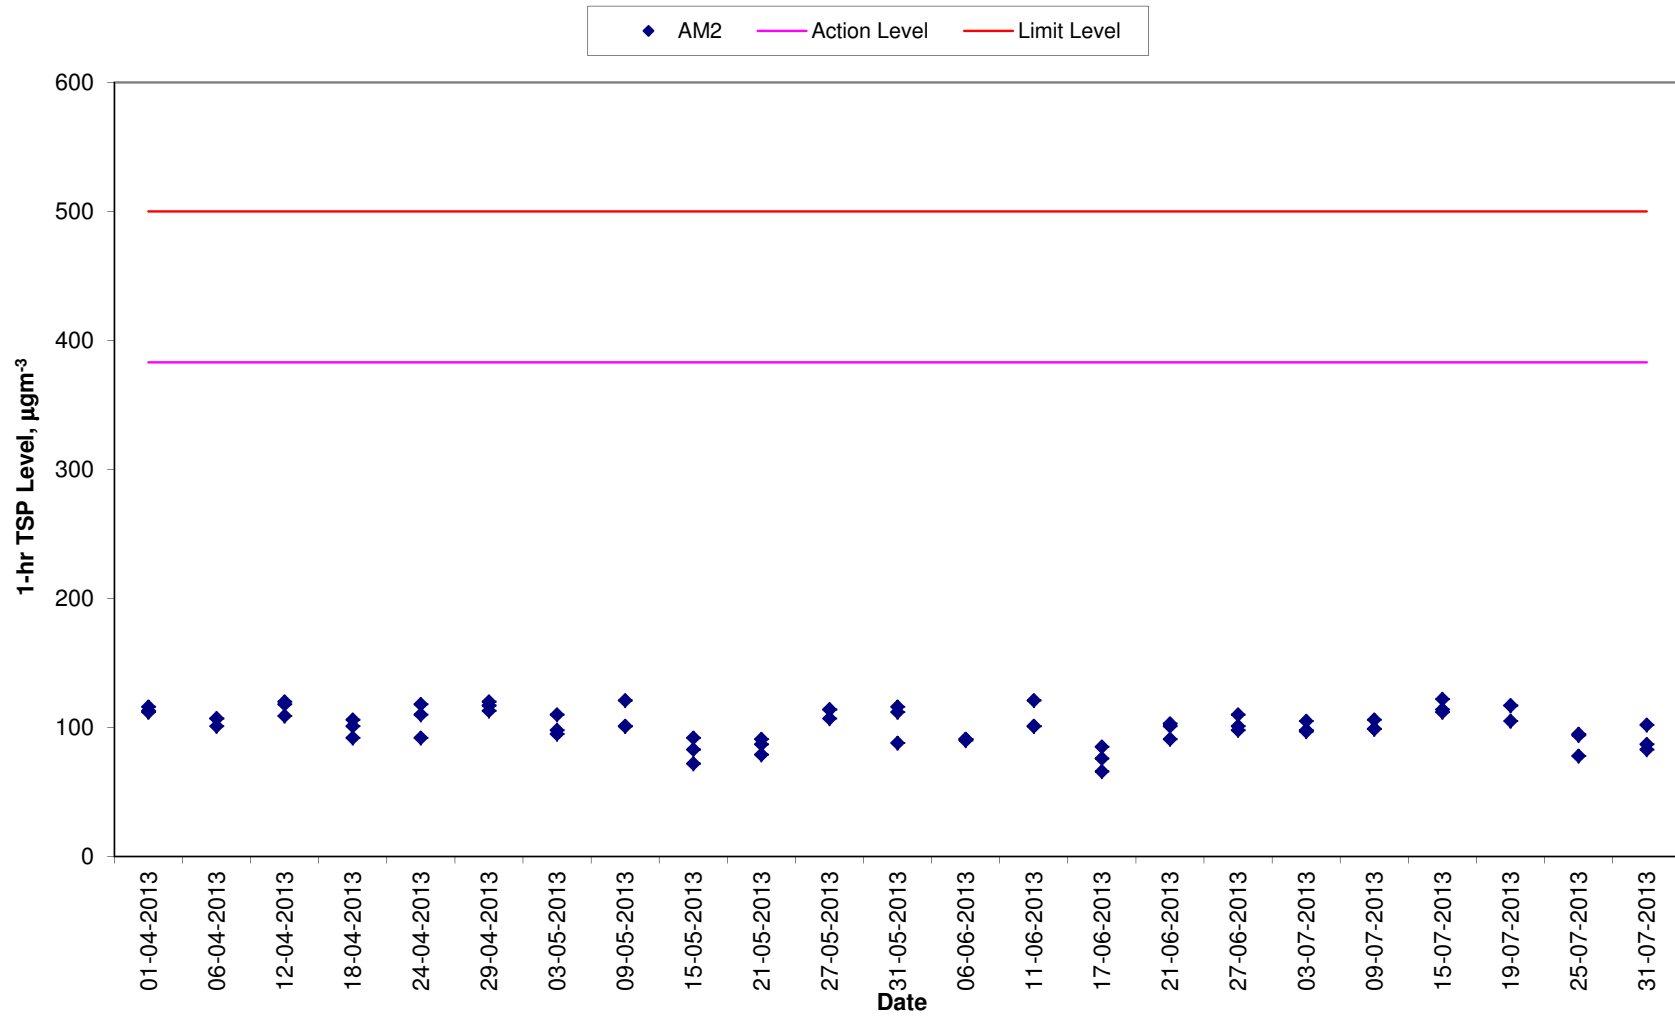
1-hr TSP Levels for the Past 4 Months AM2 (River Trade Terminal Office)

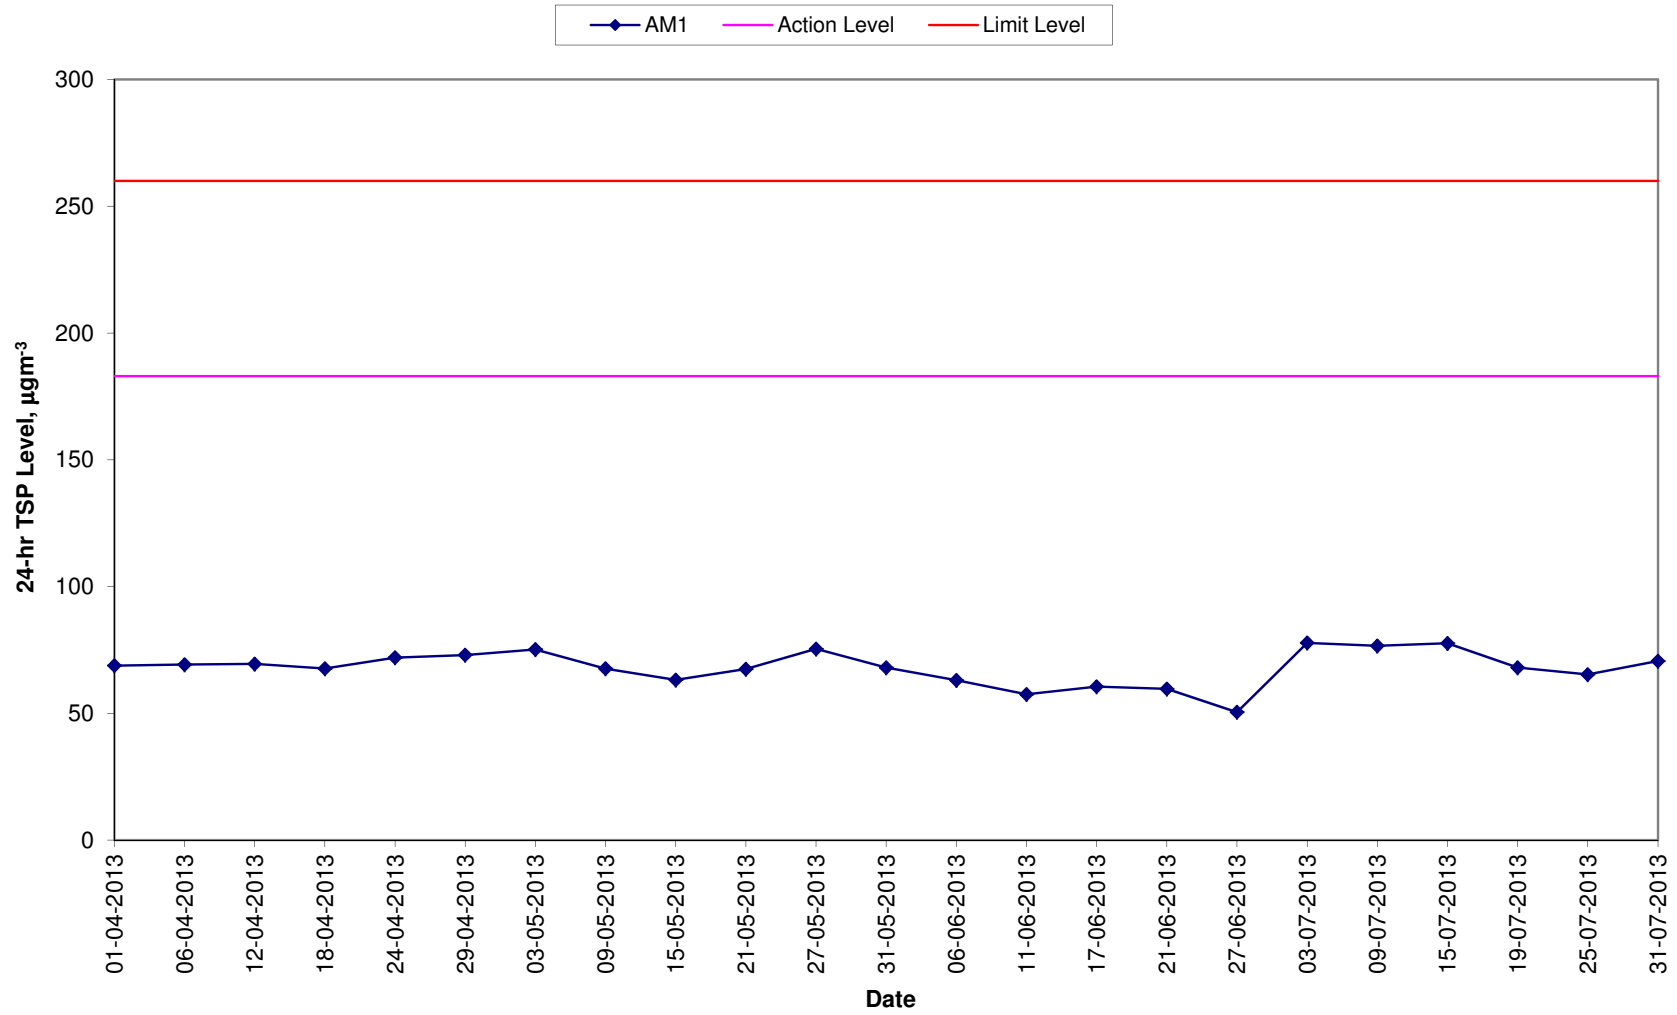
24-hr TSP Levels for the Past 4 Months AM1 (River Trade Terminal Office)

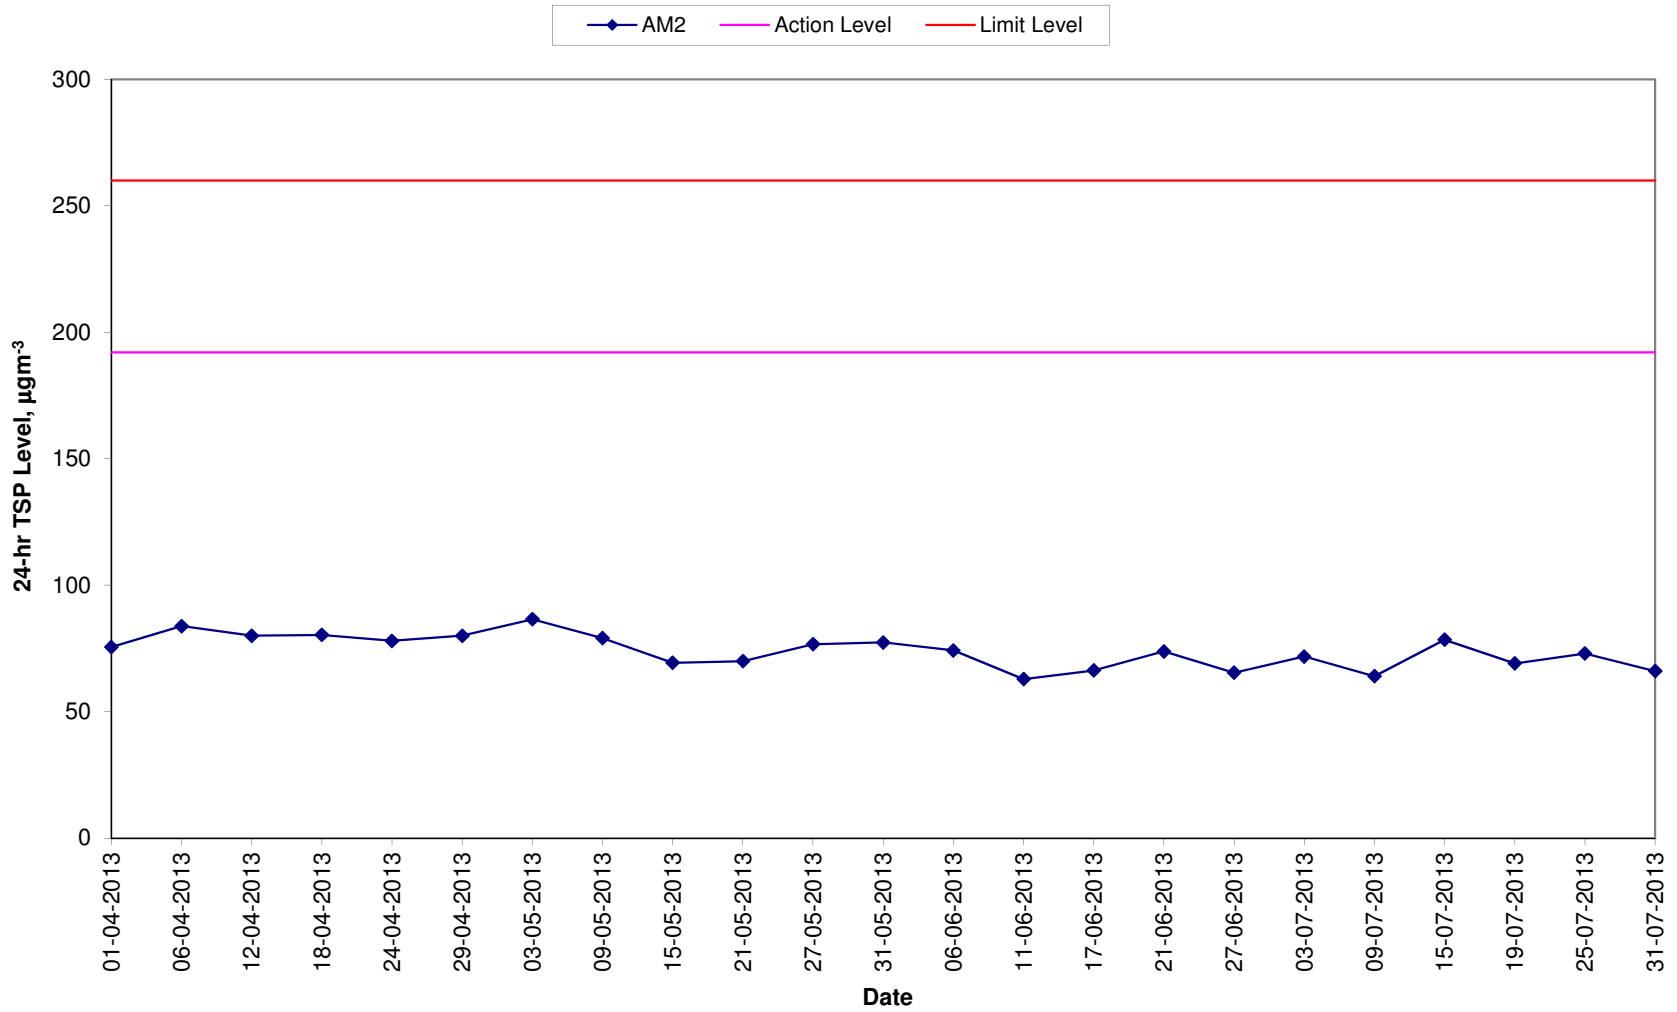
24-hr TSP Levels for the Past 4 Months AM2 (River Trade Terminal Office)
