Contract No. DC/2008/03 Design, Build and Operate Pillar Point Sewage Treatment Works: Forty-second Monthly EM&A Report

May 2014

Contract No. DC/2008/03 Design, Build and Operate Pillar Point Sewage Treatment Works: *Forty-second Monthly EM&A Report*

Monthly EM&A Report for April 2014

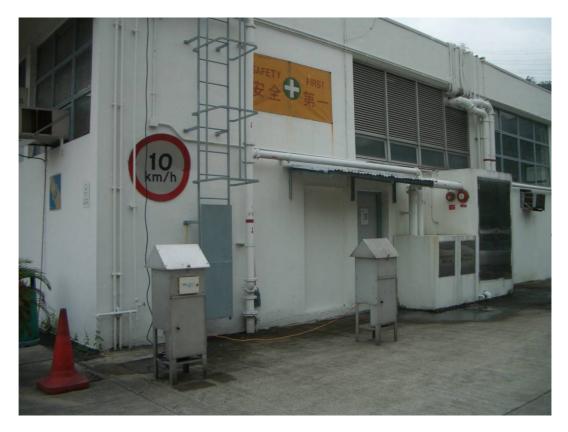
AM1 – Tuen Mun EMSD Servicing Vehicle Station

The proposed air quality monitoring stations for the construction phase of the Project, as recommended in the approved EM&A Manual, are given in *Table 3.1* and shown in *Annex D*. The proposed locations (AM1 and AM2) have been agreed with the Drainage Services Department (DSD), Environmental Protection Department (EPD) and the Independent Environmental Checker (IEC).

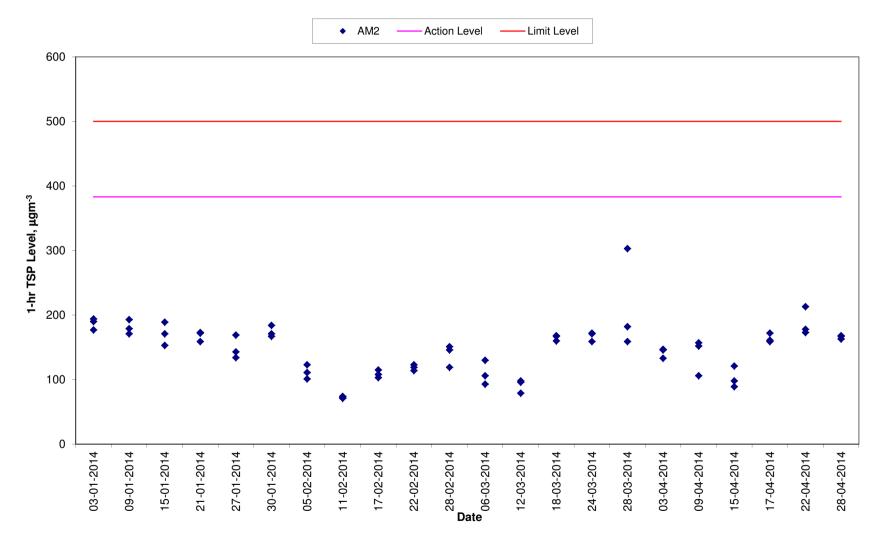
1-hr TSP Levels for the Past 4 Months AM2 (River Trade Terminal Office)

A total of 6 sets of 24-hour and 18 sets of 1-hour TSP measurements were taken at each of the monitoring stations (AM1 and AM2) during the reporting period. The monitoring data for 24-hour and 1-hour TSP together with the wind data and graphical presentations for the past 4 months are presented in *Annex G*. The weather conditions during the monitoring period ranged from sunny to rainy. The local impacts near the monitoring stations of AM1 and AM2 were mainly associated with vehicular emissions. No exceedance of Action and Limit Level of the 1-hr and 24-hr TSP was recorded during the reporting period.
