Contract No. DC/2008/03  
Design, Build and Operate Pillar  
Point Sewage Treatment Works:  
*Forty-seventh Monthly EM&A Report*

October 2014

**Contract No. DC/2008/03  
Design, Build and Operate  
Pillar Point Sewage Treatment Works**

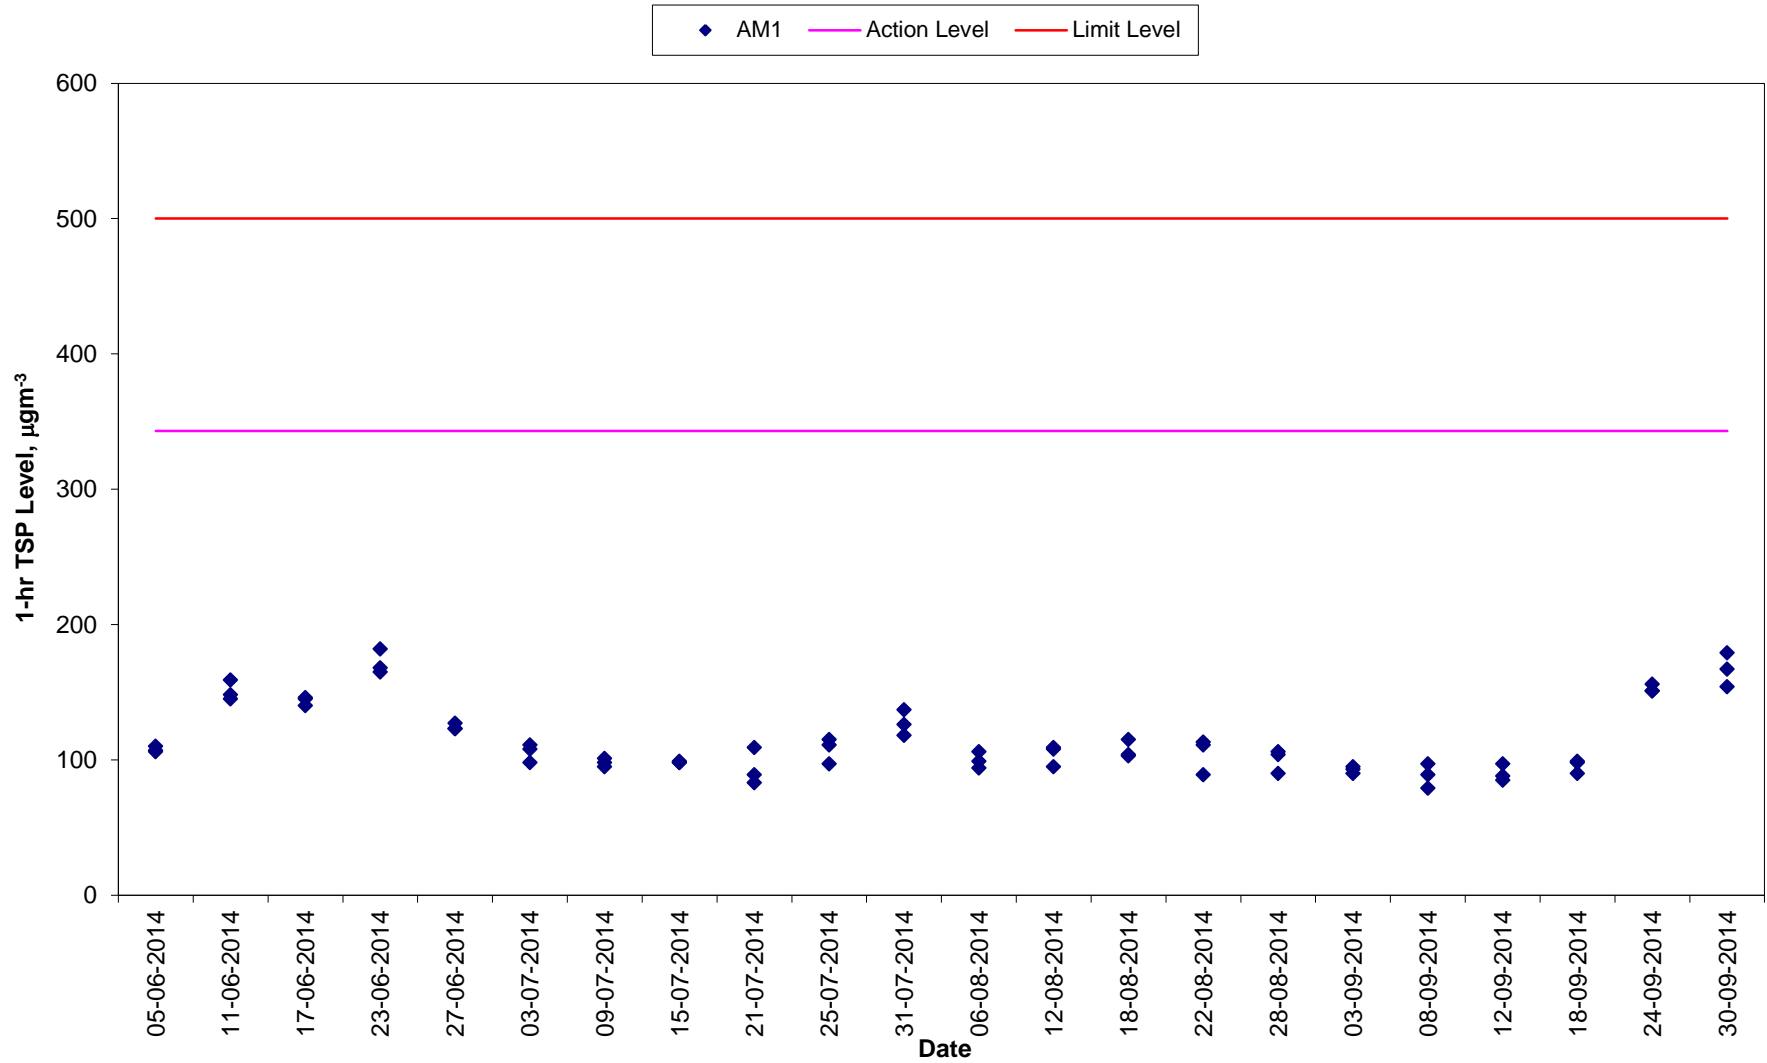
## 1-hr TSP Levels for the Past 4 Months AM1 (Tuen Mun EMSD Vehicle Servicing Station)

# Annex G TSP Monitoring Results

A total of 6 sets of 24-hour and 18 sets of 1-hour TSP measurements were taken at each of the monitoring stations (AM1 and AM2) during the reporting period. The monitoring data for 24-hour and 1-hour TSP together with the wind data and graphical presentations for the past 4 months are presented in *Annex G*. The weather conditions during the monitoring period ranged from cloudy to sunny. The local impacts near the monitoring stations of AM1 and AM2 were mainly associated with vehicular emissions. No exceedance of Action and Limit Level of the 1-hr and 24-hr TSP was recorded during the reporting period.

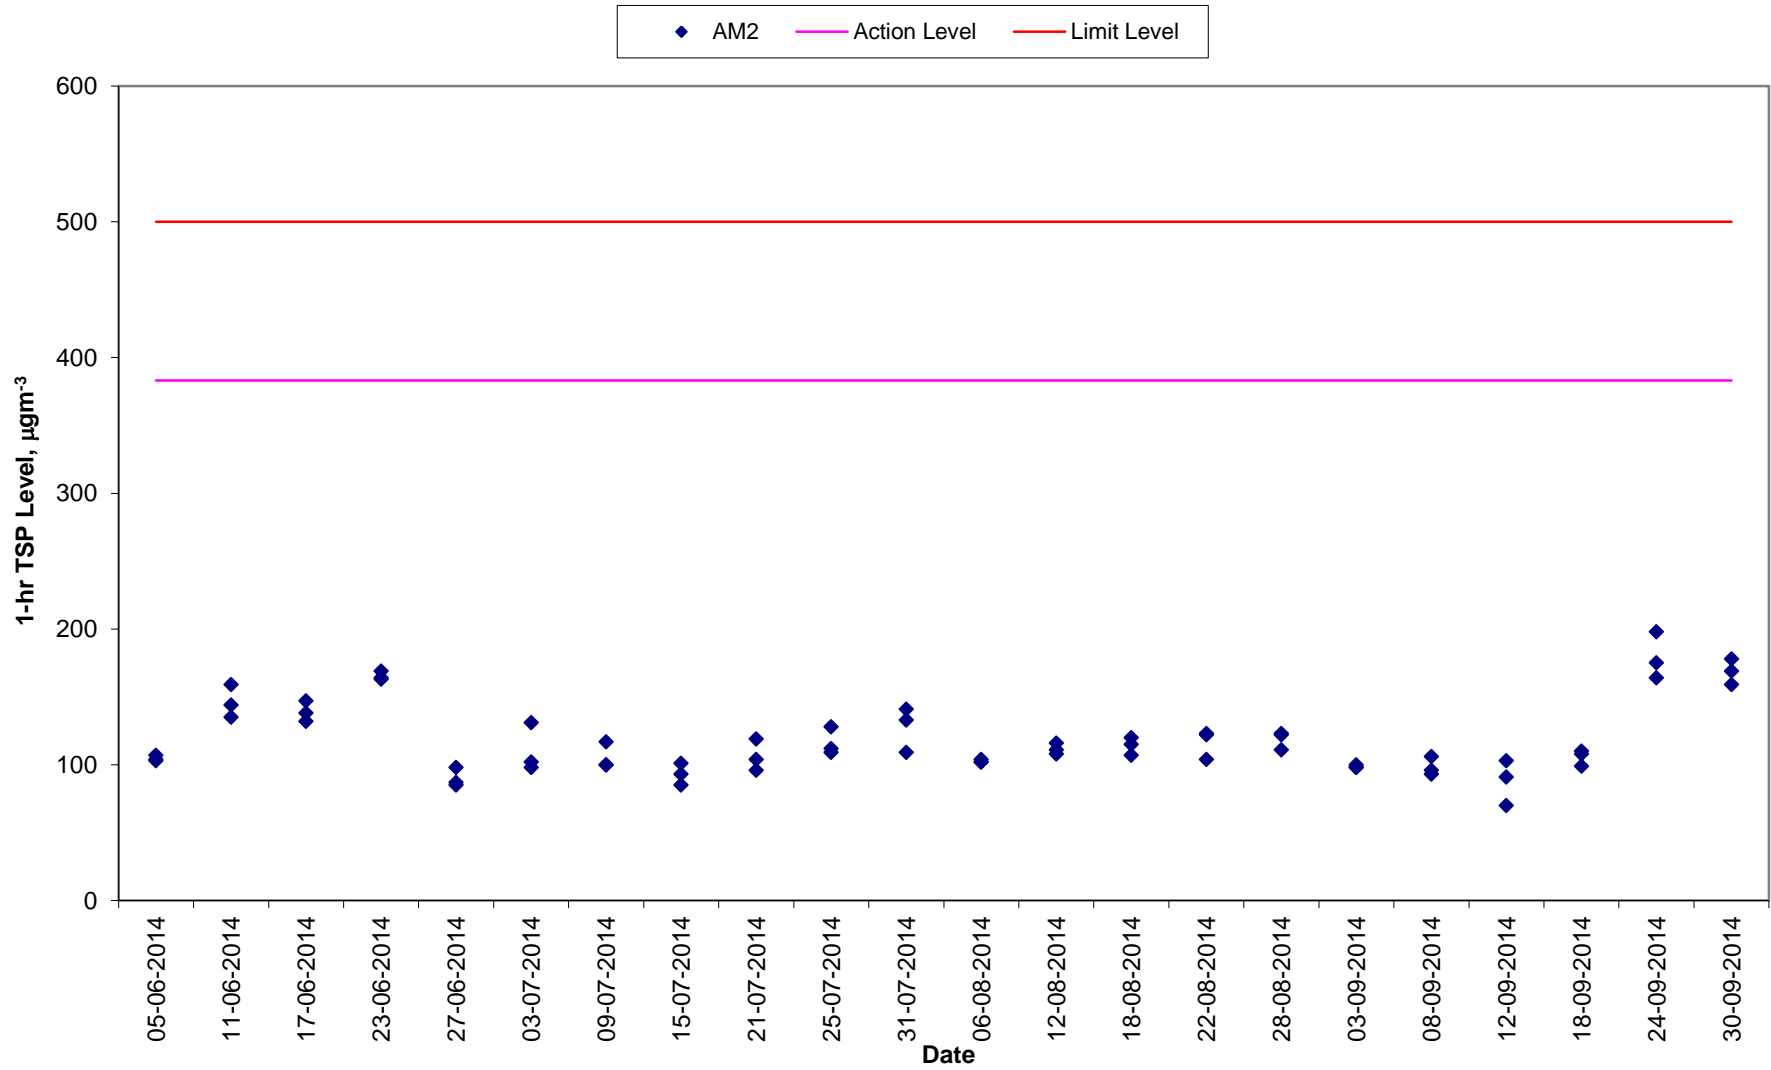
## 1-hr TSP Levels for the Past 4 Months AM2 (River Trade Terminal Office)

# Annex G TSP Monitoring Results

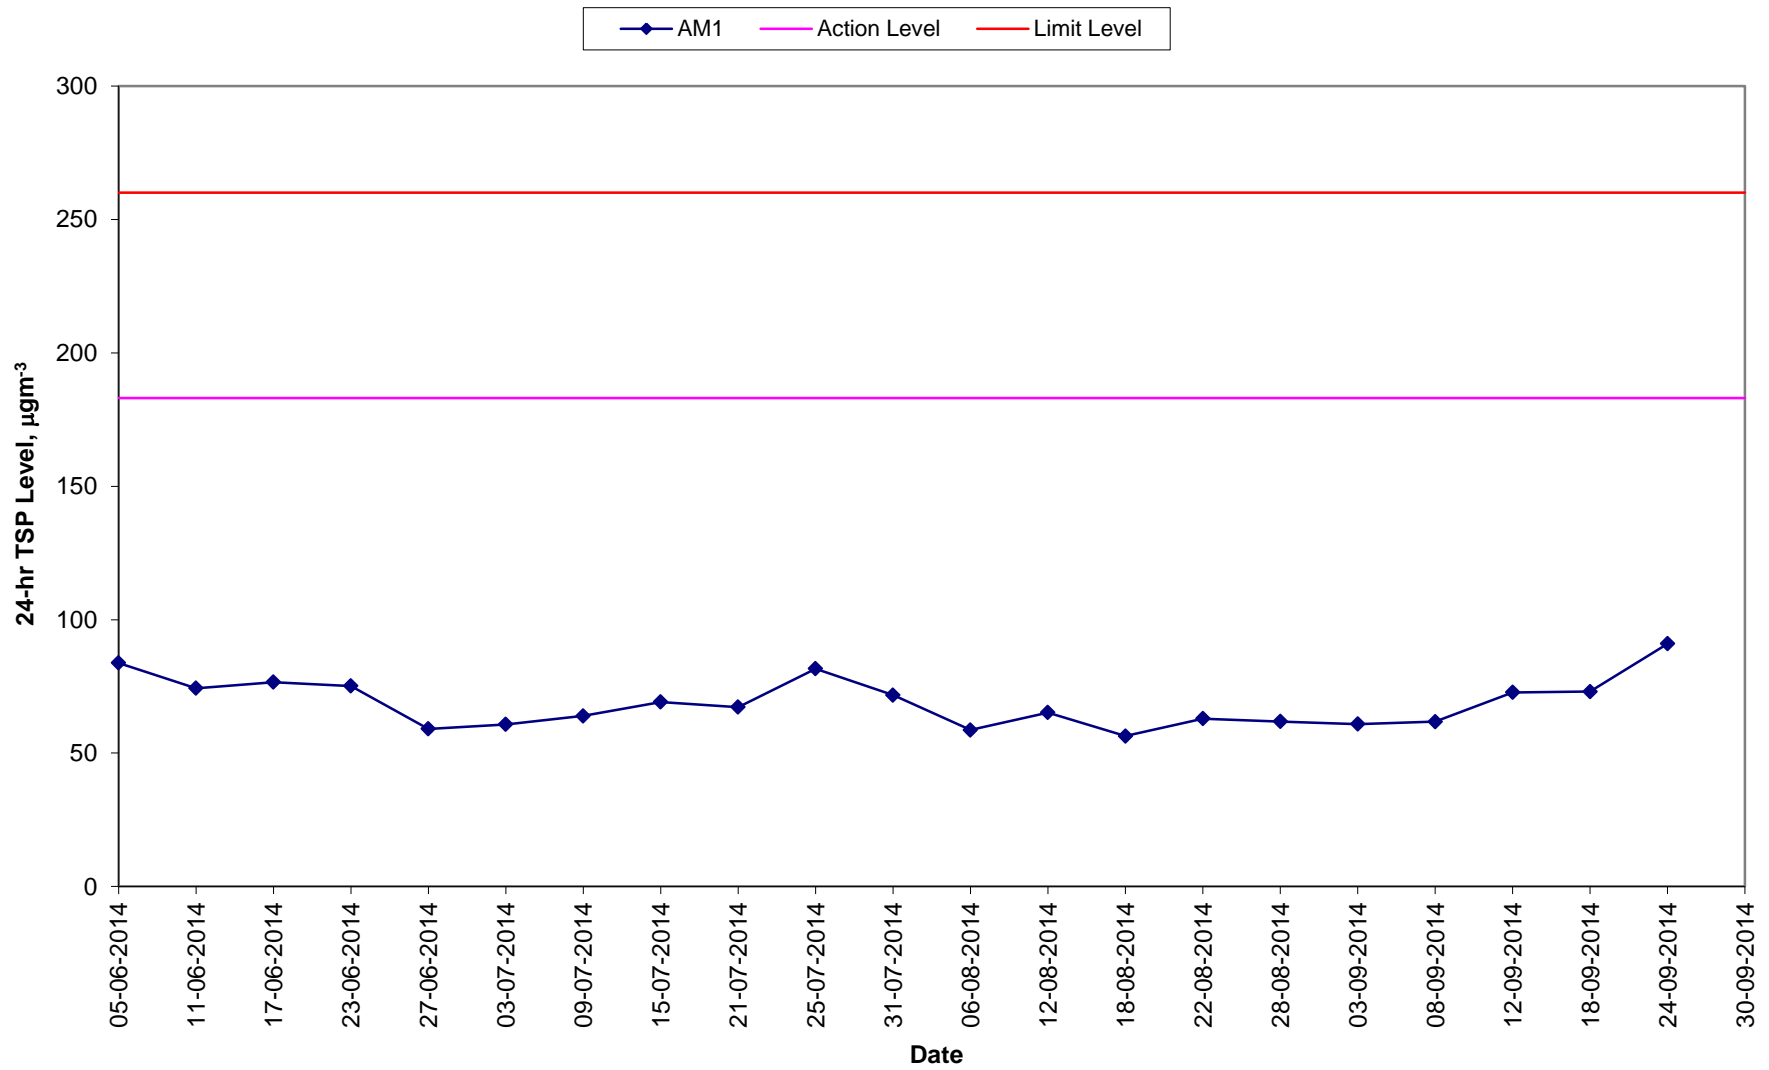
## 24-hr TSP Levels for the Past 4 Months AM1 (Tuen Mun EMSD Vehicle Servicing Station)

# Annex G TSP Monitoring Results

The monitoring results show that the average and range of the 24-hour TSP levels recorded since the commencement of the construction works have been well below the 24-hour TSP criterion in the HKAQO. Recommended mitigation measures in *Section 3.7.1.1* of EIA have been implemented throughout the construction period and were considered effective.

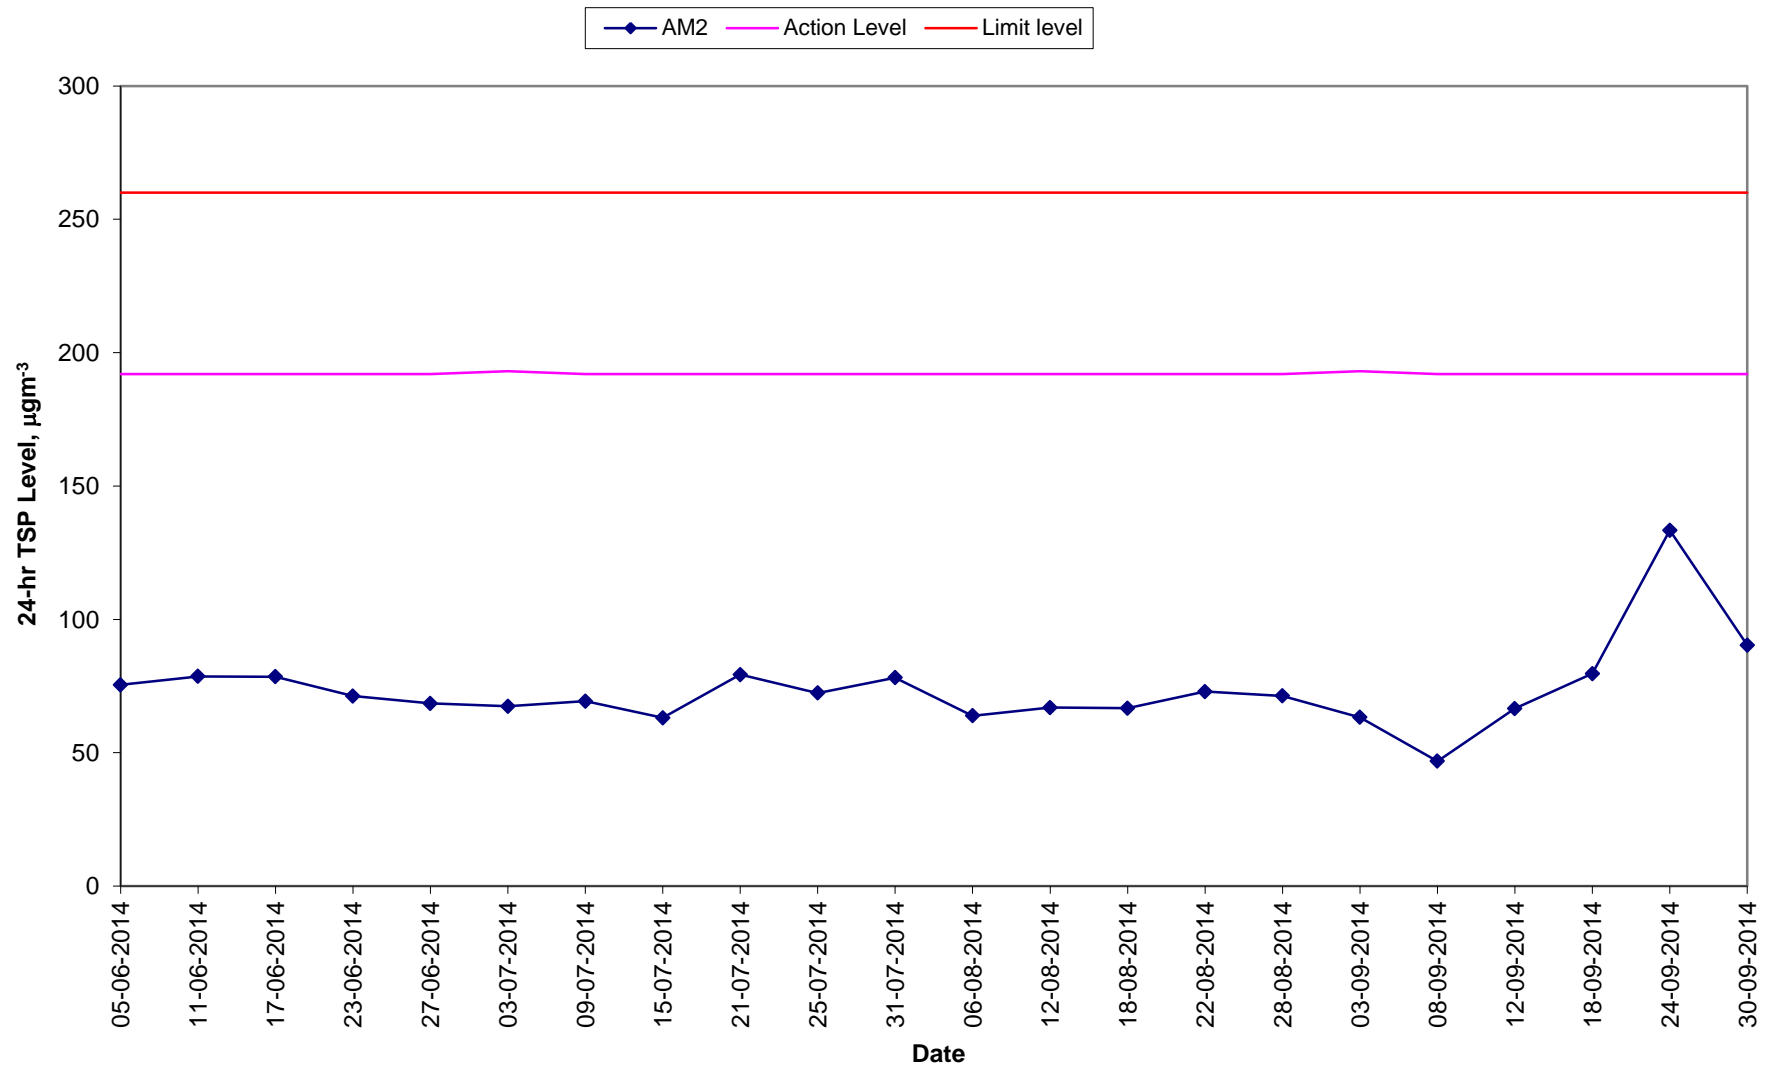
**24-hr TSP Levels for the Past 4 Months  
AM2 (River Trade Terminal Office)**

## Annex G TSP Monitoring Results
