Contract No. DC/2008/03  
Design, Build and Operate Pillar  
Point Sewage Treatment Works:  
*Forty-eighth Monthly EM&A Report*

November 2014

**Environmental Resources Management**

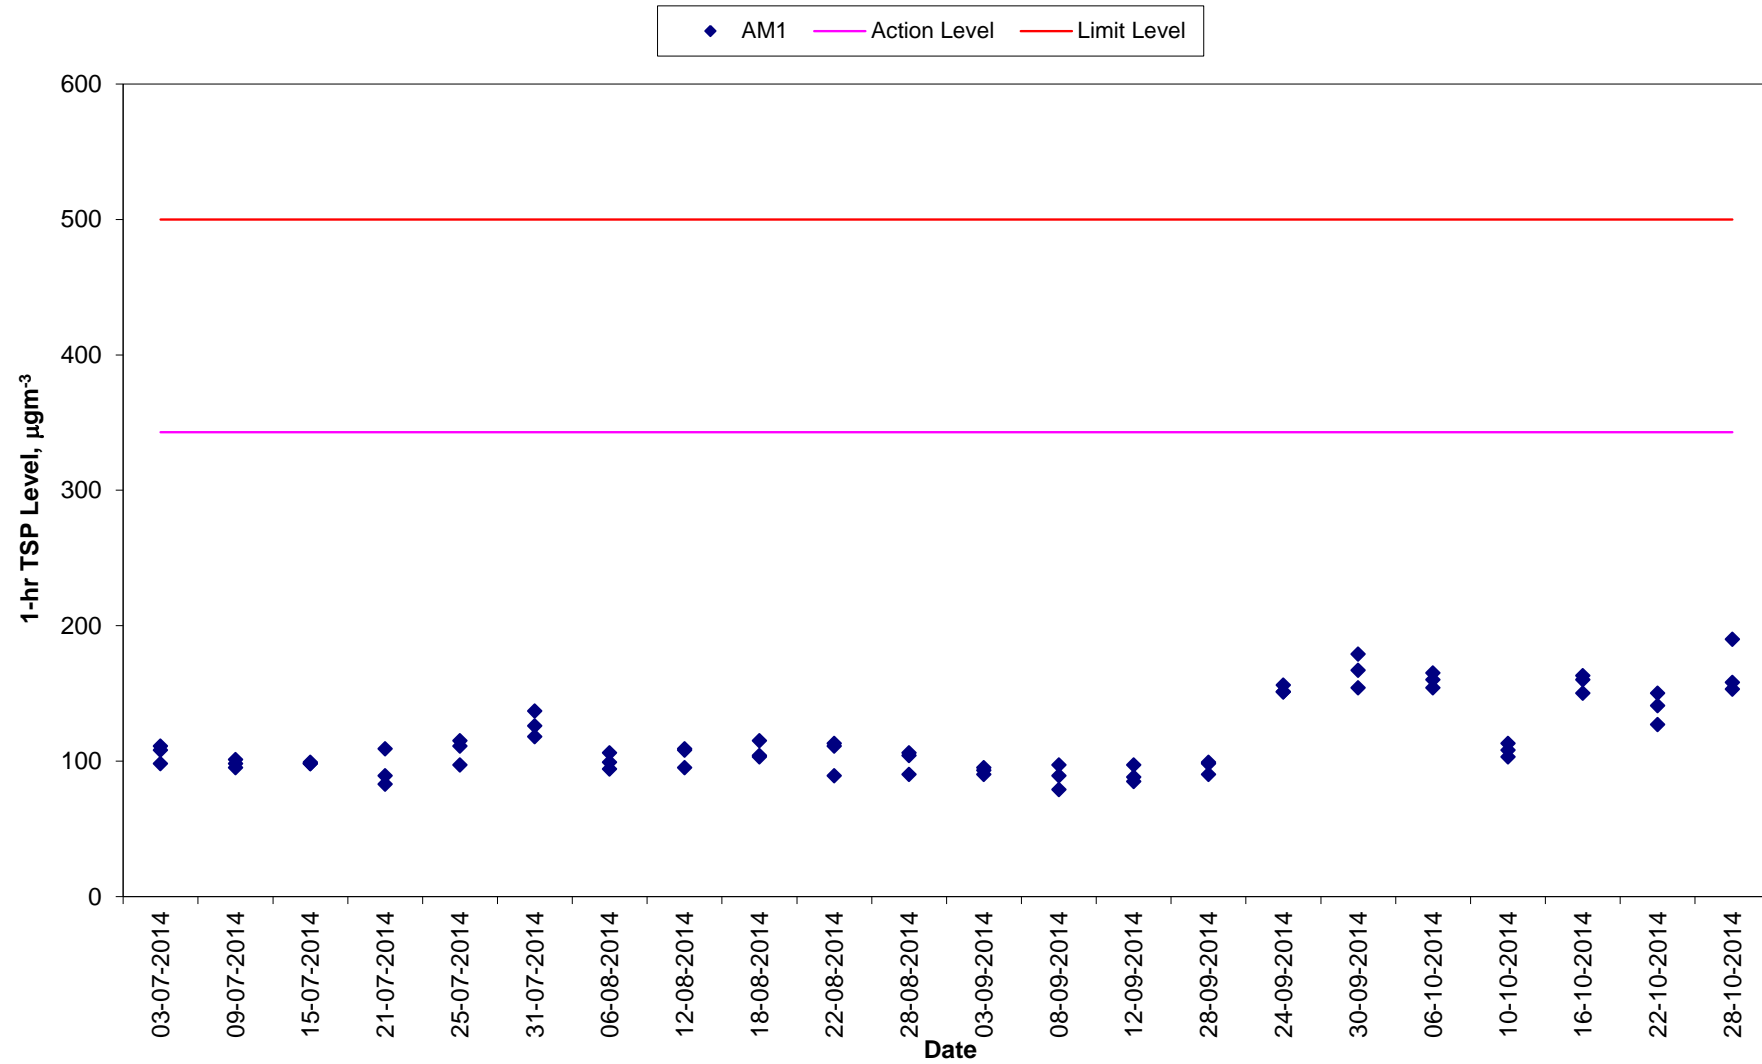
## 1-hr TSP Levels for the Past 4 Months AM1 (Tuen Mun EMSD Vehicle Servicing Station)

A total of 5 sets of 24-hour and 15 sets of 1-hour TSP measurements were taken at each of the monitoring stations (AM1 and AM2) during the reporting period. The monitoring data for 24-hour and 1-hour TSP together with the wind data and graphical presentations for the past 4 months are presented in *Annex G*. The weather conditions during the monitoring period ranged from fine to sunny. The local impacts near the monitoring stations of AM1 and AM2 were mainly associated with vehicular emissions. No exceedance of Action and Limit Level of the 1-hr and 24-hr TSP was recorded during the reporting period.

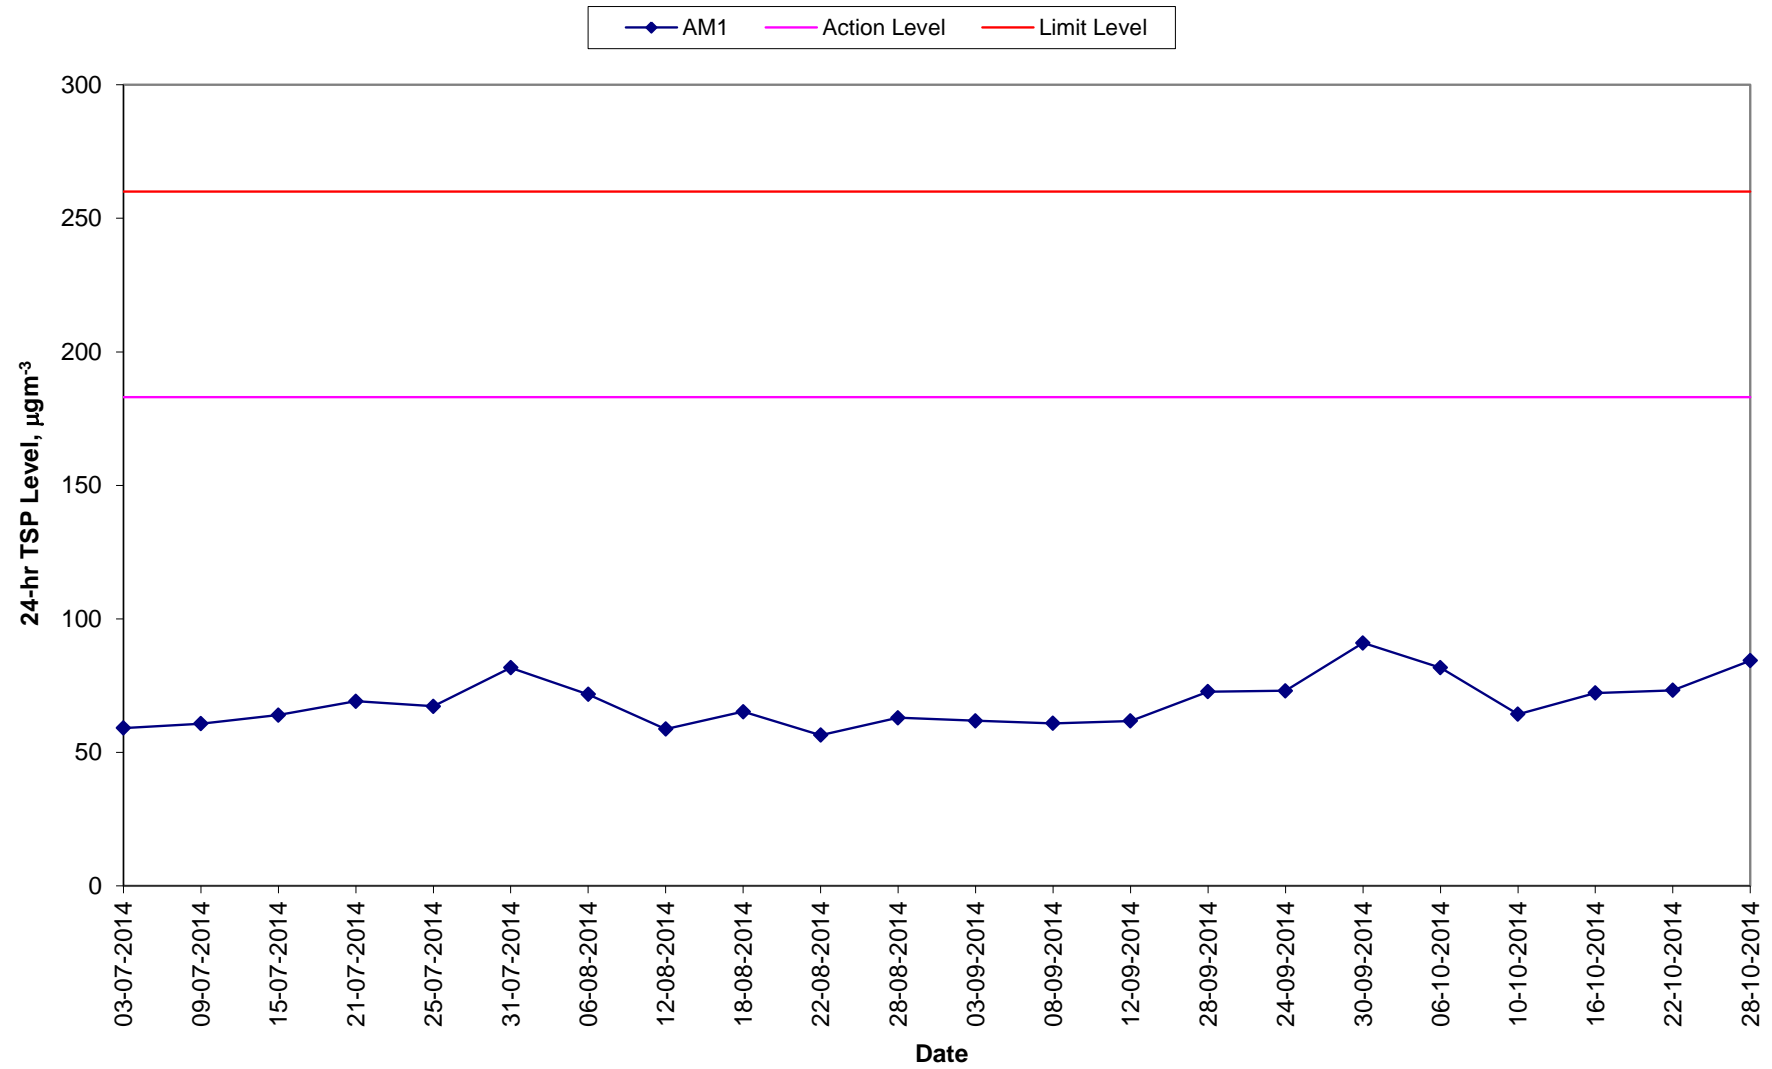
## 24-hr TSP Levels for the Past 4 Months AM1 (Tuen Mun EMSD Vehicle Servicing Station)

The monitoring results show that the average and range of the 24-hour TSP levels recorded since the commencement of the construction works have been well below the 24-hour TSP criterion in the HKAQO. Recommended mitigation measures in *Section 3.7.1.1* of EIA have been implemented throughout the construction period and were considered effective.
