Contract No. HY/2010/02

**Hong Kong – Zhuhai – Macao Bridge  
Hong Kong Boundary Crossing  
Facilities –  
Reclamation Works**

**Quarterly EM&A Report for  
March 2013- May 2013**

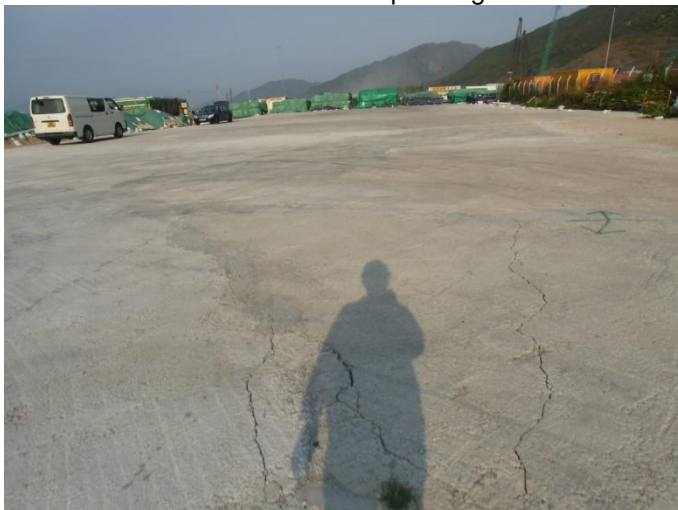
3.1.7.2 Construction activities, like sheet piling and percussive piling, were carrying out by nearby private development project during the course of monitoring, which are close to the monitoring station AMS3A but beyond the site boundary of Works Area WA2. Trucks were observed passing exposed soil surfaces at those construction sites of nearby private development project.

View of Works Area WA2 : Hard paved ground next to monitoring station AMS3A (View A)

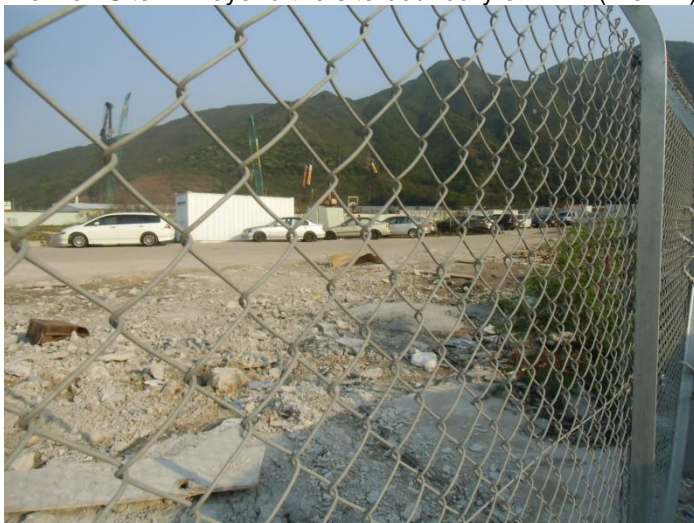
View on Site B: Beyond the site boundary of WA2 (View B)

- 3.1.7.5 As refer to the wind data collected at wind station at Works Area WA2 during the monitoring period on 4 and 5 March 13 (please see attached) south-southeast wind was prevailing during the monitoring period. Construction works carried out at construction sites of nearby private development project may contribute to the measured dust levels at the monitoring station AMS3A.

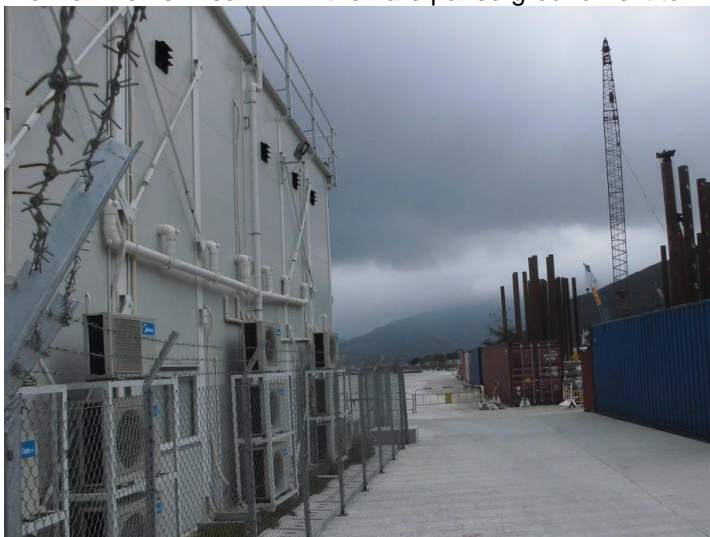
View of Works Area WA2 : the hard paved ground next to monitoring station AMS3A (View A)

3.1.8.10 The Contractor was recommended to continue implementing existing dust mitigation measures.

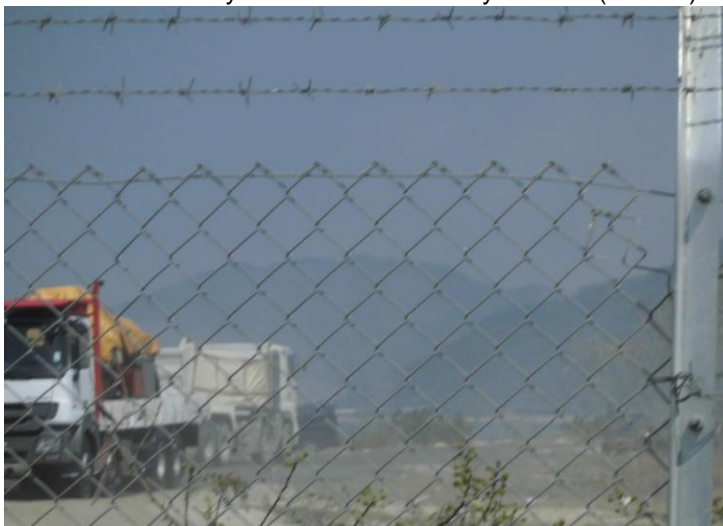
View on Site B: Beyond the site boundary of WA2 (View B)

3.1.8.5 As refer to the wind data collected at wind station at Works Area WA2 during the monitoring period on 8 and 9 March 13 (as attached) south wind was prevailing during the monitoring period. Construction works carried out at construction sites of nearby private development project may contribute to the measured dust levels at the monitoring station AMS3A.

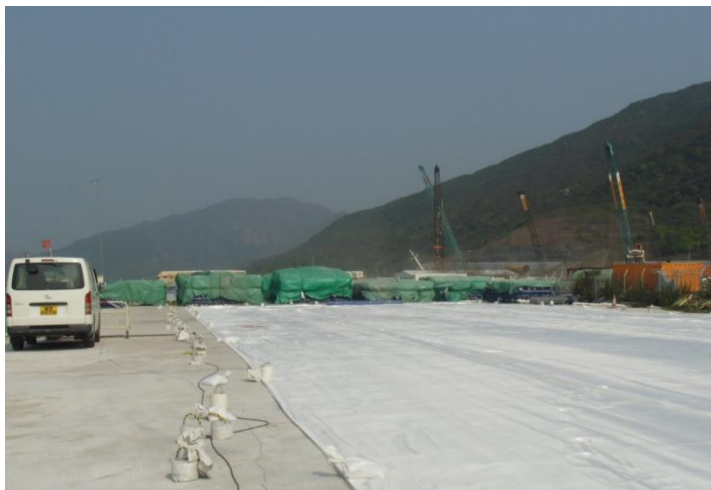
3.1.9.2 As informed by the Contractor, construction activities like sheet piling and percussive piling, were carrying out by nearby private development project during the course of monitoring, which are close to the monitoring station AMS3A but beyond the site boundary of Works Area WA2. Traffics were observed passing exposed soil surfaces at those construction sites of nearby private development project.

View of Works Area WA2 : the hard paved ground next to monitoring station AMS3A (View A)

- 3.1.9.9 The dust exceedance was therefore considered not to be due to the Project works.
- 3.1.9.10 The Contractor was recommended to continue implementing existing dust mitigation measures.

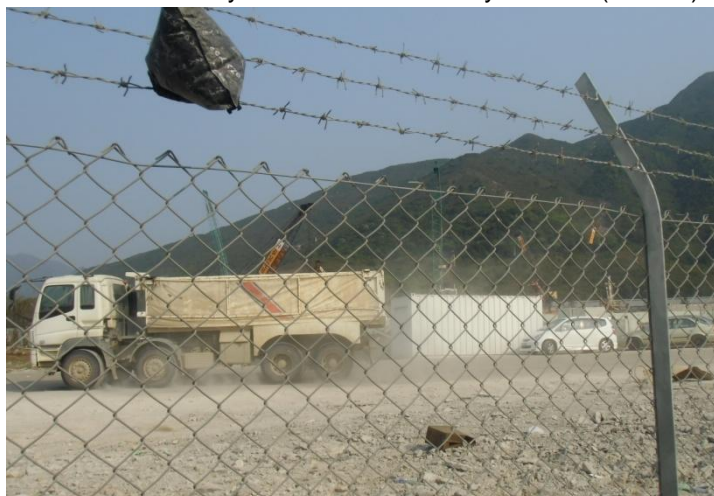
View on Site B: Beyond the site boundary of WA2 (View B)

- 3.1.9.5 As refer to the wind data collected at wind station at Works Area WA2 during the monitoring period on 14 and 15 March 13 (as attached) southeast winds was prevailing during the monitoring period. Construction works carried out at construction sites of nearby private development project may contribute to the measured dust levels at the monitoring station AMS3A.

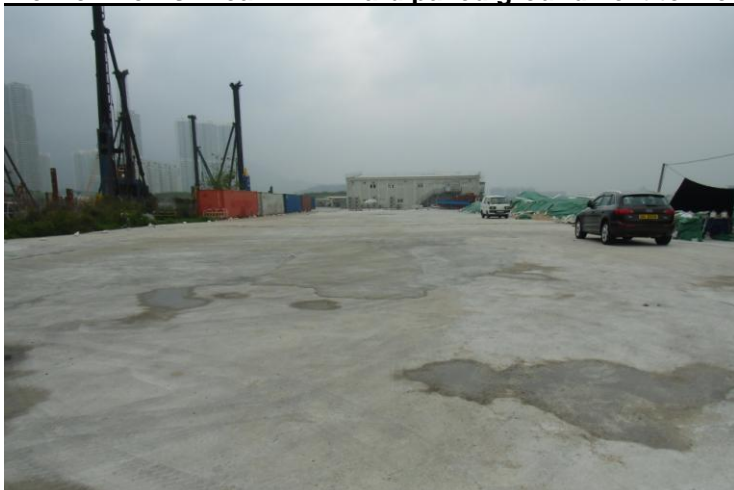
**View of Works Area WA2 : Hard paved ground next to monitoring station AMS3A (View A)**

3.1.10.10 The Contractor was recommended to continue implementing existing dust mitigation measures.

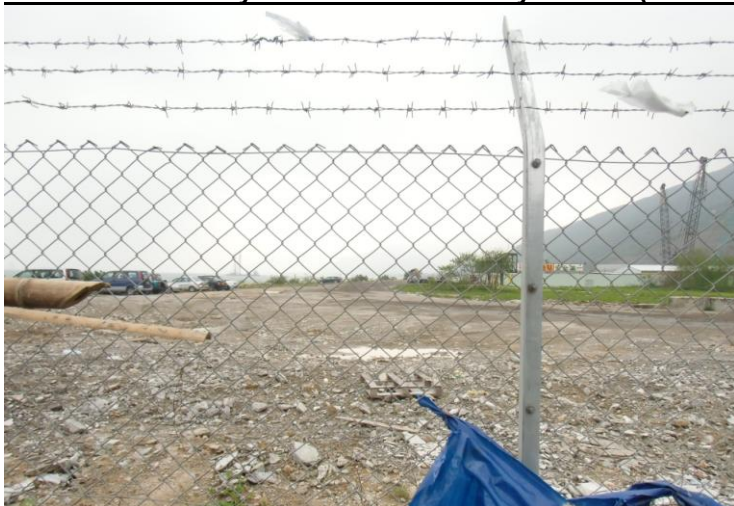
- 3.1.10.2 As informed by the Contractor, construction activities like sheet piling and percussive piling, were carrying out by nearby private development project during the course of monitoring, which are close to the monitoring station AMS3A but beyond the site boundary of Works Area WA2. Traffics were observed passing exposed soil surfaces at those construction sites of nearby private development project. Please also see photo and layout map attached for reference of site conditions.

**View on Site B: Beyond the site boundary of WA2 (View B)**

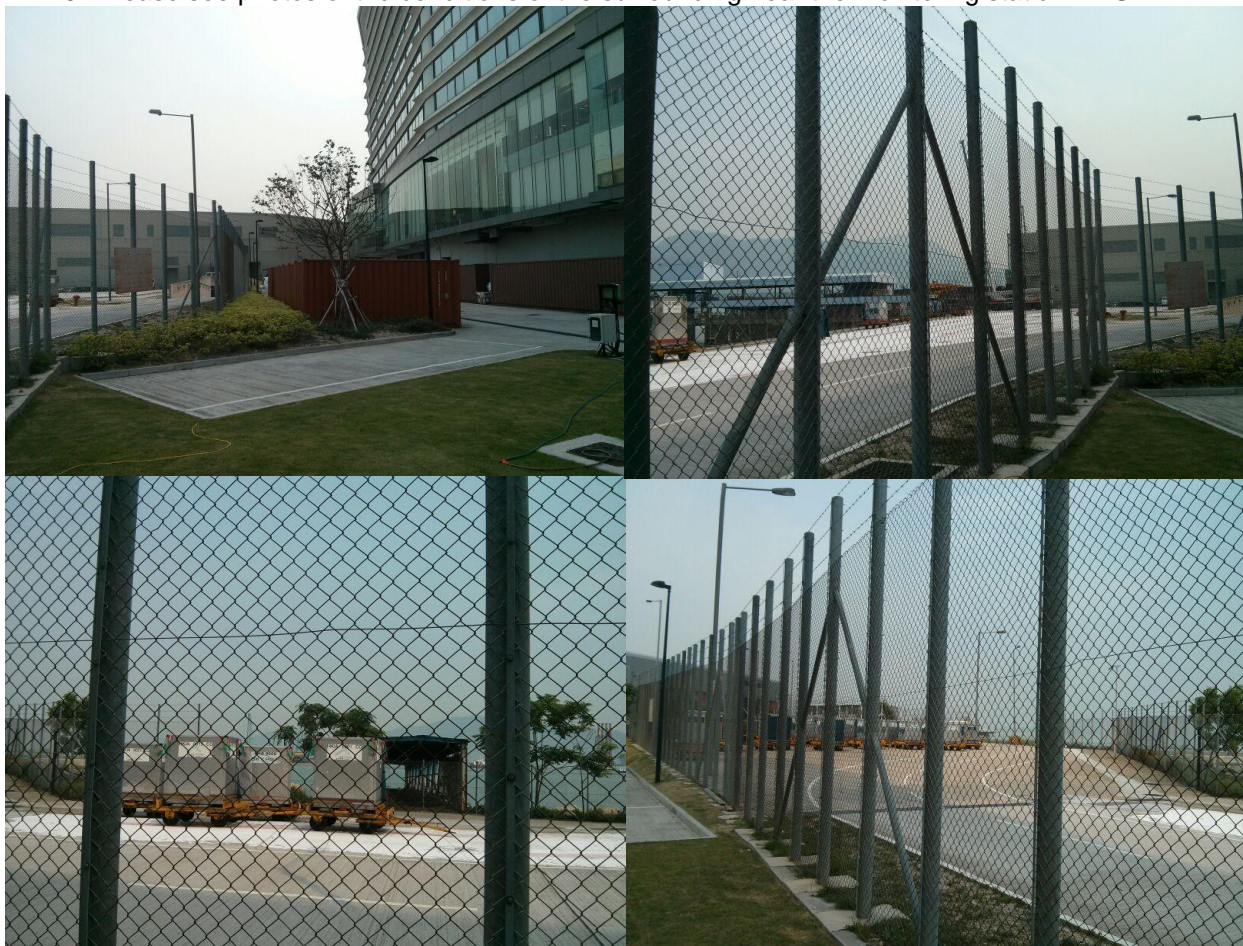
- 3.1.11.5 On the other hand, according to observation made at the monitoring station AMS7, there was no non-project potential cause/activity at the surrounding of monitoring station AMS7 which might potentially contribute to the dust action level exceedance.

3.1.11.10 Please see photos of the conditions of the surrounding near the monitoring station AMS7:

3.1.11.12 The Contractor was recommended to continue implementing existing dust mitigation measures.

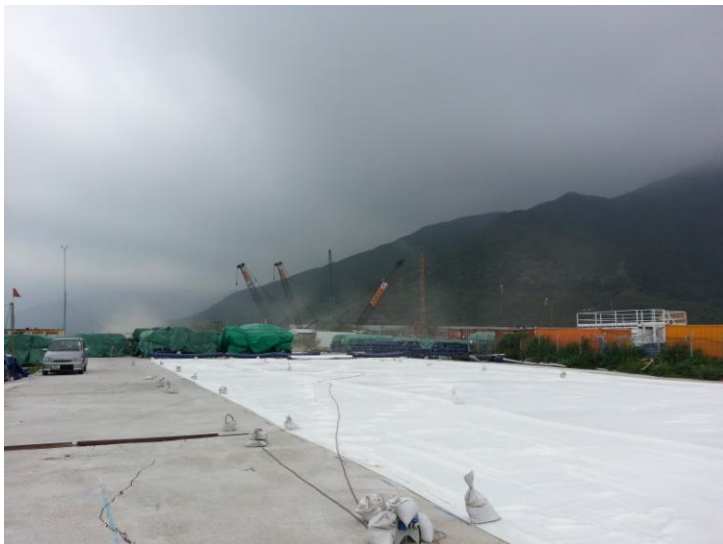
**View of Works Area WA2 : the hard paved ground next to monitoring station AMS3A (View A)**

3.1.12.11 The Contractor was recommended to continue implementing existing dust mitigation measures.

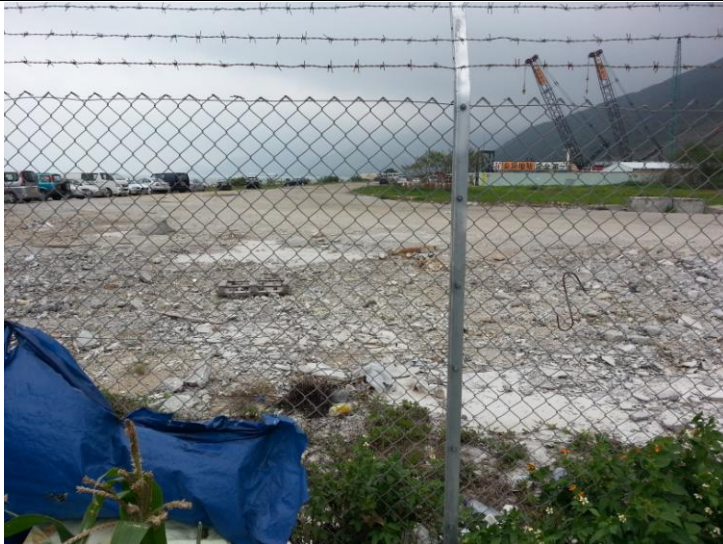
3.1.12.2 As informed by the Contractor, construction activities like sheet piling and percussive piling, were carrying out by nearby private development project during the course of monitoring, which are close to the monitoring station AMS3A but beyond the site boundary of Works Area WA2. Traffics were observed passing exposed soil surfaces at those construction sites of nearby private development project. Please also see photo and layout map attached for reference of site conditions.

**View on Site B: Beyond the site boundary of WA2 (View B)**
