Contract No. HY/2010/02

**Hong Kong – Zhuhai – Macao Bridge
Hong Kong Boundary Crossing
Facilities –
Reclamation Works**

**Quarterly EM&A Report for
December 2013- February 2014**

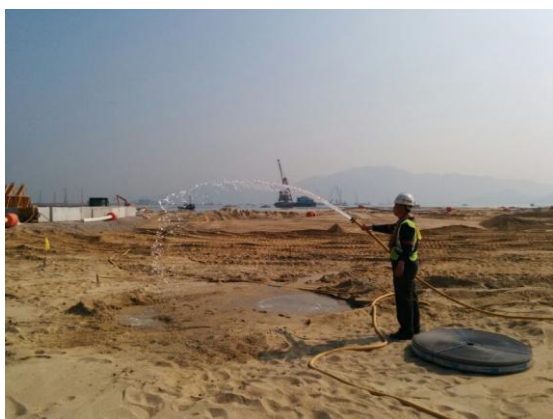
- 3.1.7.5 Photo record below shows that the Contractor implemented dust control measures on works area of Portion A:

- 3.1.7.11 The Contractor was recommended to continue implementing existing dust mitigation measures and the Contractor was reminded ensure to undertake watering at least 8 times per day on all exposed soil within the Project site and associated work areas throughout the construction phase.

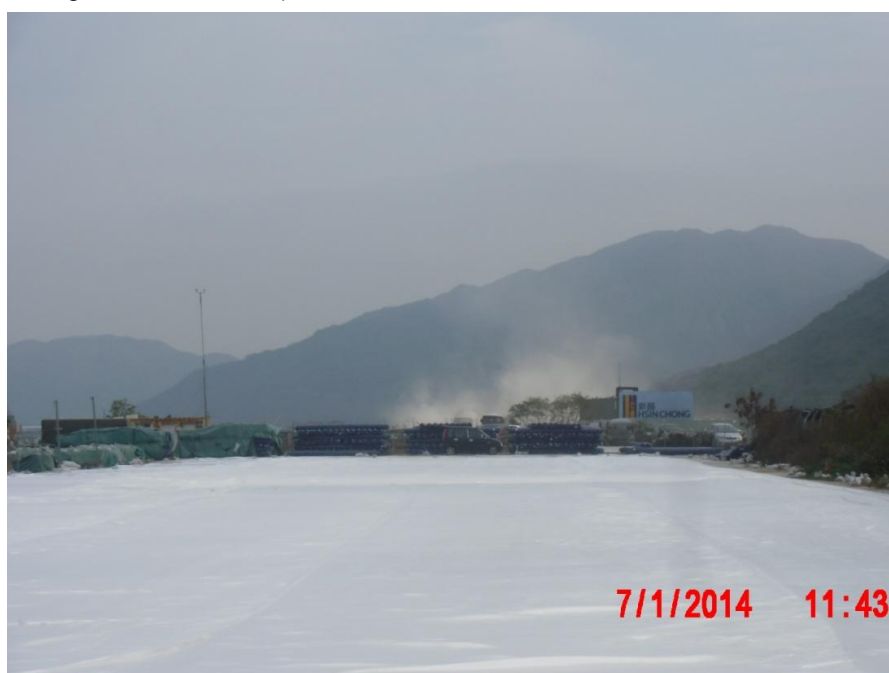
- 3.1.8.3 Photo records shows fugitive dust were generated by vehicle activities observed inside an area at construction sites of nearby private development project which are close to the monitoring station AMS3A but beyond the site boundary of Works Area WA2. (Please also see photo and layout map attached for reference of site conditions (View A.))

View A (fugitive dust were observed at the parking lot of the nearby construction site which do not belongs to this Contract)

3.1.8.9 The Contractor was recommended to continue implementing existing dust mitigation measures.

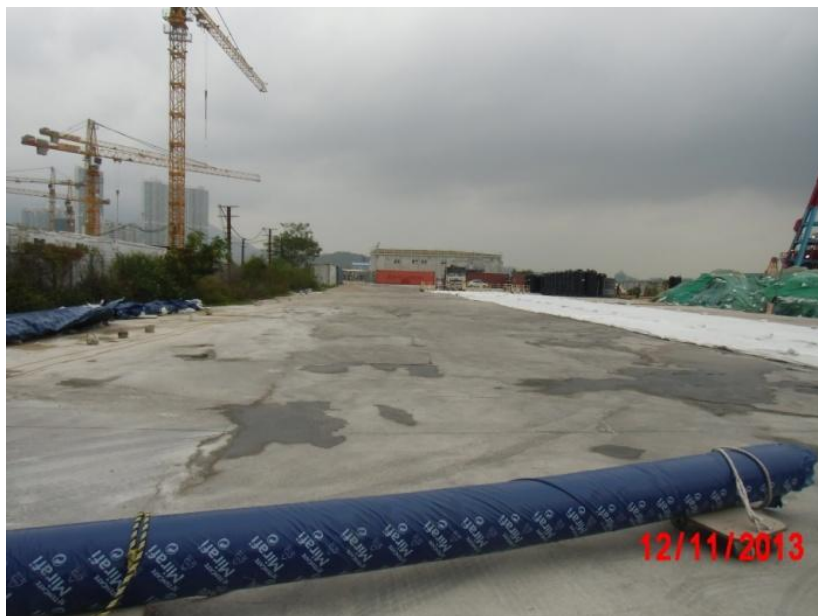
View B (Hard paved surface observed at Works Area WA2)

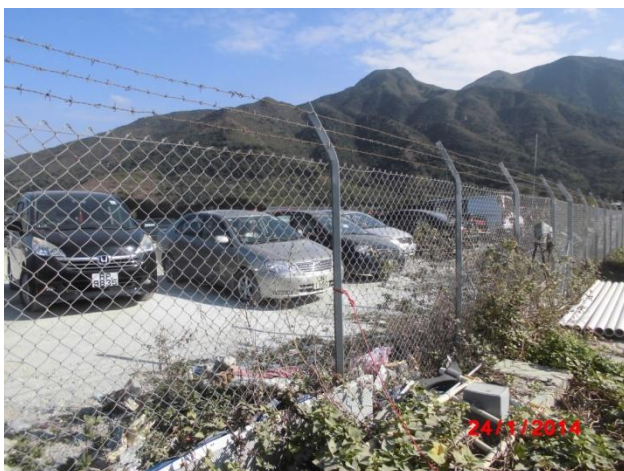
- 3.1.10.3 Photo records shows vehicle parking activities were observed inside an area at construction sites of nearby private development project which are close to the monitoring station AMS3A but beyond the site boundary of Works Area WA2. (Please also see photo and layout map attached for reference of site conditions (View A.))

View A (parking lot observed at nearby construction site which do not belongs to this Contract)

- 3.1.10.8 The dust exceedance was therefore considered not to be related to the Project works.

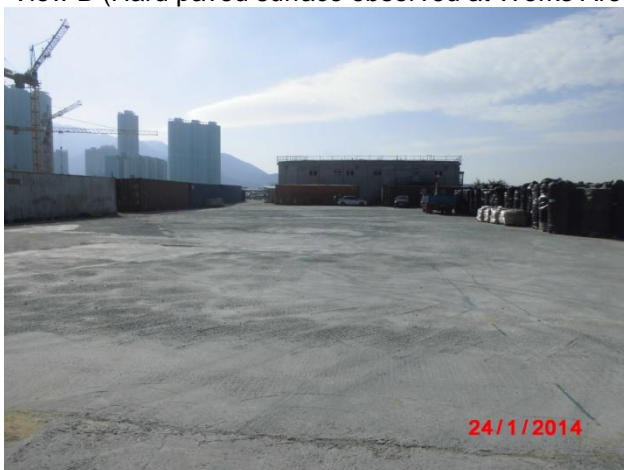
View B (Hard paved surface observed at Works Area WA2)

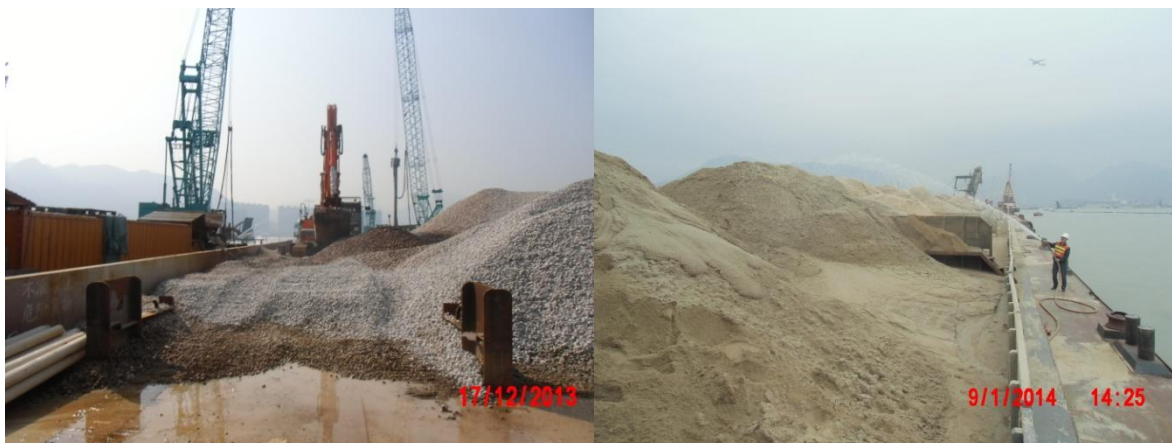
Photo record showed that the Contractor implemented dust control measures on pelican barge loaded with rock/sand. The Contractor was reminded to continue to provide dust control measures on pelican barge loaded with rock/sand.

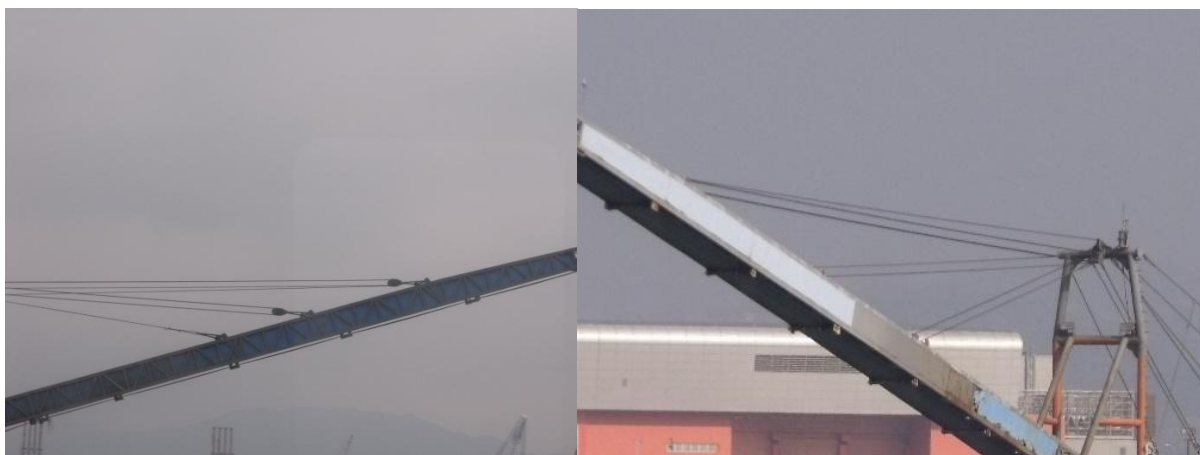
Photo record showed that the Contractor implemented dust control measures such as wind-board installed on pelican barge. The Contractor was reminded to continue to provide such dust control measure.

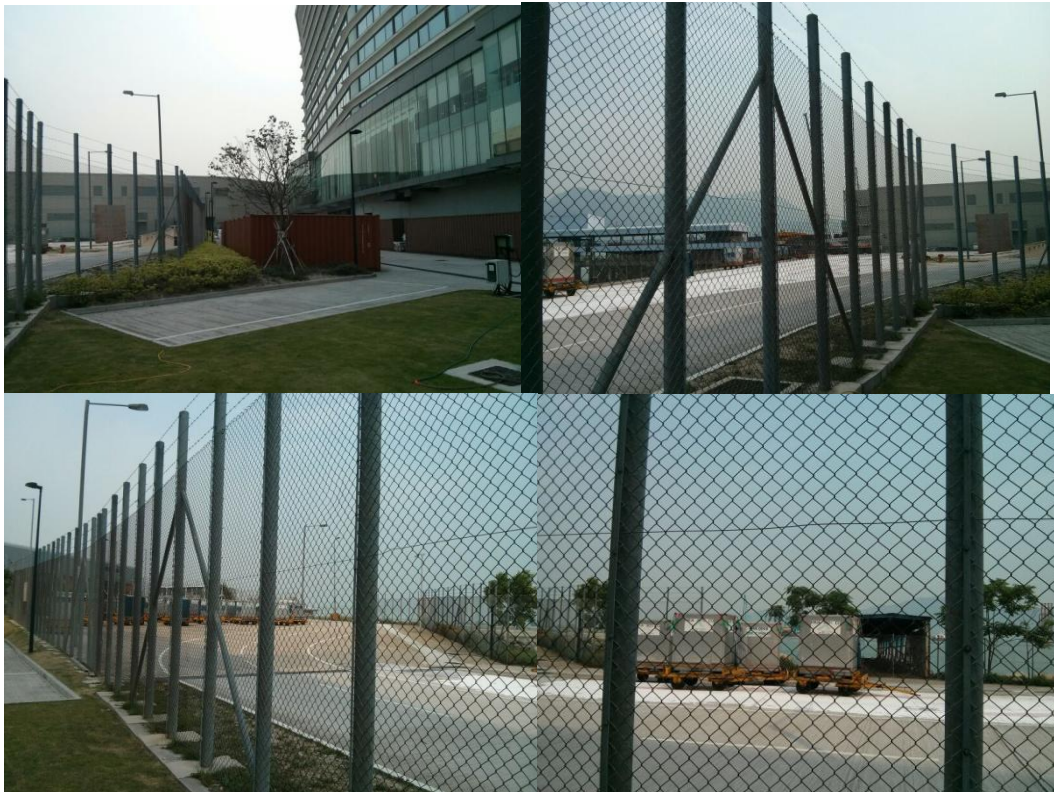
- 3.1.11.11 On the other hand, according to observation made at the monitoring station AMS7, there was no non-project potential cause/activity at the surrounding of monitoring station AMS7 which might potentially contribute to the dust action level exceedance.

Photo shows the conditions of the surrounding near the monitoring station AMS7:

3.1.11.12 The dust exceedance was therefore considered not to be due to the Project works.

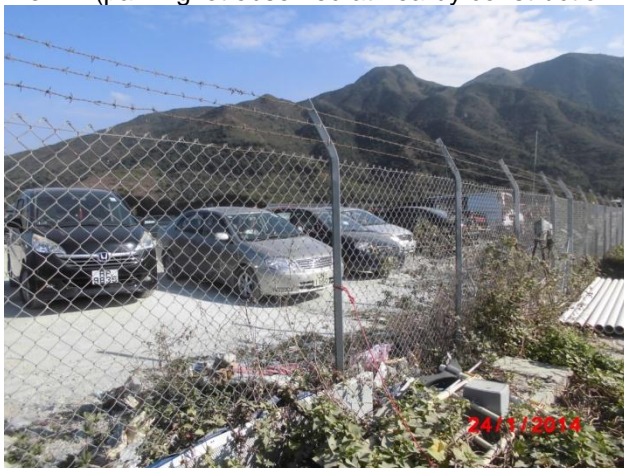
- 3.1.12.3 Photo records shows vehicle parking activities were observed inside an area at construction sites of nearby private development project which are close to the monitoring station AMS3A but beyond the site boundary of Works Area WA2. (Please also see photo and layout map attached for reference of site conditions (View A.))

View A (parking lot observed at nearby construction site which do not belongs to this Contract)

- 3.1.12.9 The dust exceedance was therefore considered not to be due to the Project works.

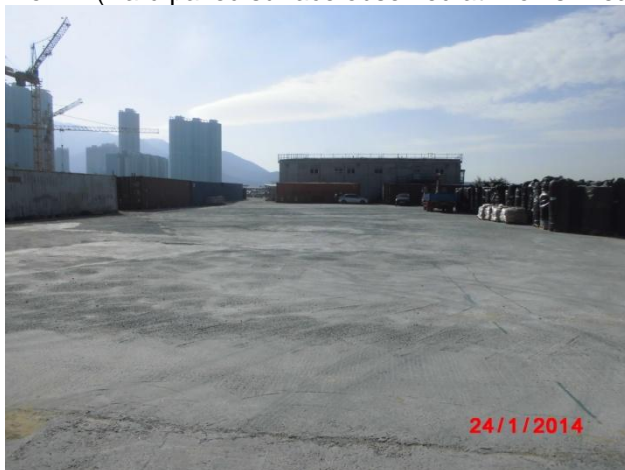
View B (Hard paved surface observed at Works Area WA2)

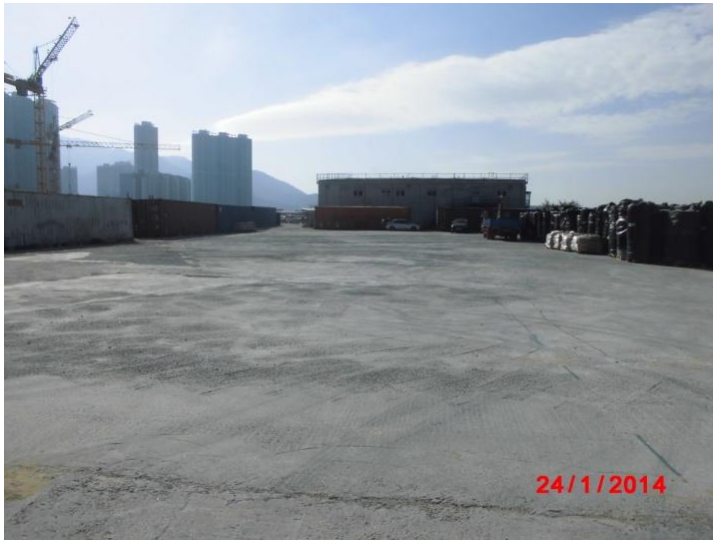
View B (Hard paved surface observed at Works Area WA2)

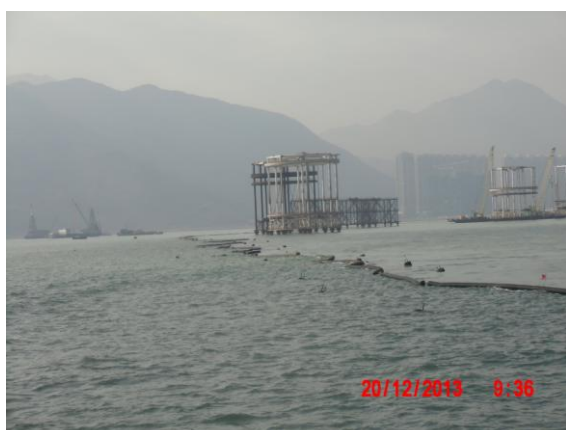
3.3.6.4 When impact water quality monitoring was carried out during mid flood tide at monitoring location IS8 on 20 Dec 13, no defects of the perimeter silt curtain was observed and no silty plume were observed to flow from the inside to the outside of the site boundary. (For reference, please see attached photo):

- 3.3.6.5 Turbidity level (NTU) result recorded on 20 Dec 13 at IS8 during flood tide is 22.3 NTU which is below the Action and Limit Level, this indicates turbidity level was not adversely affected.
- 3.3.6.6 Nevertheless, the Contractor was reminded to ensure provision of ongoing maintenance to the silt curtains and to carry out maintenance work once defects were found.
- 3.3.6.7 Maintenance work of the silt curtain was carried out by the Contractor on a daily basis except on Sunday and public holiday.
- 3.3.6.8 The exceedance was likely due to local effects in the vicinity of IS8.

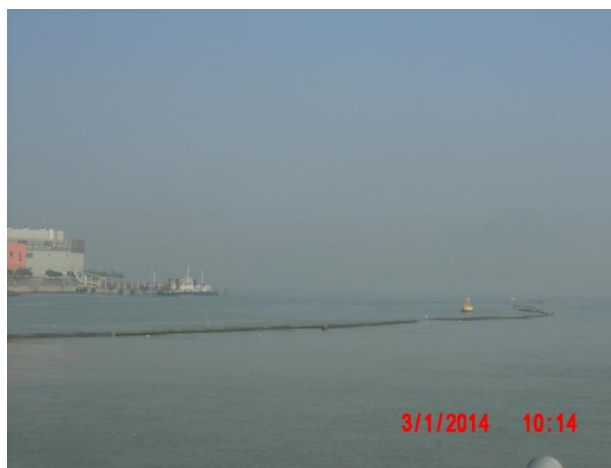
3.3.7.2 When impact water quality monitoring was carried out during mid flood tide at monitoring location IS10, SR5 and SR6 on 3 Jan 14, no silty plume were observed to flow from the inside to the outside of the northwestern part of the perimeter silt curtain.

3.3.7.3 IS10, SR5 (located outside northwest part of the perimeter silt curtain) and IS(Mf)11 (located outside north part of the perimeter silt curtain) which are closer to the active works than monitoring station SR6. Depth Averaged Suspended Solids (SS) values (in mg/L) recorded during the flood tide on the same day at IS10, SR5 and IS(Mf)11 were below the Action and Limit Level which shows that the water quality closer to active works was not adversely affected.

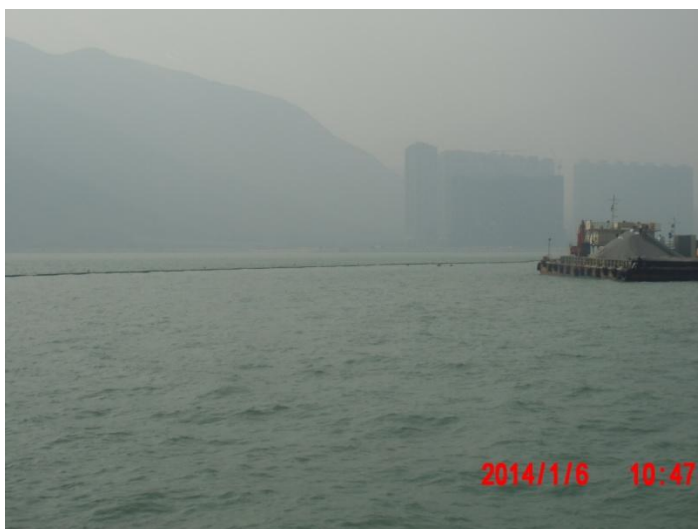
3.3.8.3 The turbidity level (in NTU) at IS(Mf)9, IS8, IS7 and IS(Mf)16 were below the action and limit level and no silt plume was observed when monitoring was conducted IS(Mf)9 and IS8, this indicates that the turbidity level (in NTU) at IS(Mf)9, IS8, IS7 and IS(Mf)16 were not adversely affected.

- 3.3.8.4 Also, with refer to the silt curtain condition on 06 Jan 14, no defects of the perimeter silt curtain was observed at south and southeast of the construction site.
- 3.3.8.5 The exceedances were likely due to local effects in the vicinity of IS(Mf)9 and IS8.
- 3.3.8.6 As such, the exceedances recorded at IS(Mf)9 and IS8 are considered non-project related.
- 3.3.8.7 The Contractor was reminded to ensure provision of ongoing maintenance to the silt curtains and to carry out maintenance work once defects were found.
- 3.3.8.8 Maintenance work of the silt curtain was carried out by the Contractor on a daily basis except on Sunday and public holiday.

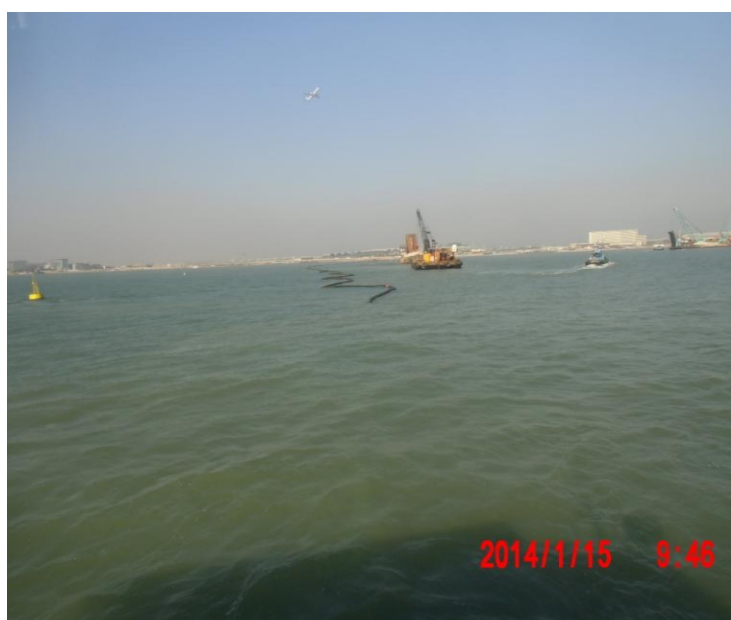
3.3.10.2 Since the turbidity level (in NTU) at IS(Mf)9, IS8, IS7 and IS(Mf)16 were below the action and limit level and no silt plume was observed when monitoring was conducted at IS(Mf)9, this indicates that the turbidity level (in NTU) at IS(Mf)9, IS8, IS7 and IS(Mf)16 were not adversely affected. Please refer to the photo record attached for sea condition recorded on 15 Jan 14 at southeast vessel entrance of the perimeter silt curtain (near monitoring station IS(Mf)9).

- 3.3.10.3 Also, with refer to the silt curtain condition on 15 Jan 14, no defects of the perimeter silt curtain was observed at south and southeast of the construction site.
- 3.3.10.4 The exceedance was likely due to local effects in the vicinity of IS(Mf)9.
- 3.3.10.5 As such, the action level exceedance recorded at IS(Mf)9 is considered non-project related.
- 3.3.10.6 The Contractor was reminded to ensure provision of ongoing maintenance to the silt curtains and to carry out maintenance work once defects were found.
- 3.3.10.7 The Contractor was reminded that, with reference to EM&A manual Clause 9.1.1, the vessel access opening of the perimeter silt curtain would be formed by two piece of silt-curtain with overlapping length of 150m minimum and a separation distance of about 50m.

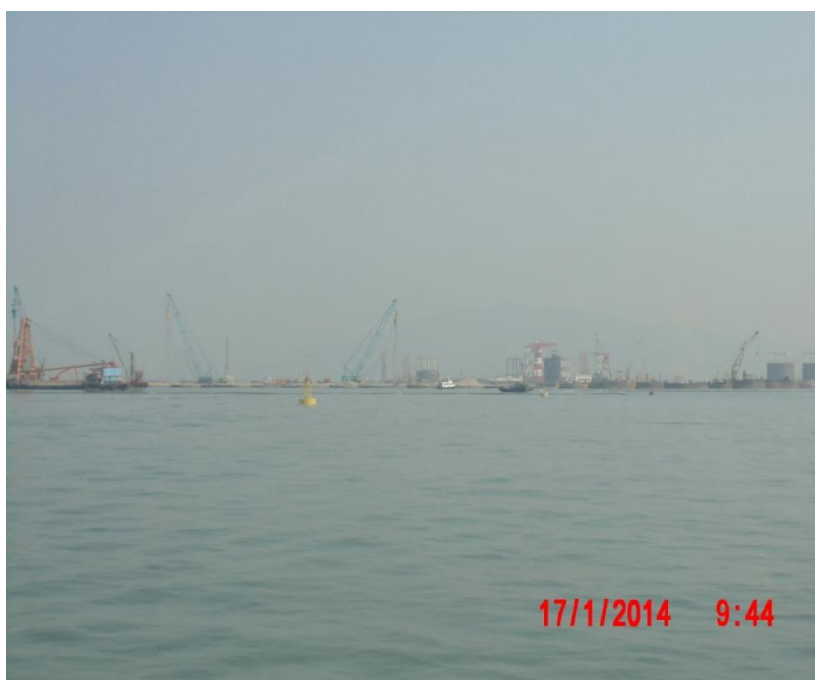
3.3.11.2 Since the turbidity level (in NTU) at IS(Mf)9, IS8, IS7 and IS(Mf)16 were below the action and limit level and no silt plume was observed when monitoring was conducted at IS(Mf)9. Please refer to the photo record below for sea condition near IS(Mf)9 on 17 Jan 14.

- 3.3.11.3 Also, with refer to the silt curtain condition on 17 Jan 14, no defects of the perimeter silt curtain was observed at south and southeast of the construction site.
- 3.3.11.4 The exceedance was likely due to local effects in the vicinity of IS(Mf)9.
- 3.3.11.5 As such, the limit level exceedance recorded at IS(Mf)9 is considered non-project related.
- 3.3.11.6 The Contractor was reminded to ensure provision of ongoing maintenance to the silt curtains and to carry out maintenance work once defects were found.
- 3.3.11.7 Maintenance work of the silt curtain was carried out by the Contractor on a daily basis except on Sunday and public holiday.

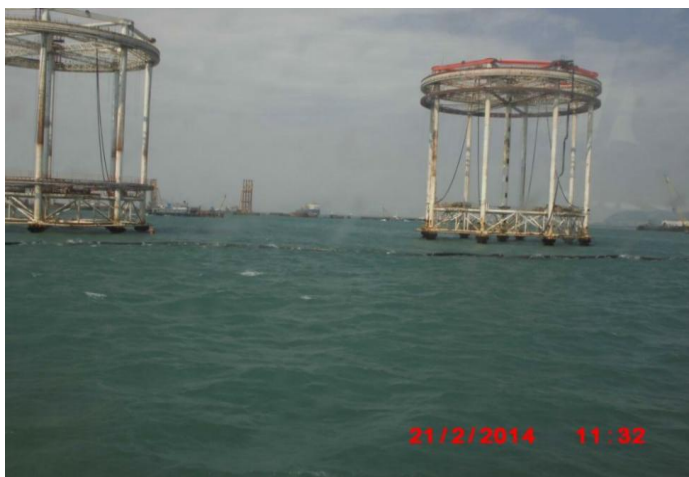
3.3.12.7 With refer to the daily silt curtain integrity checking record of 21 Feb 14, no defects was observed along the part of the perimeter silt curtain located east of HKBCF-reclamation site which is next to IS(Mf)16. For the condition of the perimeter silt curtain condition near monitoring station IS(Mf)16, please refer to the photo record below:

3.3.12.8 The exceedance was likely due to local effects in the vicinity of IS(Mf)16.

3.3.12.10 Nevertheless, the Contractor was reminded to ensure provision of ongoing maintenance to the silt curtains and to carry out maintenance work once defects were found.

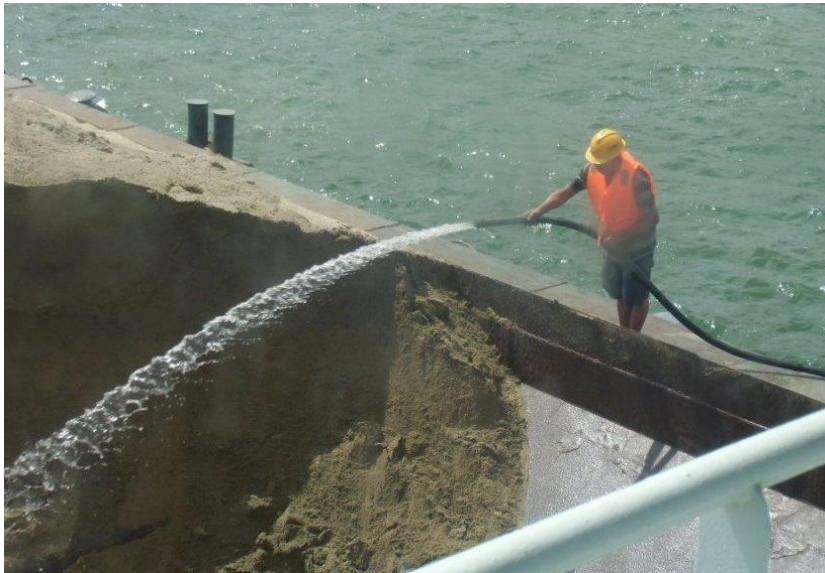
- 7.1.3.5 Photo record shows that watering equipment is provided on pelican barge loaded with sand for watering of sand filling material to keep the sand material wet.

- 7.1.3.4 The Contractor was advised to ensure to continue the provision of fugitive dust mitigation measures to barges loaded with filling material such as watering to sand filling material on sand barges to keep the surface of stockpile of filling material wet.

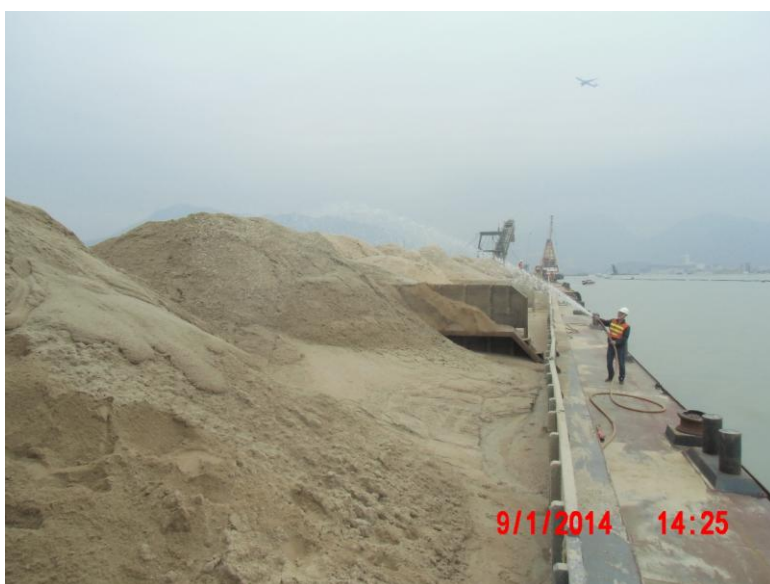
- 7.1.6.1 Site visit was conducted on 9 Jan 14 and it was observed during the site investigation that watering equipment was provided on pelican barge loaded with sand for watering of sand filling material to keep the surface of sand material wet. This is consistent with HyD's reply to Oriental Daily Newspaper that the Contractor would water the sand material to keep the sand material wet to prevent generation of fugitive dust.

- 7.1.6.2 Photo record shows that watering equipment is provided on pelican barge loaded with sand for watering of sand filling material.
