Contract No. HY/2010/02

**Hong Kong – Zhuhai – Macao Bridge  
Hong Kong Boundary Crossing  
Facilities –  
Reclamation Works**

**Quarterly EM&A Report for  
June 2014- August 2014**

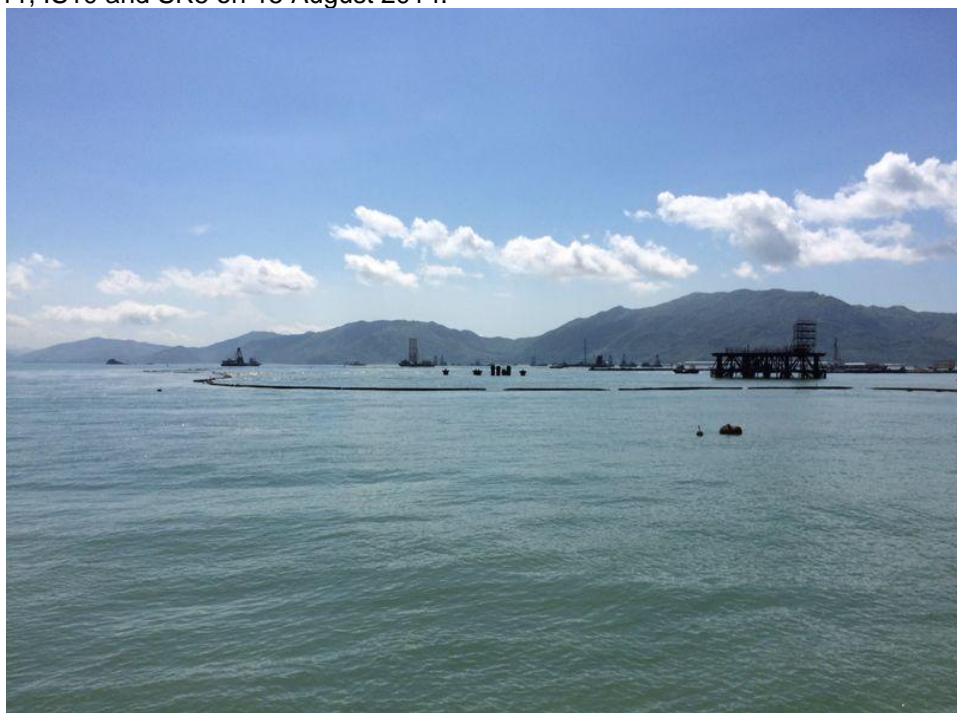
3.3.3.4 As informed by the Contractor, filling was conducted on 13, 15 and 18 August 2014 at Portion C2b, but with referred to monitoring record and photo record attached, no sediment plume has been observed to flow from the inside of the perimeter silt curtain to the outside of the perimeter silt curtain and no discoloration of sea water has been observed. Please refer to the photo attached for reference of the sea condition during ebb tide and flood tide on 15 August 2014.

- 3.3.3.6 Photo record of sea condition taken during flood tide at north of HKBCF Reclamation Works near IS(Mf)11, IS10 and SR5 on 15 August 2014.

3.3.3.12 Nevertheless, the Contractor was reminded to ensure provision of ongoing maintenance to the silt curtains and to carry out maintenance work once defects were found.

3.3.3.13 With reference to the silt curtain checking record on 27 August 2014, the defect observed on 15 August 2014 at north part of the perimeter silt curtain has been repaired. As informed by the Contractor, maintenance work of the silt curtain is on-going and carried out by the Contractor on a daily basis.

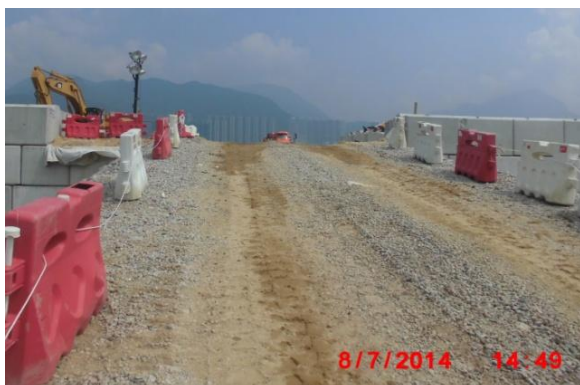
- After reviewing the available information provided by the complainant, the source of light is likely from lighting system for the construction works conducted at night.
- With referred to the photo record below, there is measure to control night-time lighting and glare such as hooding lights, please see below photo record of hooding of lights.

- In addition, as informed by the Contractor, construction works would be carried out at night in order to be in line with the progress of this project, however, the Contractor has arranged major activities to be performed during the day time to minimize works in the night time.
- As such, the visual impact complaint is likely to be related to the construction works of this Contract.
- As informed by the Contractor, all the night-lighting is movable and would be moved according to the reclamation progress. However, all the night-lighting has been provided with hooding.
- The Contractor was reminded to continue to properly implement existing mitigation measure for visual impact such as provide night-lighting with hooding.
- In addition, the Contractor was recommended to adjust the orientation of light to minimize glare to residence as far as possible.

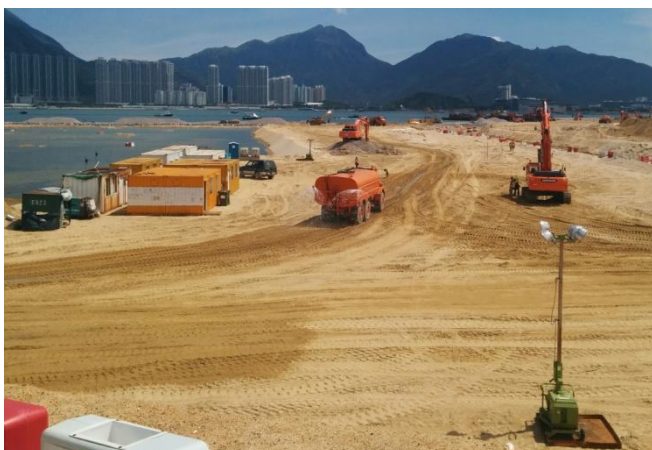
- The Contractor was reminded to continue to properly implement existing mitigation measure for visual impact such as provide night-lighting with hooding.
- In addition, the Contractor was recommended to adjust the orientation of light to minimize glare to residence as far as possible.
- Photo record on 16 July 2014 shows that the recommended mitigation measures has been implemented by the Contractor:

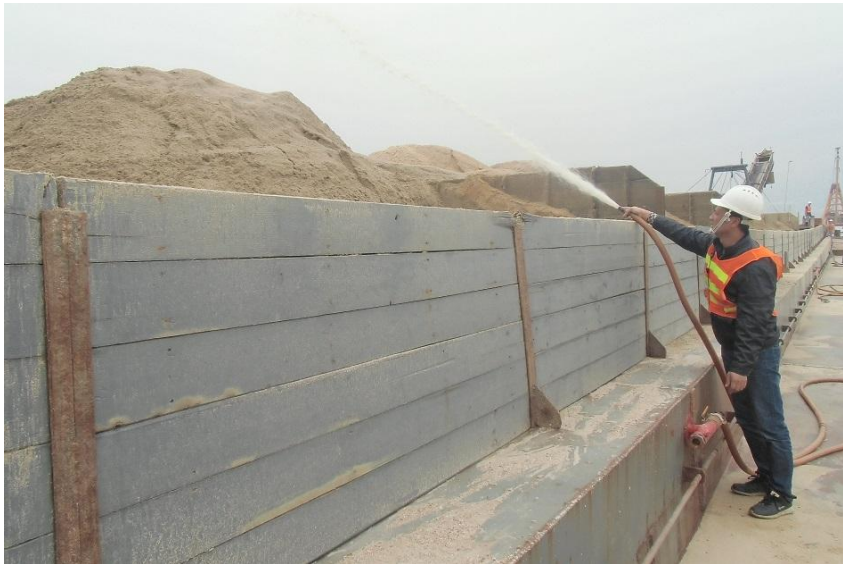
- There is no sufficient information provided by the complainant to make sure that the concerned barges are related to this project.
- Date of the observed impact was not specified by the complainant so the impact air quality monitoring (IAQM) results available for August 2014 for monitoring stations close to the concerned area – AQMS1, ASR1, ASR5, ASR6 and ASR10 have been reviewed and there was no impact air quality monitoring result that shows 1-hour TSP or 24-hour TSP exceeded the action (AL)/limit level (LL).
- Photo record below shows that Sand barges are equipped with watering equipments. And watering equipment was used to keep the sand filling material wet.

- In addition, site inspection has been jointly conducted with the Contractor and RSS on 28 August 2014, but no generation of fugitive dust was observed to be caused by barges loaded with filling material.
