Development of a Biodiesel Plant at Tseung Kwan O Industrial Estate

Monthly EM&A Report

February 2018

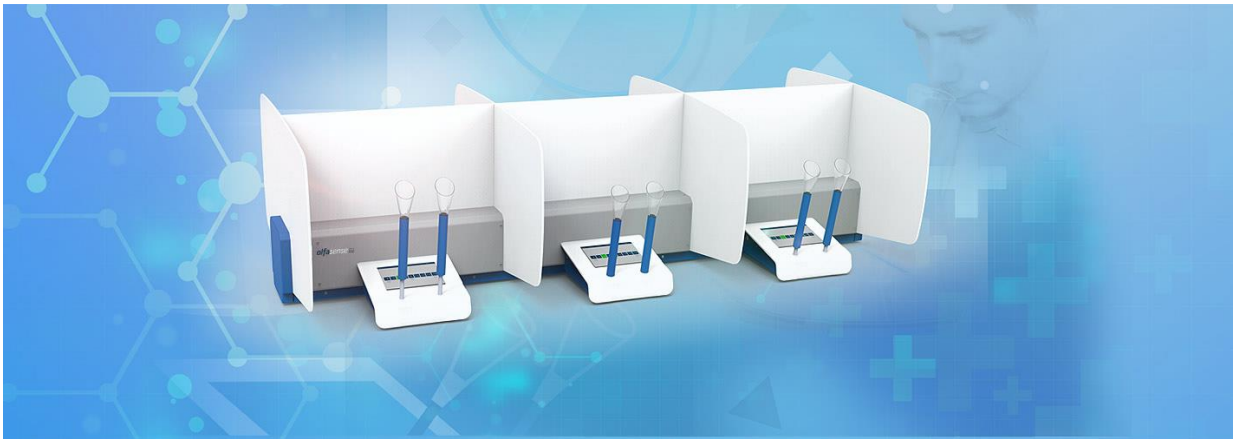
Odour concentration is determined by a Dynamic Olfactometer (TO evolution) in accordance with the European Standard Method (EN13725). This European Standard specifies a method for the objective determination of the odour concentration of a gaseous sample using dynamic olfactometry with human assessors and the emission rate of odours emanating from point sources, area sources with outward flow and area sources without outward flow. This European Standard is applicable to the measurement of odour concentration of pure substances, defined mixtures and undefined mixtures of gaseous odorants in air or nitrogen, using dynamic olfactometry with a panel of human assessors being the sensor. The unit of measurement is the odour unit per cubic metre: OU_E/m^3 . The odour concentration is measured by determining the dilution factor required to reach the detection threshold. The odour concentration at the detection threshold is defined as $1 \text{ OU}_E/\text{m}^3$. The odour concentration is then expressed in terms of multiples of the detection threshold. The range of measurement is typically from $2^2 \text{ OU}_E/\text{m}^3$ to $2^{17} \text{ OU}_E/\text{m}^3$ (excluding pre-dilution).

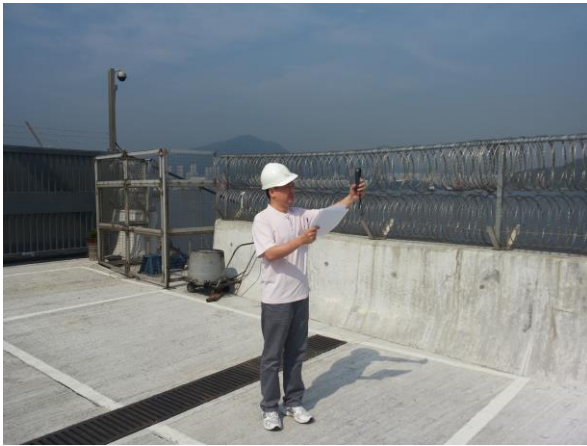
1

- 4.5 The illustrations about odour patrol activities at different locations are presented below:
