Development of a Biodiesel Plant at Tseung Kwan O Industrial Estate

Monthly EM&A Report

June 2019

Development of a Biodiesel Plant at Tseung Kwan O Industrial Estate - Operation Phase

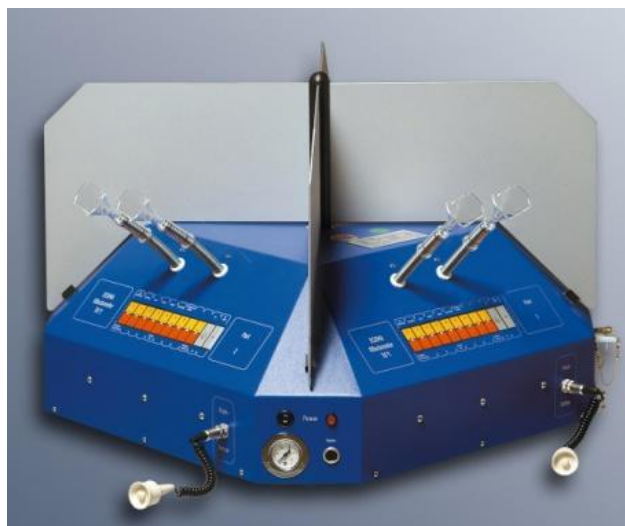
Odour concentration is determined by a Dynamic Olfactometer (TO9) in accordance with the European Standard Method (EN13725). This European Standard specifies a method for the objective determination of the odour concentration of a gaseous sample using dynamic olfactometry with human assessors and the emission rate of odours emanating from point sources, area sources with outward flow and area sources without outward flow. This European Standard is applicable to the measurement of odour concentration of pure substances, defined mixtures and undefined mixtures of gaseous odorants in air or nitrogen, using dynamic olfactometry with a panel of human assessors being the sensor. The unit of measurement is the odour unit per cubic metre: OU_E/m^3 . The odour concentration is measured by determining the dilution factor required to reach the detection threshold. The odour concentration at the detection threshold is defined as $1 \text{ OU}_E/\text{m}^3$. The odour concentration is then expressed in terms of multiples of the detection threshold. The range of measurement is typically from $2^2 \text{ OU}_E/\text{m}^3$ to $2^{17} \text{ OU}_E/\text{m}^3$ (excluding pre-dilution).

Olfactometer

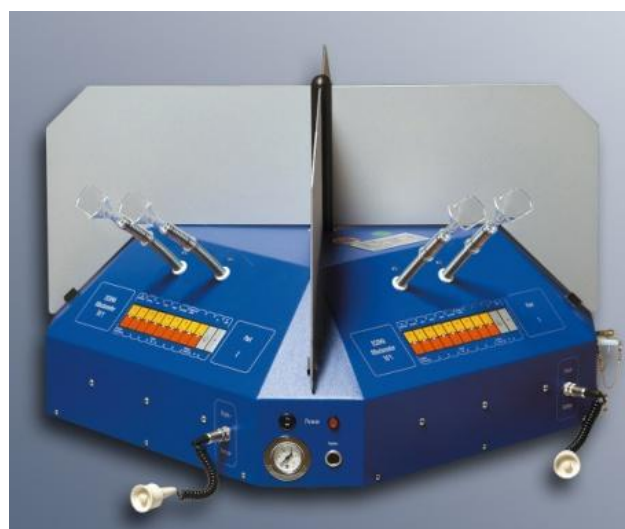
Odour concentration is determined by a Dynamic Olfactometer (TO9) in accordance with the European Standard Method (EN13725). This European Standard specifies a method for the objective determination of the odour concentration of a gaseous sample using dynamic olfactometry with human assessors and the emission rate of odours emanating from point sources, area sources with outward flow and area sources without outward flow. This European Standard is applicable to the measurement of odour concentration of pure substances, defined mixtures and undefined mixtures of gaseous odorants in air or nitrogen, using dynamic olfactometry with a panel of human assessors being the sensor. The unit of measurement is the odour unit per cubic metre: OU_E/m^3 . The odour concentration is measured by determining the dilution factor required to reach the detection threshold. The odour concentration at the detection threshold is defined as $1 \text{ OU}_E/\text{m}^3$. The odour concentration is then expressed in terms of multiples of the detection threshold. The range of measurement is typically from $2^2 \text{ OU}_E/\text{m}^3$ to $2^{17} \text{ OU}_E/\text{m}^3$ (excluding pre-dilution).

Olfactometer

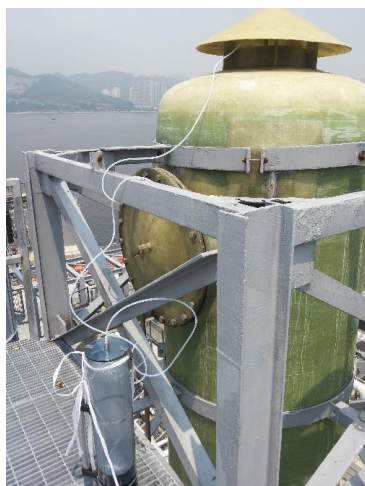
The photos about the on-site sampling activity at the final air scrubber are presented below,

Final air scrubber

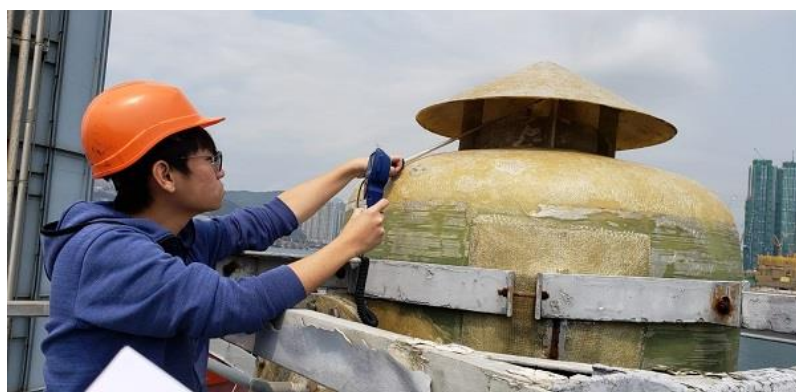
Final air scrubber
