Development of a Biodiesel Plant at Tseung Kwan O Industrial Estate

Monthly EM&A Report

December 2019

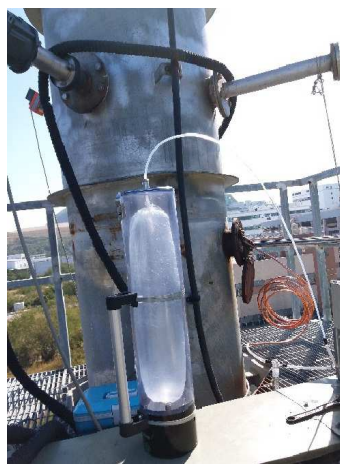
Boiler stack (EP2)

The photo about the on-site sampling activity at the final air scrubber is presented below,
