Development of a Biodiesel Plant at Tseung Kwan O Industrial Estate

Monthly EM&A Report

January 2020

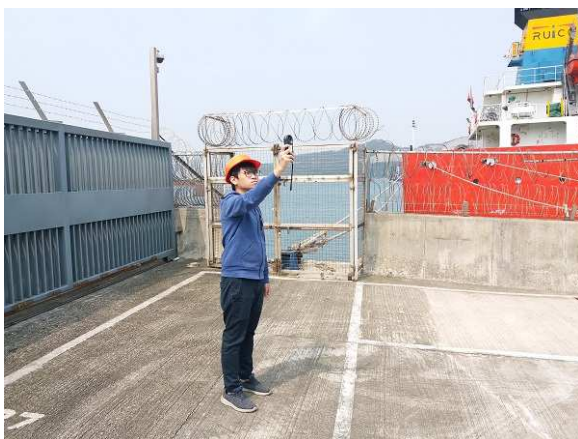
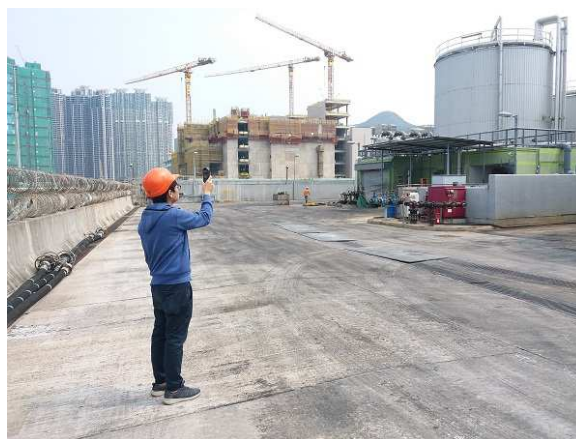
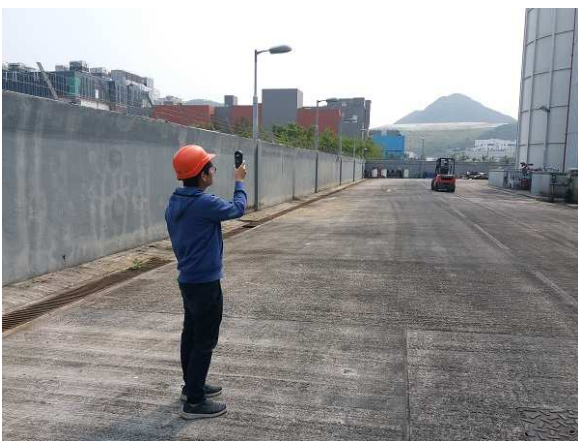
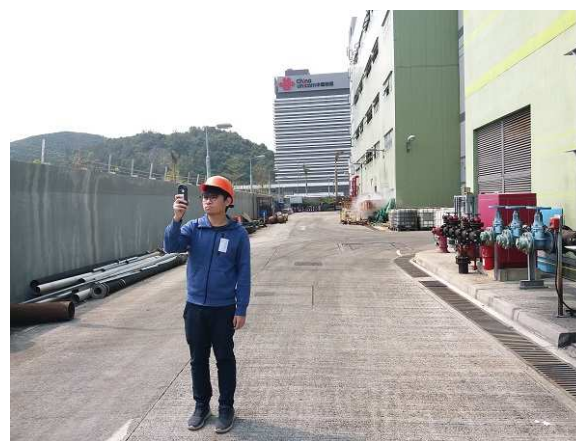
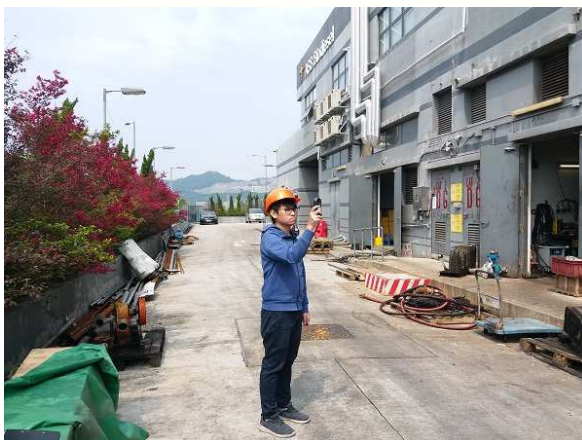
- 4.5 The illustrations about odour patrol activities at different locations are presented below:

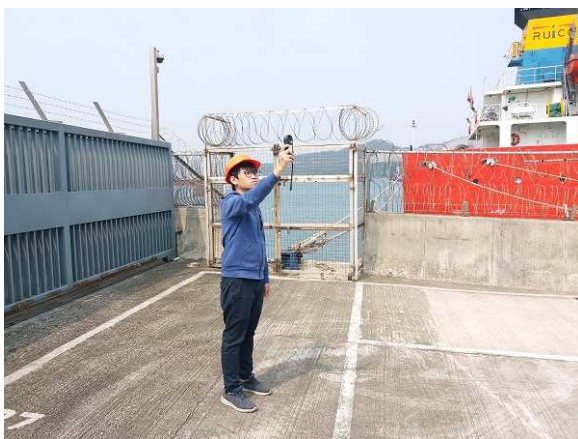
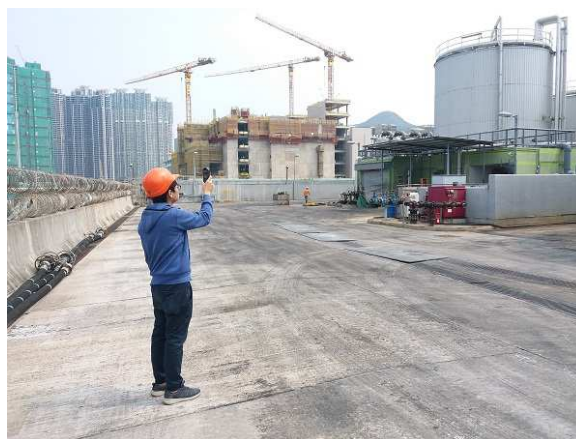
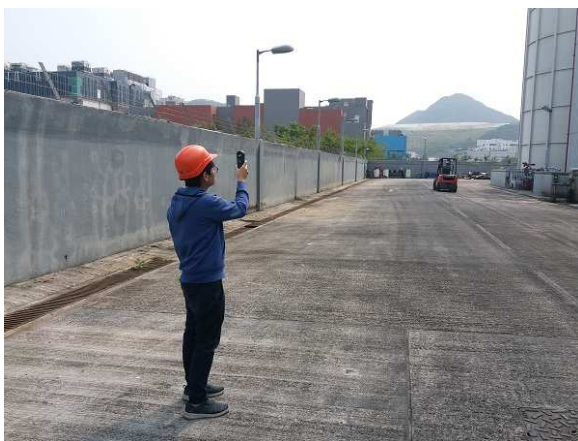
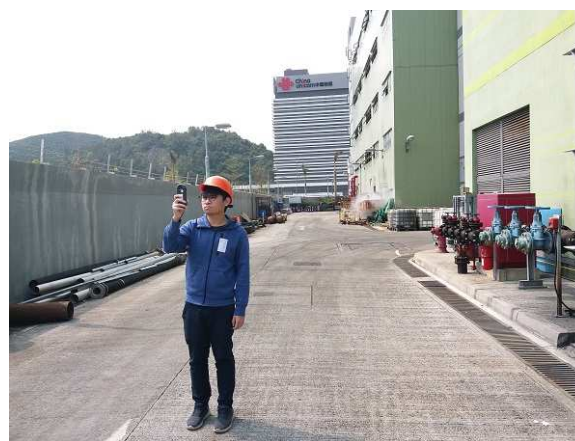
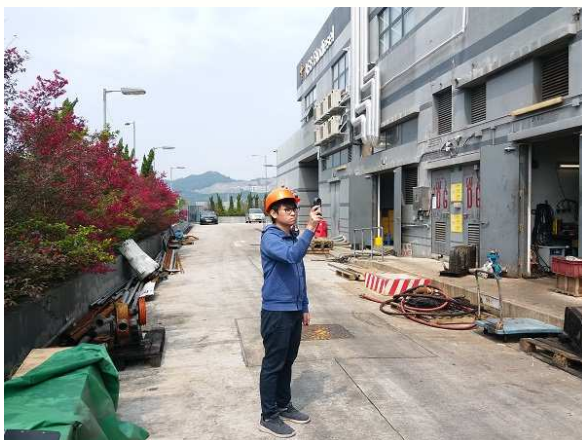
- 4.5 The illustrations about odour patrol activities at different locations are presented below:
