# ASB Biodiesel (Hong Kong) Limited

## Development of a Biodiesel Plant at Tseung Kwan O Industrial Estate

Monthly EM&A Report

February 2020

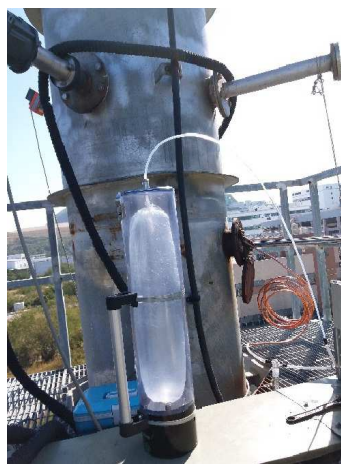
The photo about the on-site sampling activity at the final air scrubber is presented below,

Boiler stack (EP2)
