Development of a Biodiesel Plant at Tseung Kwan O Industrial Estate

Monthly EM&A Report

March 2020

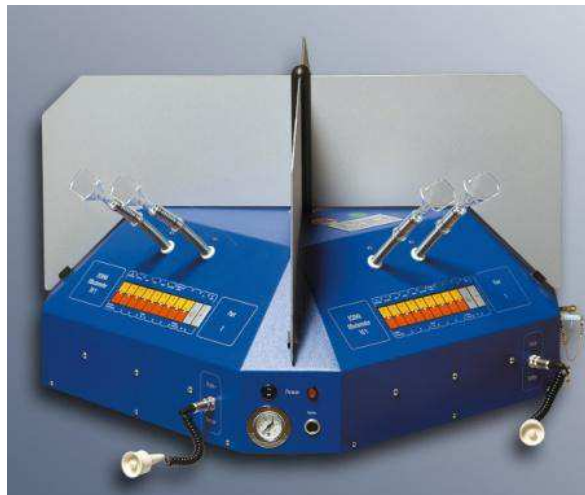
Odour concentration is determined by a Dynamic Olfactometer (TO9) in accordance with the European Standard Method (EN13725). This European Standard specifies a method for the objective determination of the odour concentration of a gaseous sample using dynamic olfactometry with human assessors and the emission rate of odours emanating from point sources, area sources with outward flow and area sources without outward flow. This European Standard is applicable to the measurement of odour concentration of pure substances, defined mixtures and undefined mixtures of gaseous odorants in air or nitrogen, using dynamic olfactometry with a panel of human assessors being the sensor. The unit of measurement is the odour unit per cubic metre: OU_E/m^3 . The odour concentration is measured by determining the dilution factor required to reach the detection threshold. The odour concentration at the detection threshold is defined as $1 \text{ OU}_E/\text{m}^3$. The odour concentration is then expressed in terms of multiples of the detection threshold. The range of measurement is typically from $2^2 \text{ OU}_E/\text{m}^3$ to $2^{17} \text{ OU}_E/\text{m}^3$ (excluding pre-dilution).

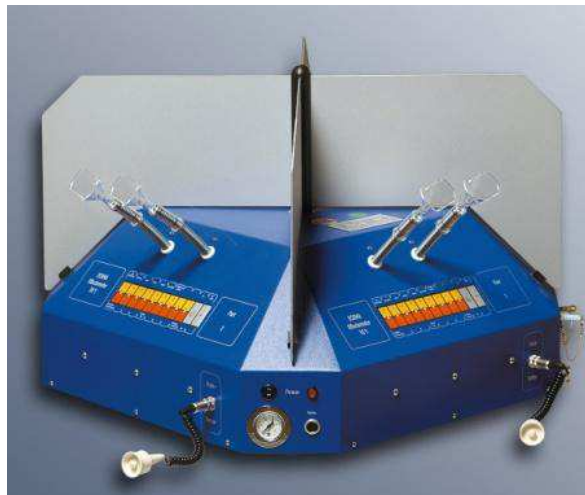
Odour concentration is determined by a Dynamic Olfactometer (TO9) in accordance with the European Standard Method (EN13725). This European Standard specifies a method for the objective determination of the odour concentration of a gaseous sample using dynamic olfactometry with human assessors and the emission rate of odours emanating from point sources, area sources with outward flow and area sources without outward flow. This European Standard is applicable to the measurement of odour concentration of pure substances, defined mixtures and undefined mixtures of gaseous odorants in air or nitrogen, using dynamic olfactometry with a panel of human assessors being the sensor. The unit of measurement is the odour unit per cubic metre: OU_E/m^3 . The odour concentration is measured by determining the dilution factor required to reach the detection threshold. The odour concentration at the detection threshold is defined as $1 \text{ OU}_E/\text{m}^3$. The odour concentration is then expressed in terms of multiples of the detection threshold. The range of measurement is typically from $2^2 \text{ OU}_E/\text{m}^3$ to $2^{17} \text{ OU}_E/\text{m}^3$ (excluding pre-dilution).

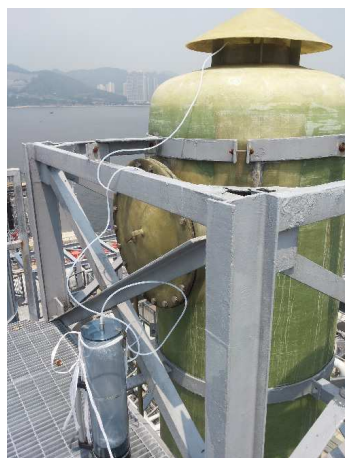
Final air scrubber

The photos about the on-site sampling activity at the final air scrubber are presented below,
