Development of a Biodiesel Plant at Tseung Kwan O Industrial Estate

Monthly EM&A Report

May 2020

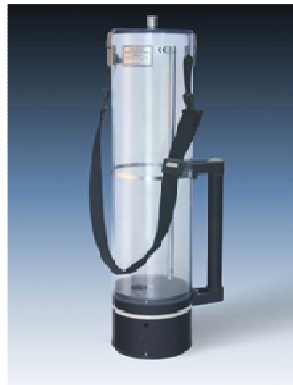
Odour Sampling System

Odour gas sample is collected by a Sampling Device Standard consists of a vacuum container, which is evacuated by a vacuum pump. The sampling point and the standard sampler are connected by a probe. Due to the evacuation in the sampling device, the sample bag, inside the device, sucks in sample air via the probe. During this process, none of its components come into contact with the sample air due to the construction of the sampling device.

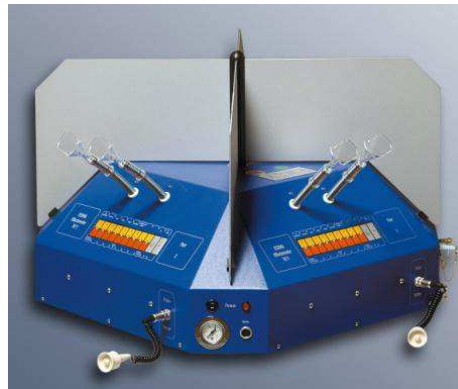
Odour concentration is determined by a Dynamic Olfactometer (TO9) in accordance with the European Standard Method (EN13725). This European Standard specifies a method for the objective determination of the odour concentration of a gaseous sample using dynamic olfactometry with human assessors and the emission rate of odours emanating from point sources, area sources with outward flow and area sources without outward flow. This European Standard is applicable to the measurement of odour concentration of pure substances, defined mixtures and undefined mixtures of gaseous odorants in air or nitrogen, using dynamic olfactometry with a panel of human assessors being the sensor. The unit of measurement is the odour unit per cubic metre: OU_E/m^3 . The odour concentration is measured by determining the dilution factor required to reach the detection threshold. The odour concentration at the detection threshold is defined as $1 OU_E/m^3$. The odour concentration is then expressed in terms of multiples of the detection threshold. The range of measurement is typically from $2^2 OU_E/m^3$ to $2^{17} OU_E/m^3$ (excluding pre-dilution).

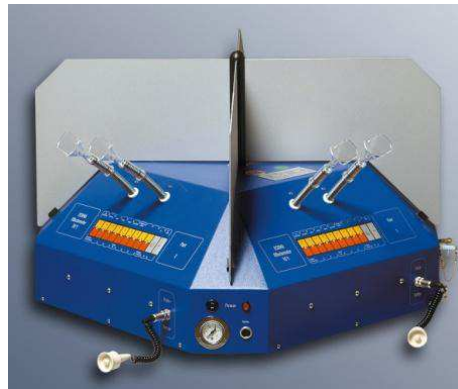
Odour concentration is determined by a Dynamic Olfactometer (TO9) in accordance with the European Standard Method (EN13725). This European Standard specifies a method for the objective determination of the odour concentration of a gaseous sample using dynamic olfactometry with human assessors and the emission rate of odours emanating from point sources, area sources with outward flow and area sources without outward flow. This European Standard is applicable to the measurement of odour concentration of pure substances, defined mixtures and undefined mixtures of gaseous odorants in air or nitrogen, using dynamic olfactometry with a panel of human assessors being the sensor. The unit of measurement is the odour unit per cubic metre: OU_E/m^3 . The odour concentration is measured by determining the dilution factor required to reach the detection threshold. The odour concentration at the detection threshold is defined as $1 OU_E/m^3$. The odour concentration is then expressed in terms of multiples of the detection threshold. The range of measurement is typically from $2^2 OU_E/m^3$ to $2^{17} OU_E/m^3$ (excluding pre-dilution).
