ASB Biodiesel (Hong Kong) Limited

Development of a Biodiesel Plant at Tseung Kwan O Industrial Estate

Monthly Environmental Monitoring and Audit Report for June 2020

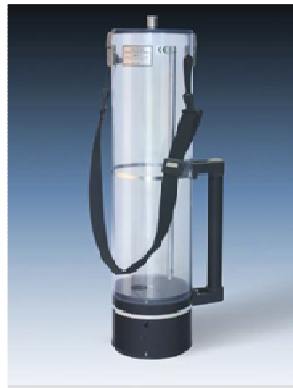
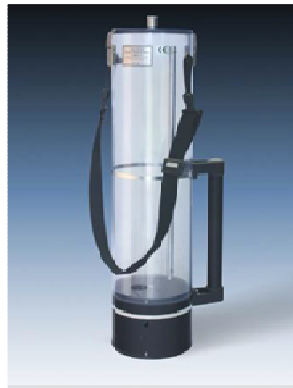
Odour Sampling System

Odour gas sample is collected by a Sampling Device Standard consists of a vacuum container, which is evacuated by a vacuum pump. The sampling point and the standard sampler are connected by a probe. Due to the evacuation in the sampling device, the sample bag, inside the device, sucks in sample air via the probe. During this process, none of its components come into contact with the sample air due to the construction of the sampling device.

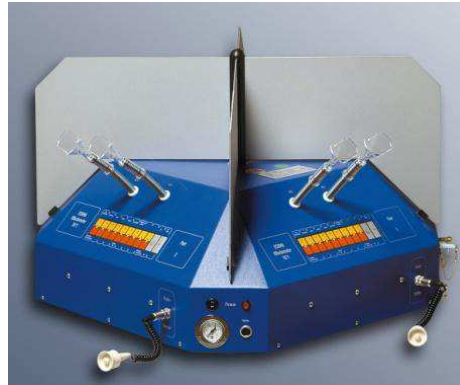
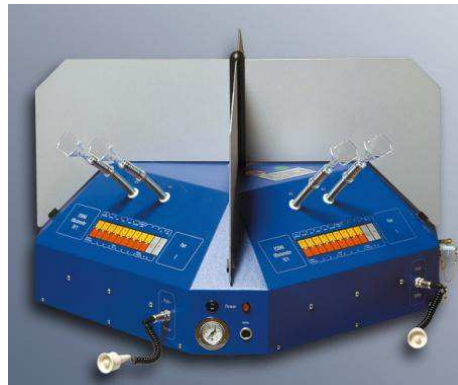
Odour concentration is determined by a Dynamic Olfactometer (TO9) in accordance with the European Standard Method (EN13725). This European Standard specifies a method for the objective determination of the odour concentration of a gaseous sample using dynamic olfactometry with human assessors and the emission rate of odours emanating from point sources, area sources with outward flow and area sources without outward flow. This European Standard is applicable to the measurement of odour concentration of pure substances, defined mixtures and undefined mixtures of gaseous odorants in air or nitrogen, using dynamic olfactometry with a panel of human assessors being the sensor. The unit of measurement is the odour unit per cubic metre: OU_E/m^3 . The odour concentration is measured by determining the dilution factor required to reach the detection threshold. The odour concentration at the detection threshold is defined as $1 OU_E/m^3$. The odour concentration is then expressed in terms of multiples of the detection threshold. The range of measurement is typically from $2^2 OU_E/m^3$ to $2^{17} OU_E/m^3$ (excluding pre-dilution).
