# ASB Biodiesel (Hong Kong) Limited

**Development of a Biodiesel Plant at  
Tseung Kwan O Industrial Estate**

**Monthly Environmental Monitoring and  
Audit Report for  
October 2020**

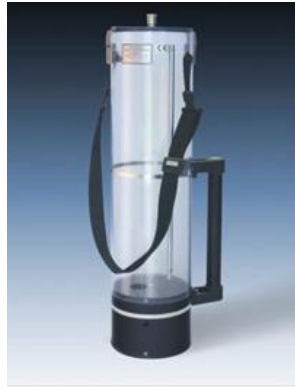
Odour Sampling System

Odour gas sample is collected by a Sampling Device Standard consists of a vacuum container, which is evacuated by a vacuum pump. The sampling point and the standard sampler are connected by a probe. Due to the evacuation in the sampling device, the sample bag, inside the device, sucks in sample air via the probe. During this process, none of its components come into contact with the sample air due to the construction of the sampling device.

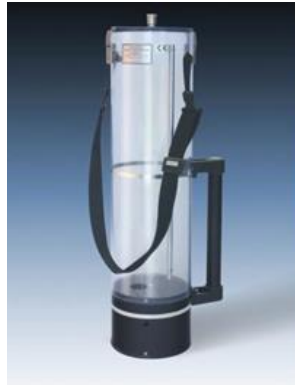
Odour Sampling System

Odour gas sample is collected by a Sampling Device Standard consists of a vacuum container, which is evacuated by a vacuum pump. The sampling point and the standard sampler are connected by a probe. Due to the evacuation in the sampling device, the sample bag, inside the device, sucks in sample air via the probe. During this process, none of its components come into contact with the sample air due to the construction of the sampling device.
