ASB Biodiesel (Hong Kong) Limited

**Development of a Biodiesel Plant at
Tseung Kwan O Industrial Estate**

**Monthly Environmental Monitoring and
Audit Report for
March 2022**

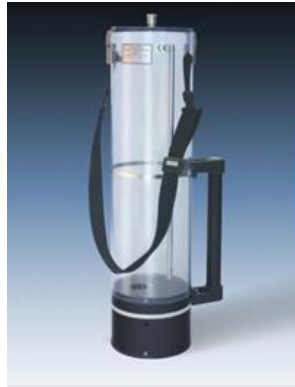
Odour Sampling System

Odour gas sample is collected by a Sampling Device Standard consists of a vacuum container, which is evacuated by a vacuum pump. The sampling point and the standard sampler are connected by a probe. Due to the evacuation in the sampling device, the sample bag, inside the device, sucks in sample air via the probe. During this process, none of its components come into contact with the sample air due to the construction of the sampling device.

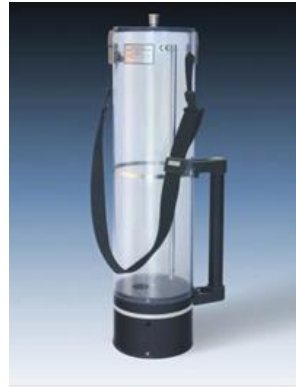
Odour Sampling System

Odour gas sample is collected by a Sampling Device Standard consists of a vacuum container, which is evacuated by a vacuum pump. The sampling point and the standard sampler are connected by a probe. Due to the evacuation in the sampling device, the sample bag, inside the device, sucks in sample air via the probe. During this process, none of its components come into contact with the sample air due to the construction of the sampling device.
