**Contract No. HY/2012/07
Tuen Mun – Chek Lap Kok Link –
Southern Connection Viaduct Section**

*First Annual Environmental Monitoring & Audit
(EM&A) Report*

**Contract No. HY/2012/07 TM-CLKL Southern Connection Viaduct
Section
First Annual EM&A Report (October 2013 – October 2014)**

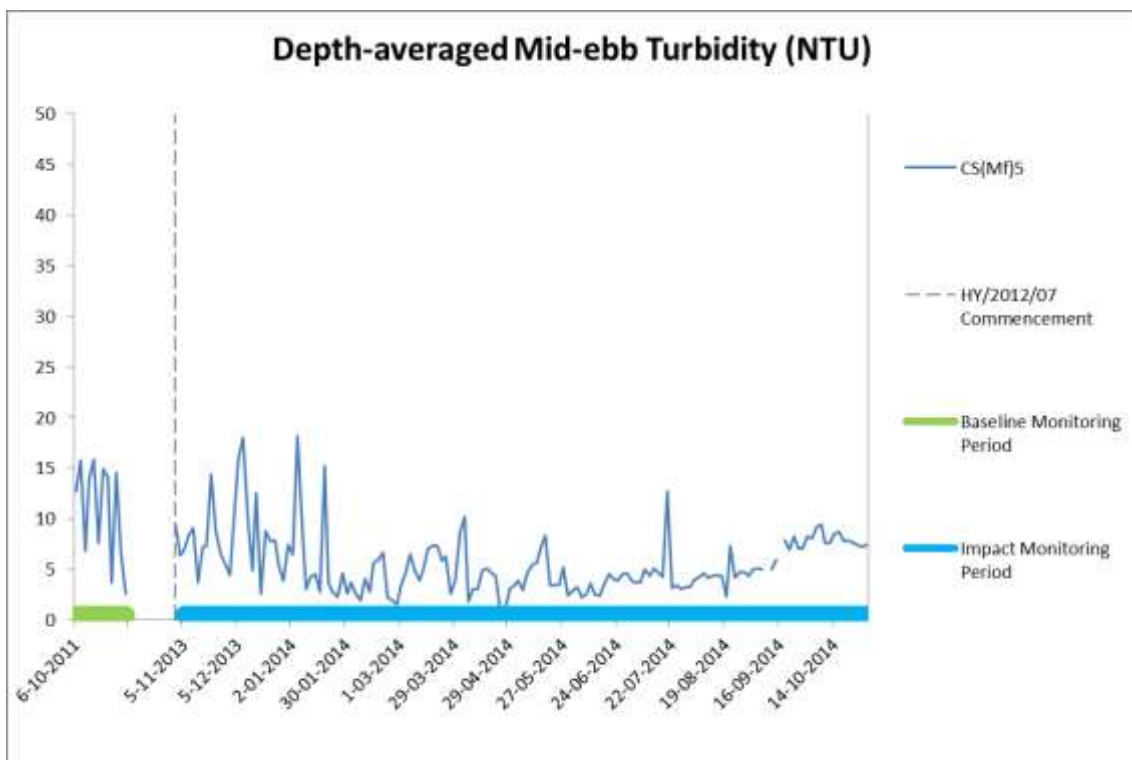
Figure F21 Impact Monitoring – Mean Level of depth-averaged Turbidity (NTU) during mid-ebb tide between 31 October 2013 and 31 October 2014 at CS(Mf)3 and CS(Mf)5.

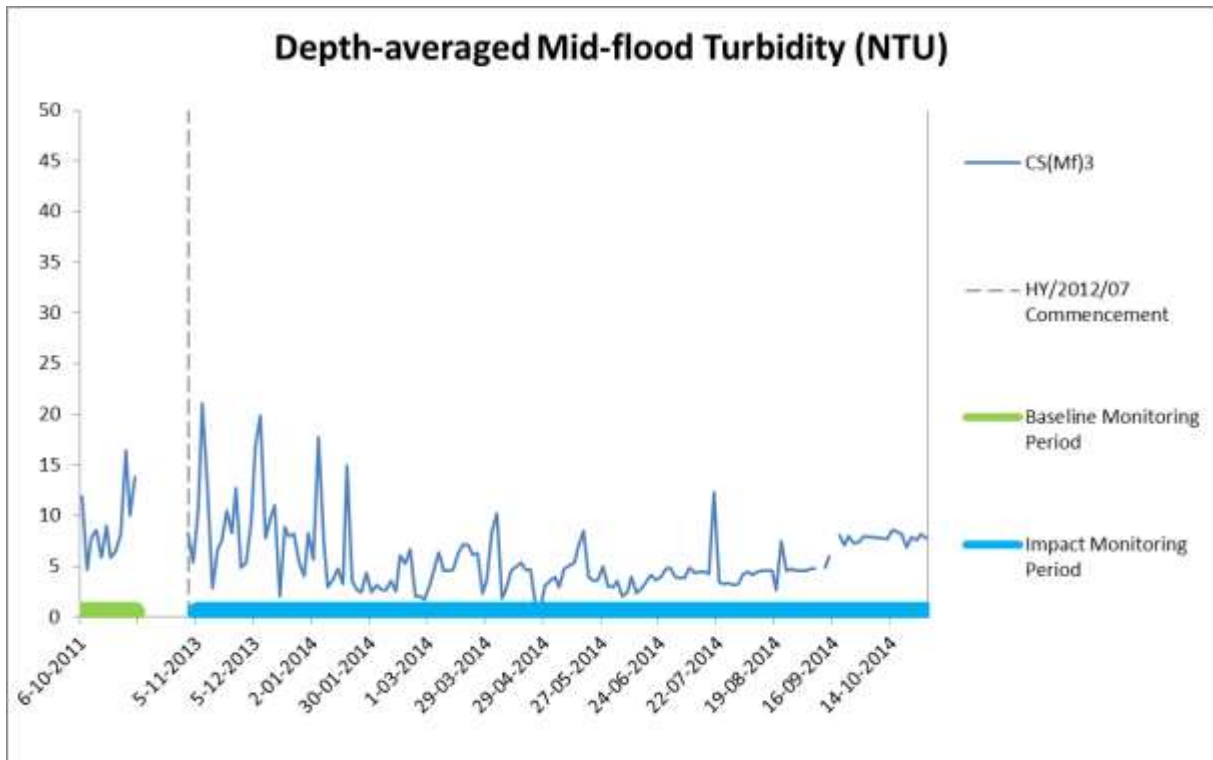
Figure F25 Impact Monitoring – Mean Level of depth-averaged Turbidity (NTU) during mid-flood tide between 31 October 2013 and 31 October 2014 at CS(Mf)3 and CS(MF)5.

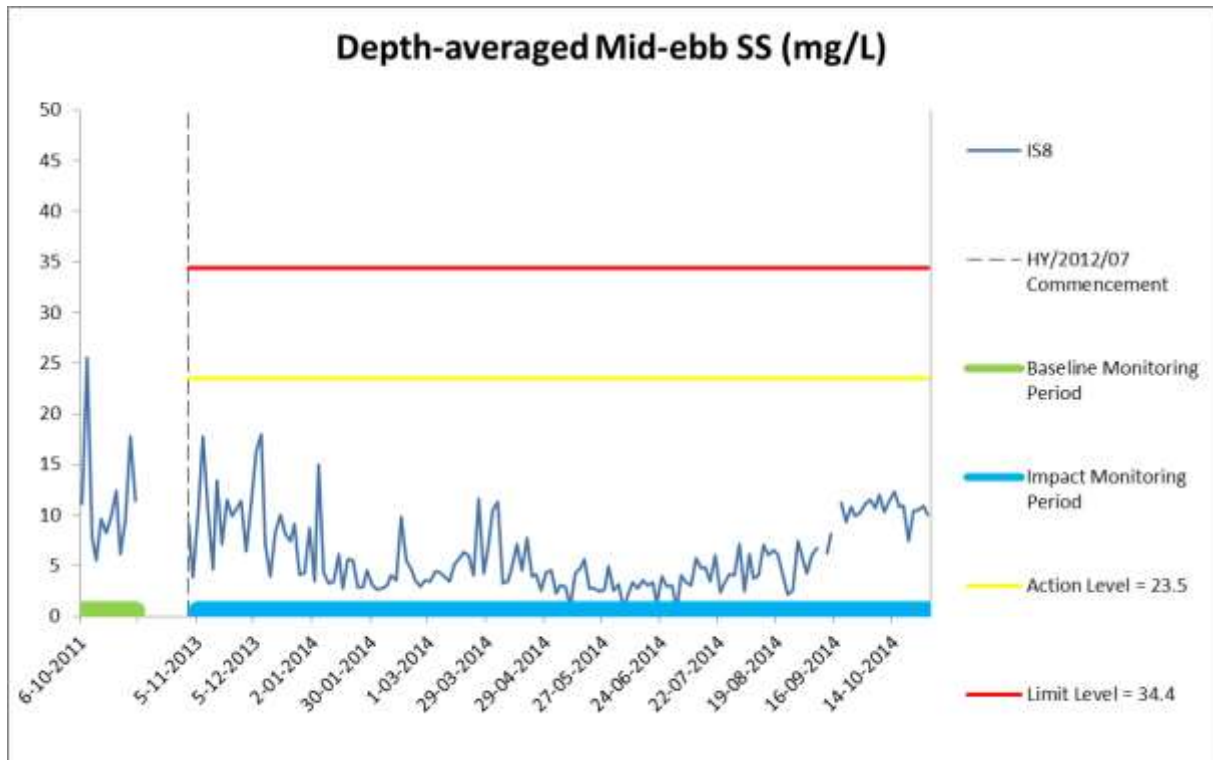
Figure F31 Impact Monitoring – Mean Level of depth-averaged Suspended Solids (mg/L) during mid-ebb tide between 31 October 2013 and 31 October 2014 at IS8 and SR4.
