Contract No. HY/2012/08
Tuen Mun – Chek Lap Kok Link –
Northern Connection Sub-sea Tunnel
Section

First Quarterly Environmental Monitoring & Audit (EM&A) Report

05 May 2014

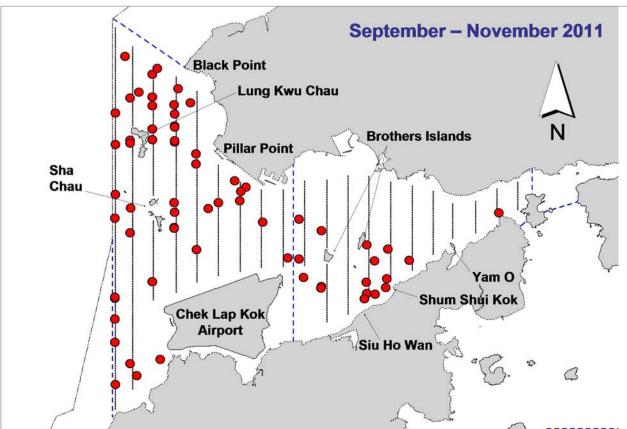
Figure 1. Distribution of Chinese white dolphin sighting in Northwest and Northeast Lantau during HKLR03 impact phase (top) and baseline monitoring surveys (bottom)

- 3.2. Distribution
- 3.2.1. Distribution of dolphin sightings made during the HKLR03 monitoring surveys in December 2013 to February 2014 is shown in Figure 1. The majority of dolphin sightings were made in the northwestern portion of the North Lantau region. Concentration of sightings were located within the Sha Chau and Lung Kwu Chau Marine Park, and to the west of Black Point (Figure 1). On the other hand, a few dolphin groups were sighted near Pillar Point, and near the Brothers Islands (Figure 1).

- 3.2.2. One sighting was made very close to the reclamation site of TMCLKL northern landfall, but none of the dolphin groups were sighted in the vicinity of TMCLKL southern viaduct section, or the HKLR03/HKBCF reclamation site (Figure 1). Only one dolphin sighting was made near the HKLR09 alignment (Figure 1).

- 3.2.3. Sighting distribution of the present impact phase monitoring period (December 2013 February 2014) was compared to the one in the baseline monitoring period (September to November 2011). During the present quarter, dolphins rarely occurred in NEL region, which was in stark contrast to their frequent occurrence around the Brothers Islands and in the vicinity of HKBCF reclamation site during the baseline period (Figure 1). On the other hand, dolphin occurrence in the northwestern portion of North Lantau region was largely similar between the baseline and impact phase quarters, but there appeared to be fewer dolphins occurred in the middle portion of North Lantau region where dolphins supposedly moved between their core areas around Lung Kwu Chau and the Brothers Islands (Figure 1).
