**Contract No. HY/2012/07**  
**Tuen Mun – Chek Lap Kok Link –**  
**Southern Connection Viaduct Section**

*Second Quarterly Environmental Monitoring &  
Audit (EM&A) Report*

04 August 2014

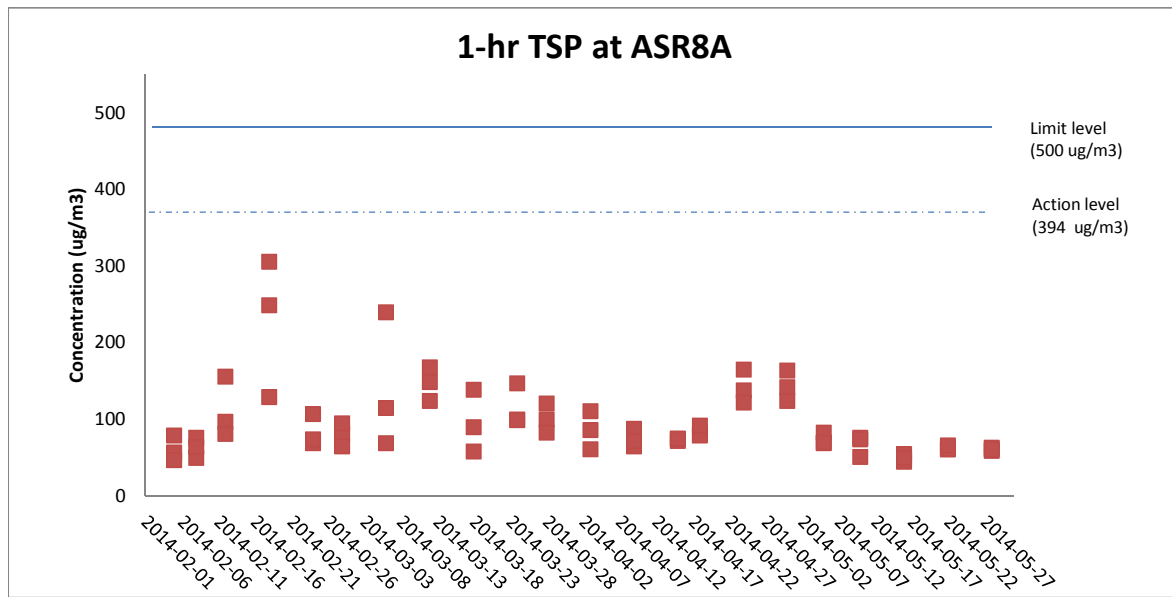
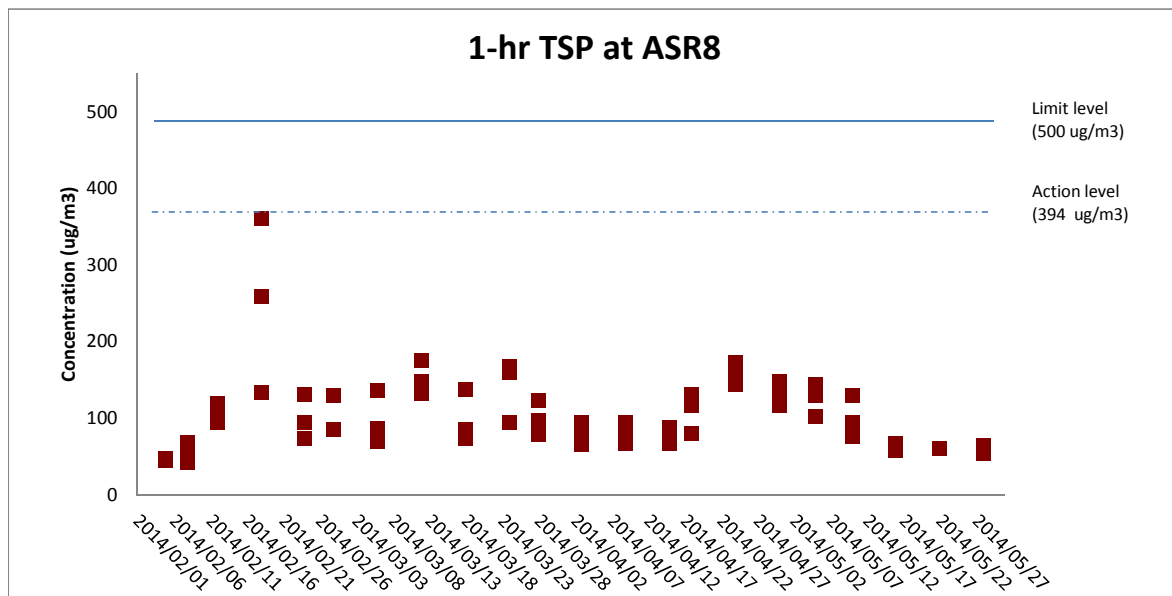
Impact Air Quality  
Monitoring Graphical  
Presentation

Weather condition within the reporting period varied between sunny to rainy.

Major construction works undertaken within the reporting period include site office erection, fence relocation for Viaduct A, C & D and land piling at Viaduct B.

Marine works within the reporting period include rockfill platform construction, marine piling platform installation and survey tower erection.

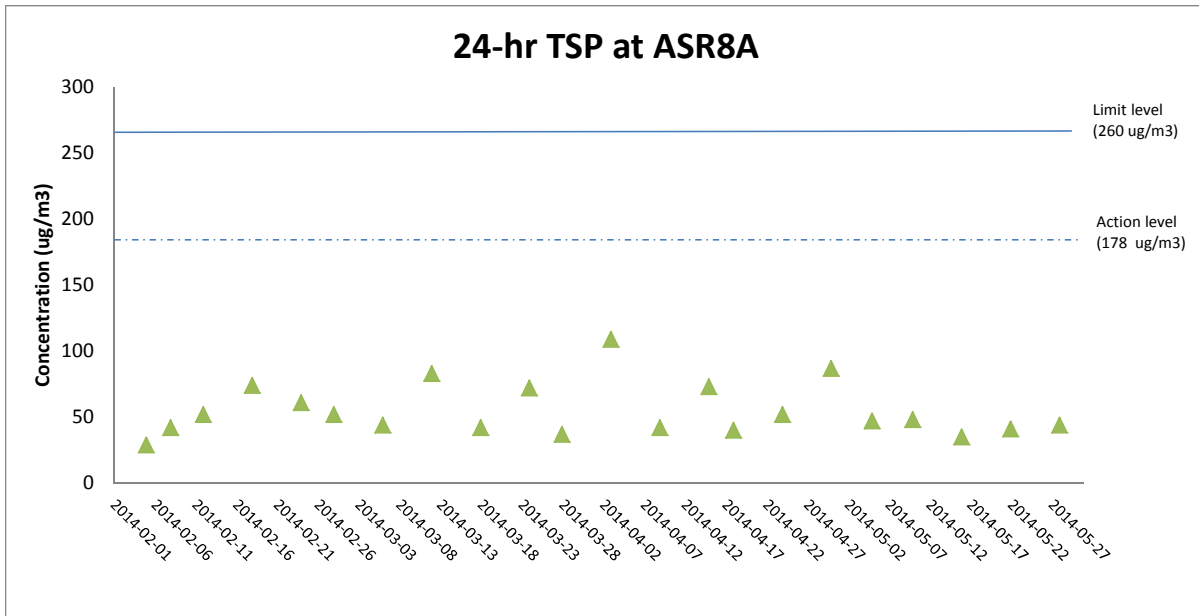
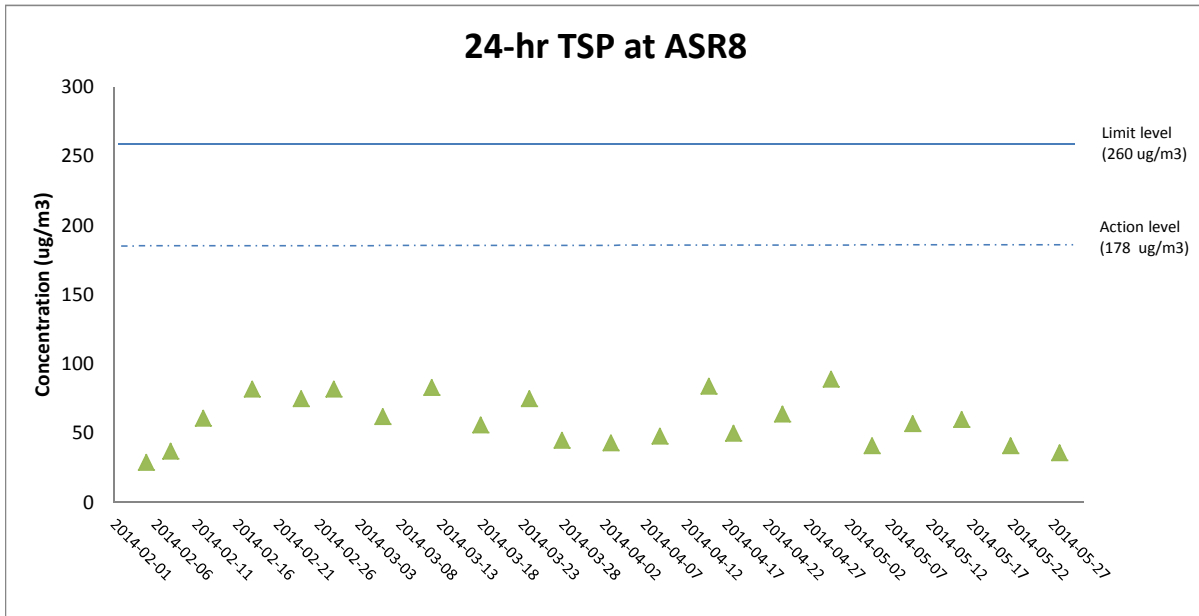
Weather condition within the reporting period varied between sunny to rainy.

Major construction works undertaken within the reporting period include site office erection, fence relocation for Viaduct A, C & D and land piling at Viaduct A.

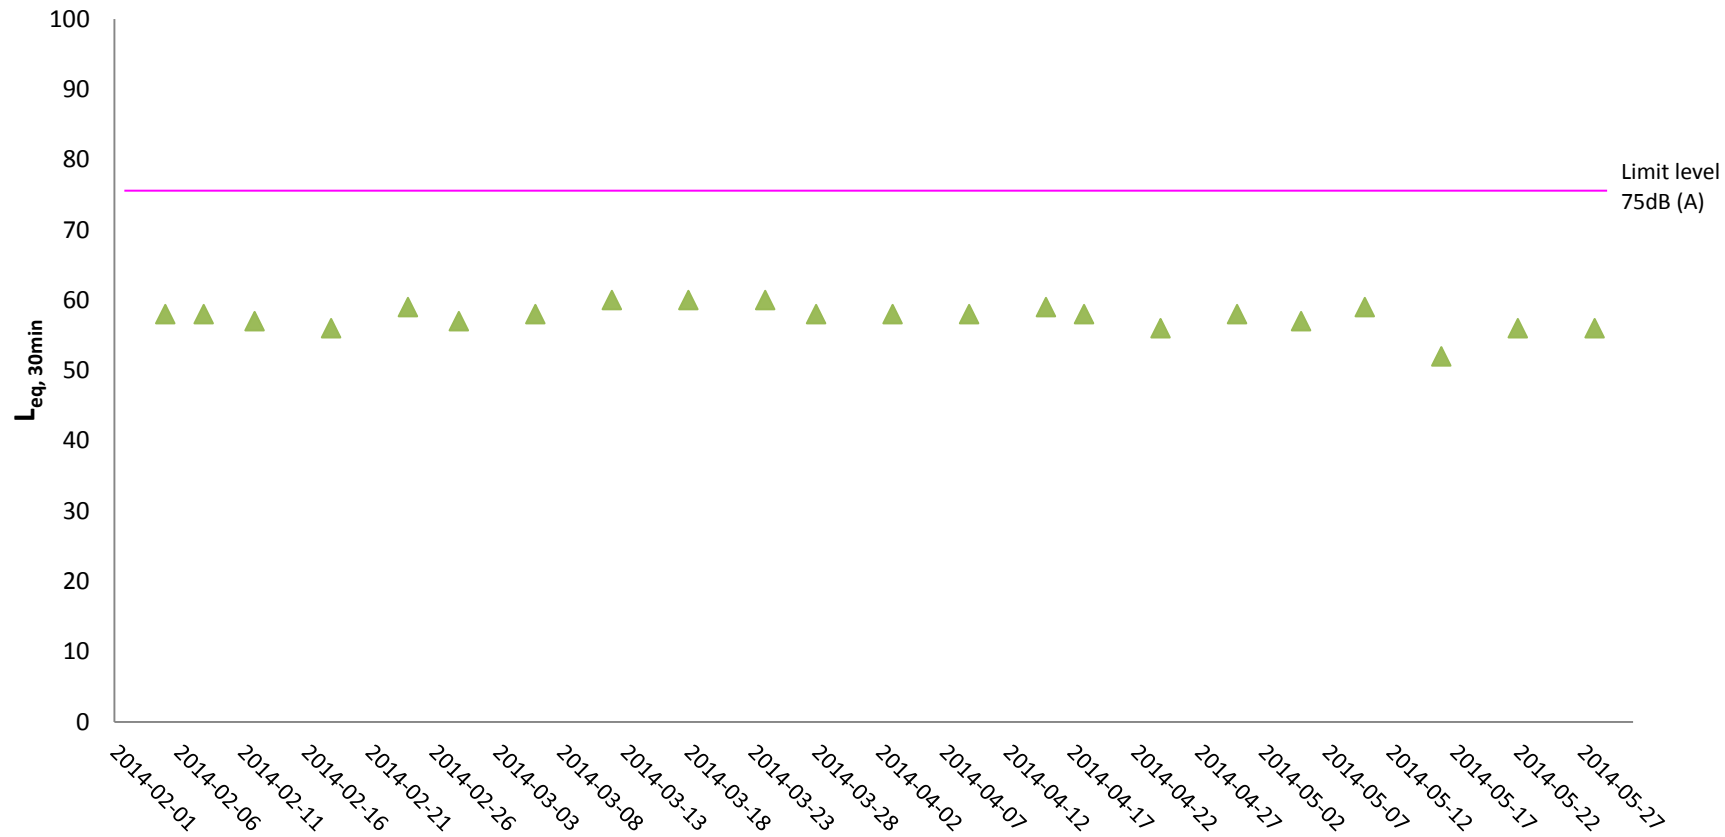
## Noise Monitoring Results at NSR 1 ( $L_{eq, 30min}$ )

*Weather condition within the reporting period varied between sunny to rainy.*

*Major construction works undertaken within the reporting period include site office erection, fence relocation for Viaduct A, C & D and land piling at Viaduct B.*

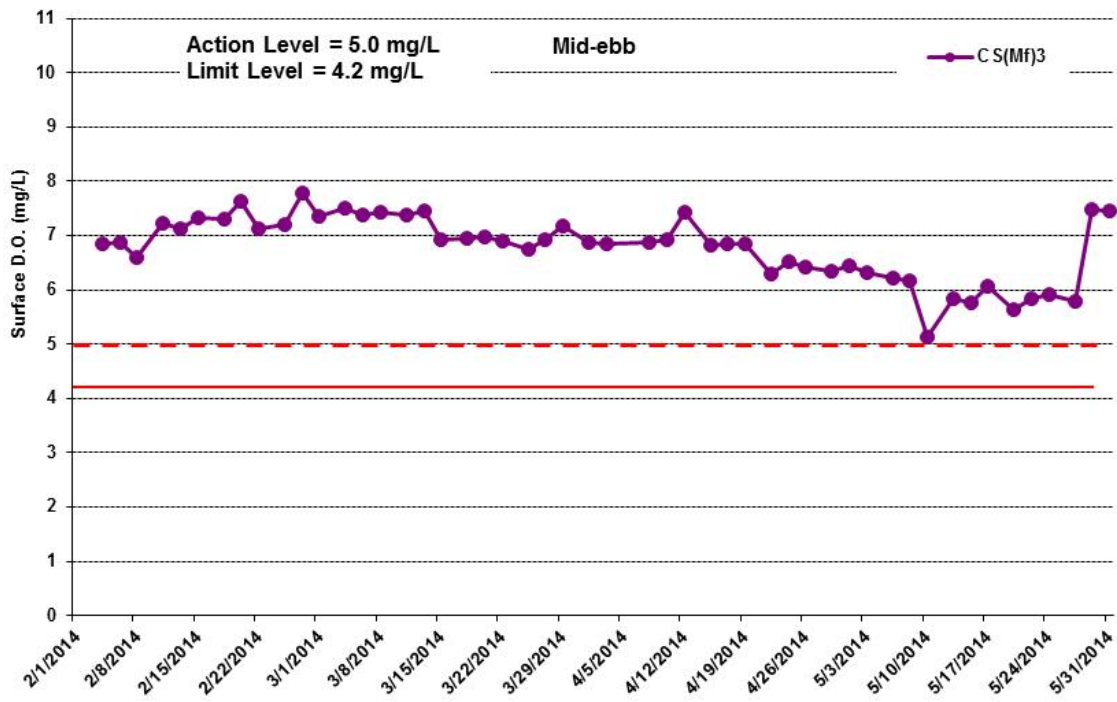
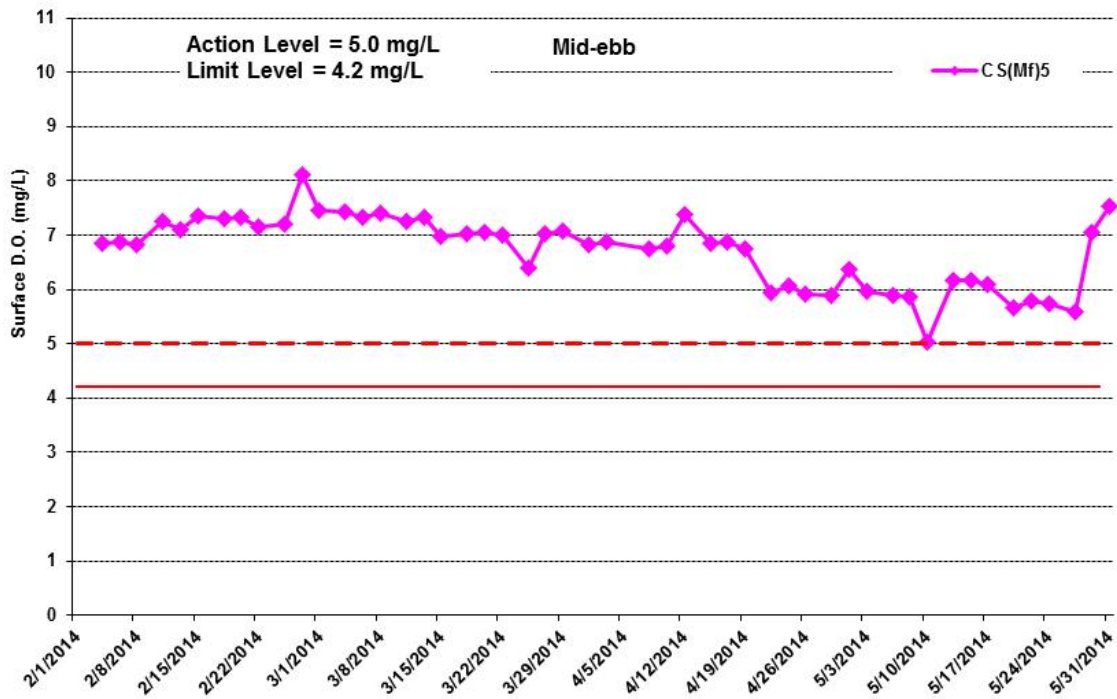
**Figure H1 Impact Monitoring - Mean Level of Dissolved Oxygen (mg/L) in surface waters during mid-ebb tide between 1 February to 31 May 2014 at CS(Mf)3 and CS(Mf)5.**

*(Weather condition varied between sunny to rainy within the reporting period. Marine works within the reporting period include rockfill platform construction, marine piling platform installation and survey tower erection.)*

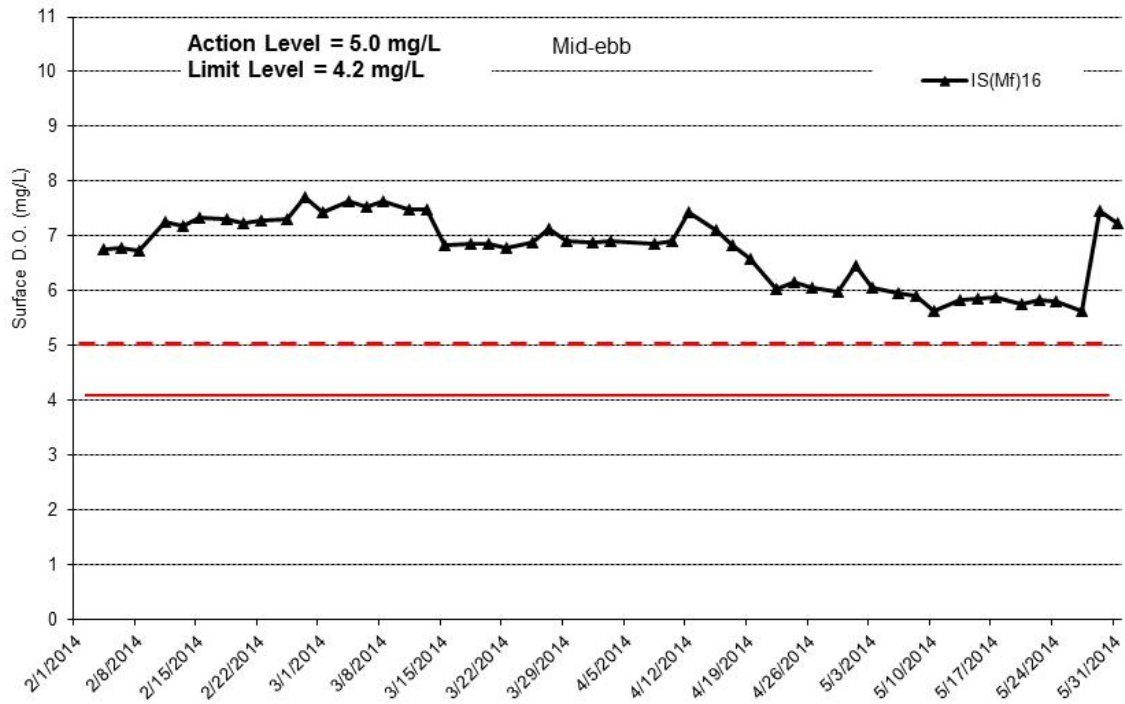
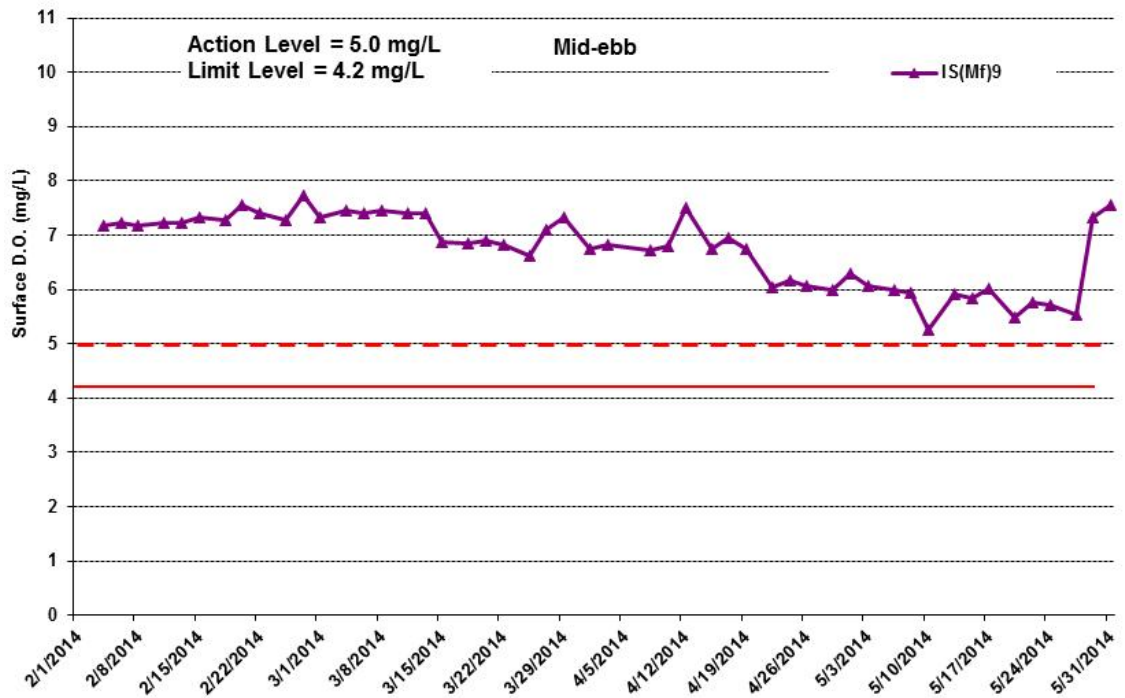
**Figure H2 Impact Monitoring - Mean Level of Dissolved Oxygen (mg/L) in surface waters during mid-ebb tide between 1 February to 31 May 2014 at IS(Mf)16 and IS(Mf)9.**

*(Weather condition varied between sunny to rainy within the reporting period. Marine works within the reporting period include rockfill platform construction, marine piling platform installation and survey tower erection.)*

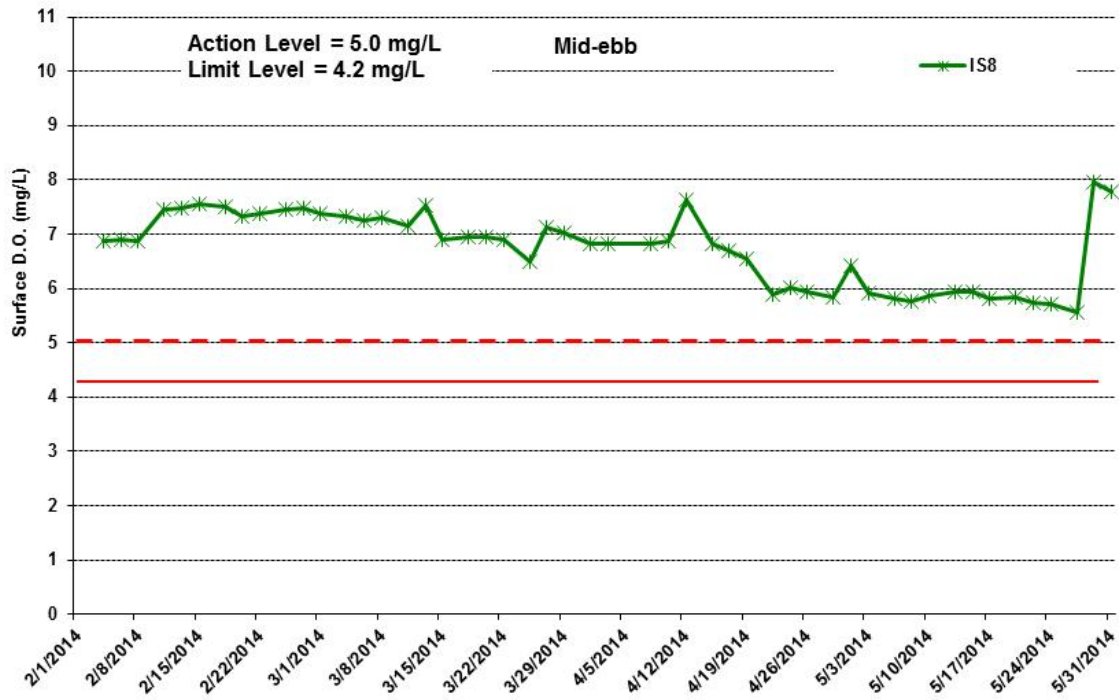
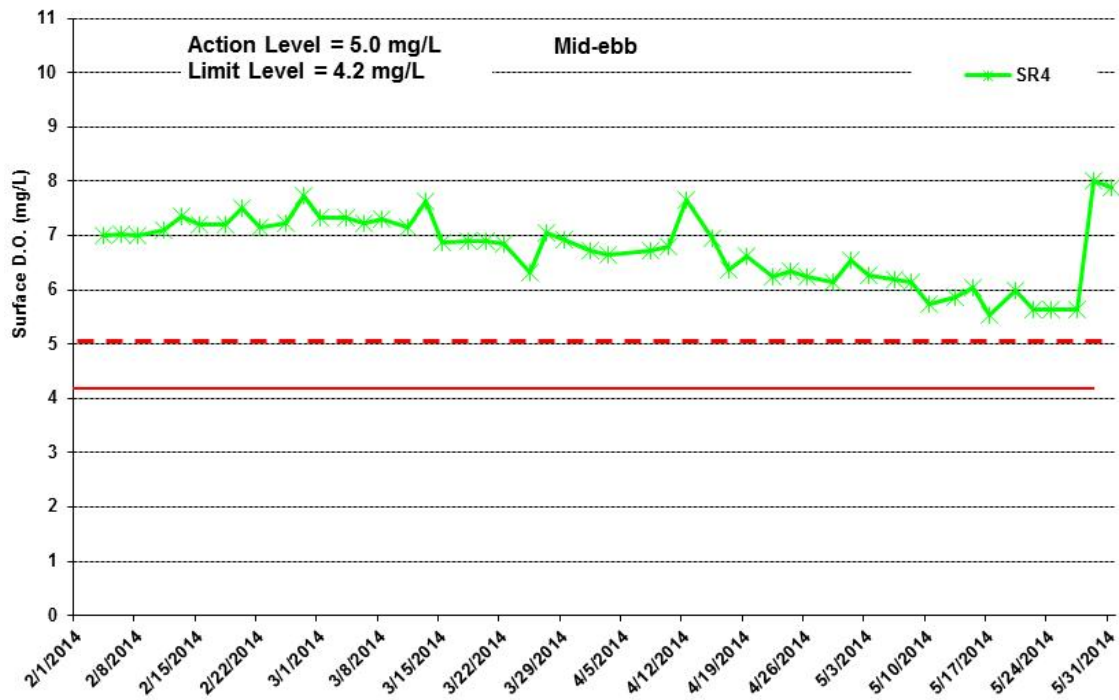
**Figure H3 Impact Monitoring - Mean Level of Dissolved Oxygen (mg/L) in surface waters during mid-ebb tide between 1 February to 31 May 2014 at IS8 and SR4.**

*(Weather condition varied between sunny to rainy within the reporting period. Marine works within the reporting period include rockfill platform construction, marine piling platform installation and survey tower erection.)*

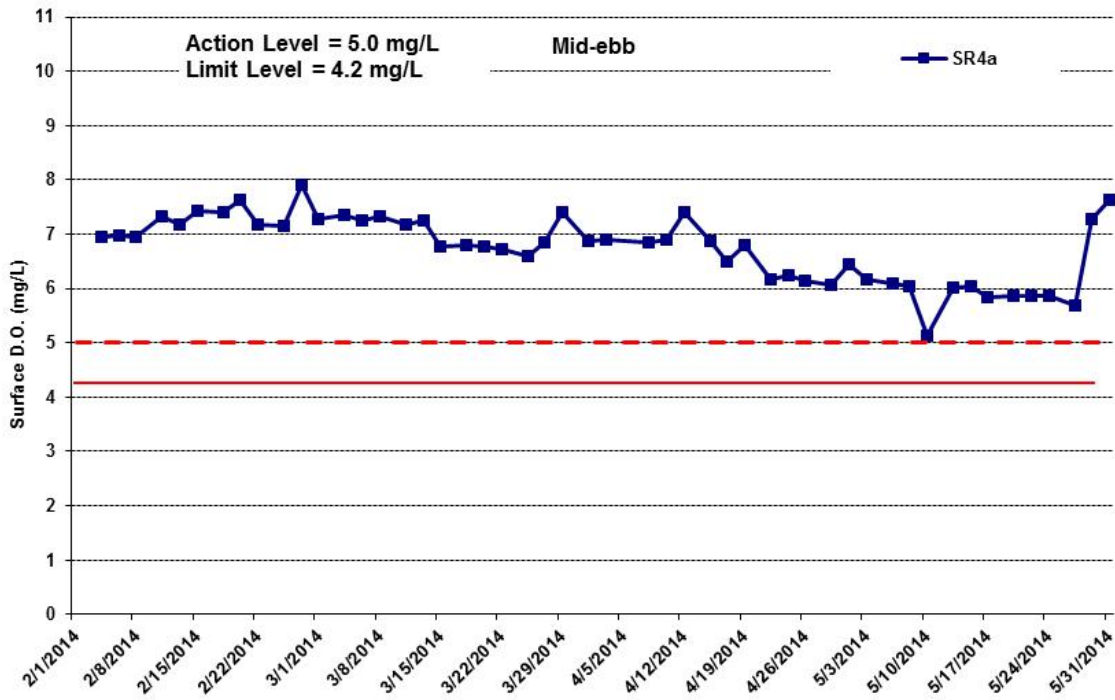
**Figure H4 Impact Monitoring - Mean Level of Dissolved Oxygen (mg/L) in surface waters during mid-ebb tide between 1 February to 31 May 2014 at SR4a.**

*(Weather condition varied between sunny to rainy within the reporting period. Marine works within the reporting period include rockfill platform construction, marine piling platform installation and survey tower erection.)*

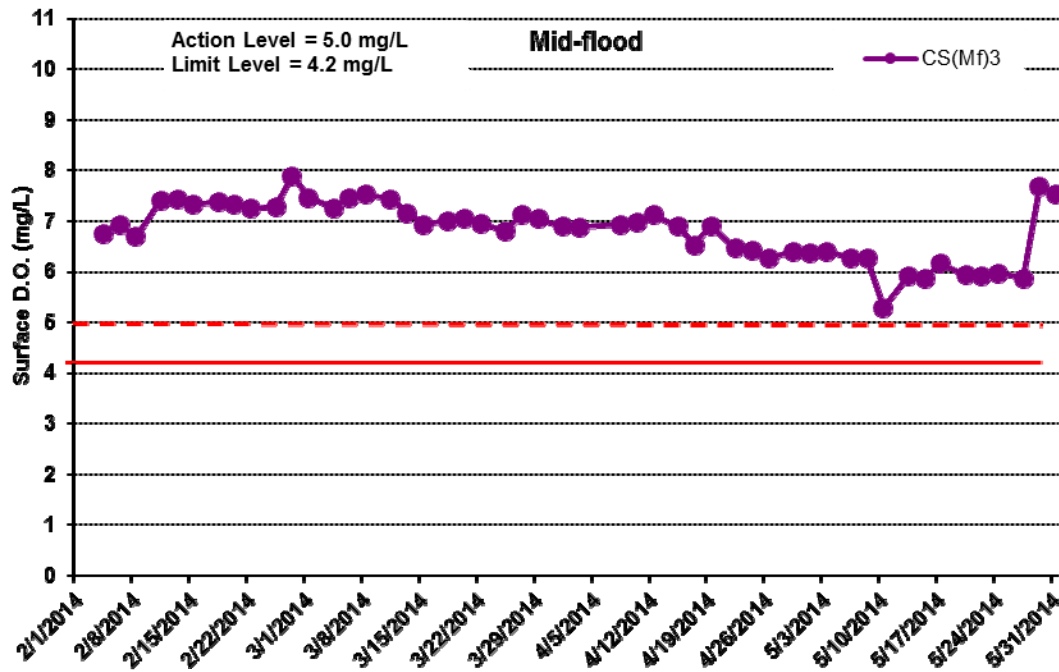
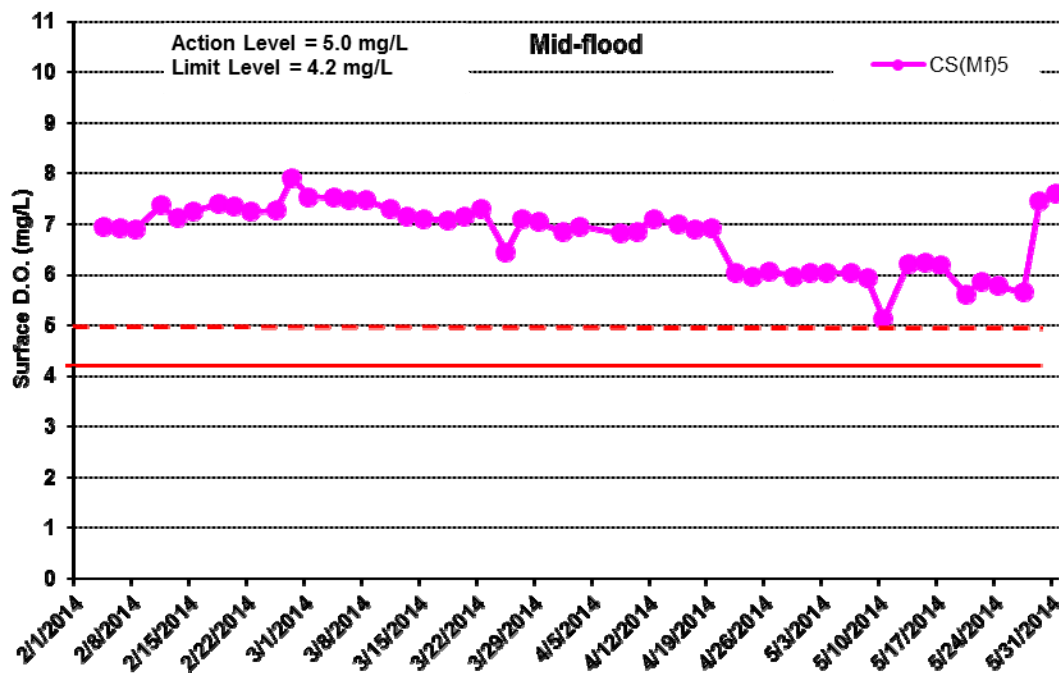
**Figure H5 Impact Monitoring - Mean Level of Dissolved Oxygen (mg/L) in surface waters during mid-flood tide between 1 February to 31 May 2014 at CS(Mf)3 and CS(Mf)5.**

*(Weather condition varied between sunny to rainy within the reporting period. Marine works within the reporting period include rockfill platform construction, marine piling platform installation and survey tower erection.)*

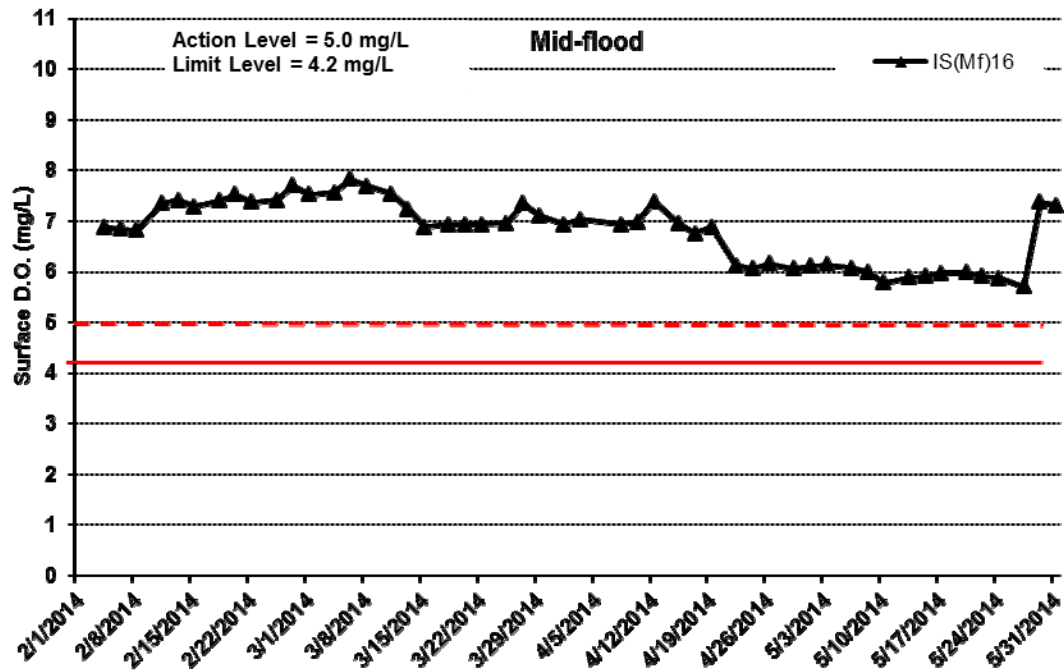
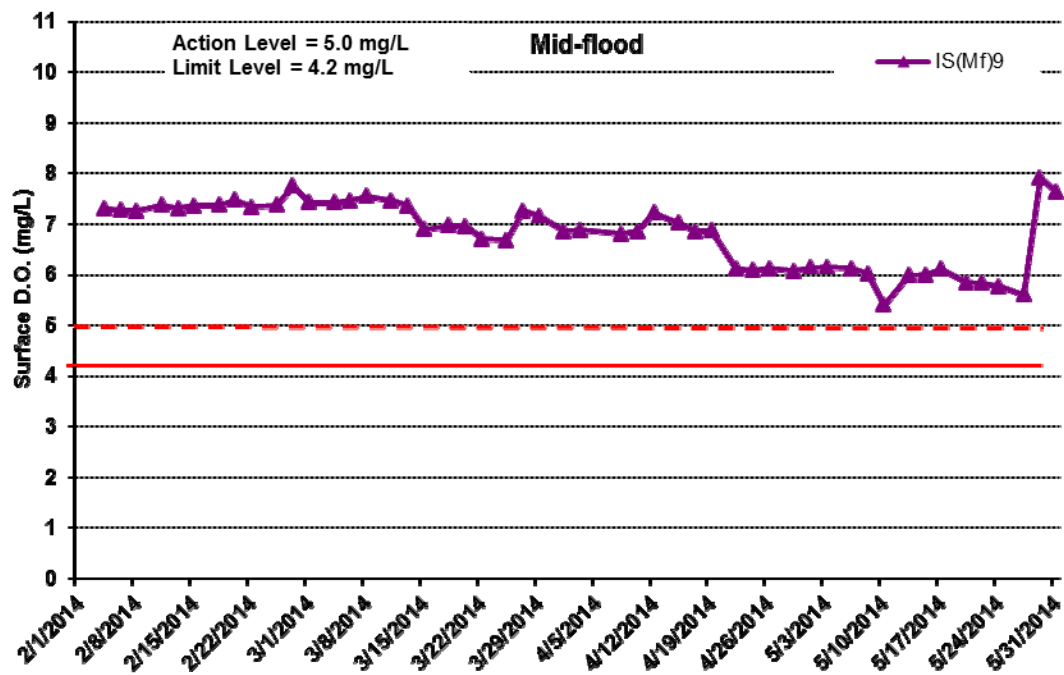
**Figure H6 Impact Monitoring - Mean Level of Dissolved Oxygen (mg/L) in surface waters during mid-flood tide between 1 February to 31 May 2014 at IS(Mf)16 and IS(Mf)9.**

*(Weather condition varied between sunny to rainy within the reporting period. Marine works within the reporting period include rockfill platform construction, marine piling platform installation and survey tower erection.)*

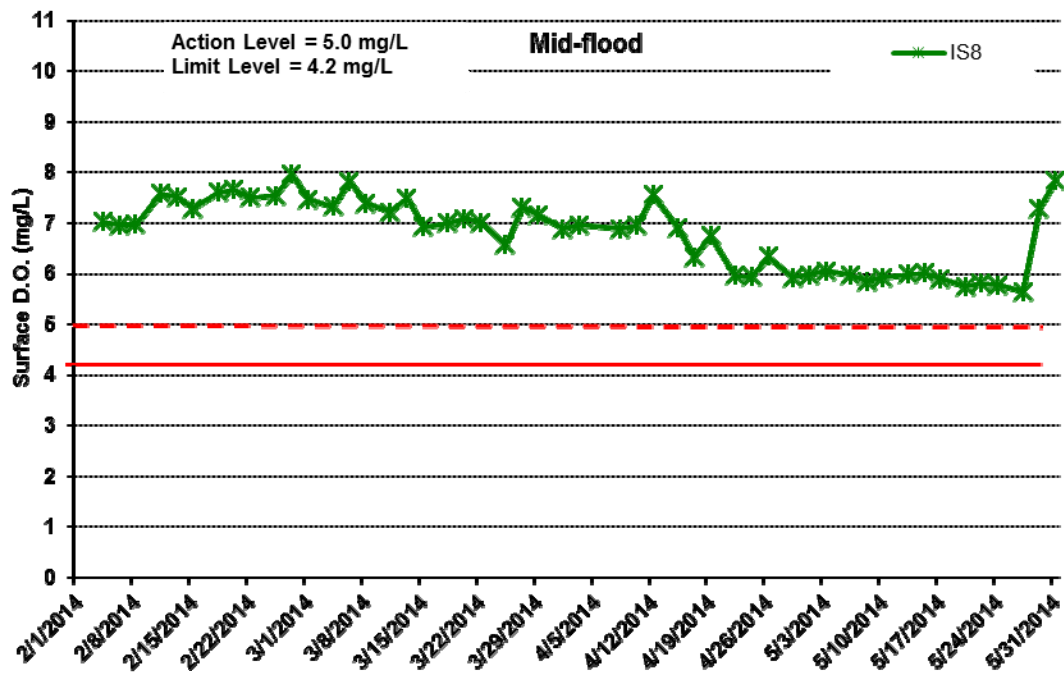
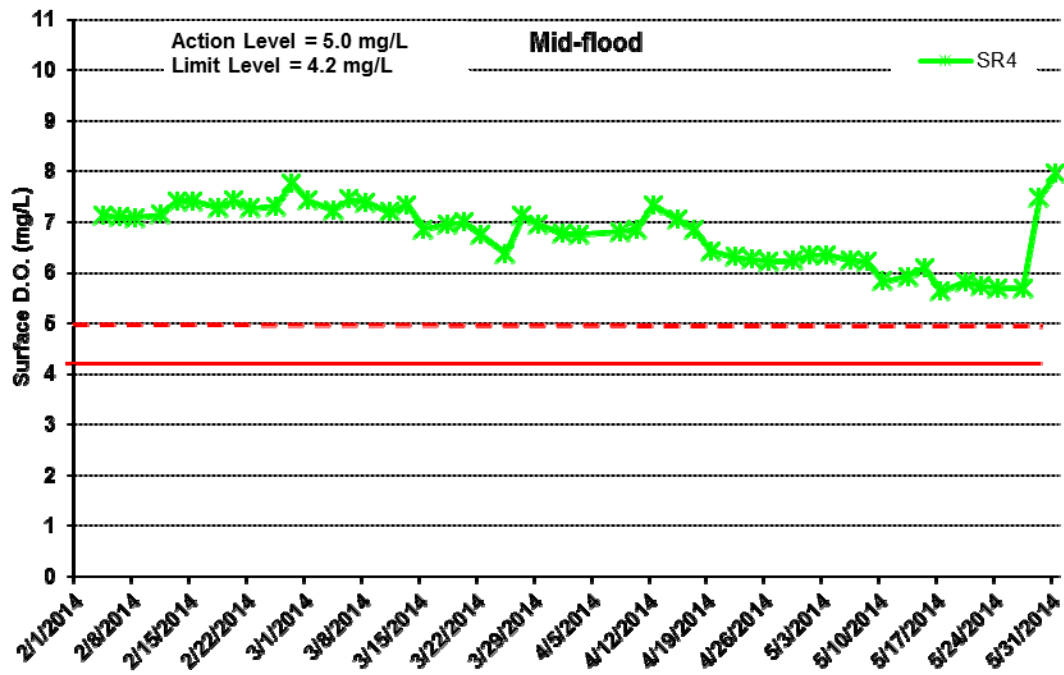
**Figure H7 Impact Monitoring – Mean Level of Dissolved Oxygen (mg/L) in surface waters during mid-flood tide between 1 February to 31 May 2014 at IS8 and SR4.**

*(Weather condition varied between sunny to rainy within the reporting period. Marine works within the reporting period include rockfill platform construction, marine piling platform installation and survey tower erection.)*

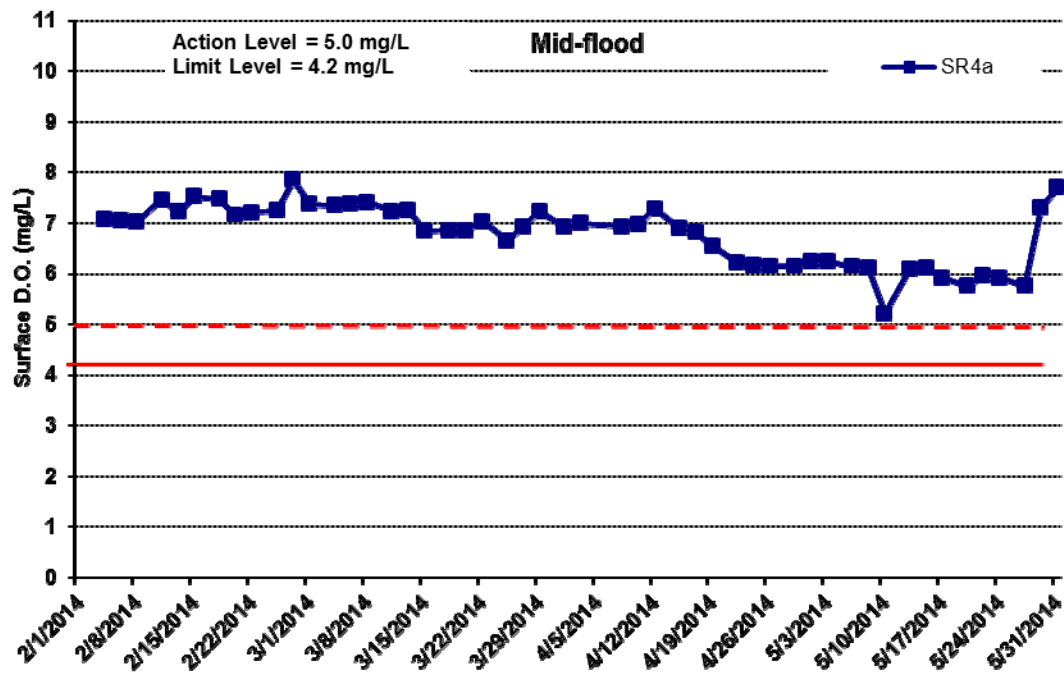
**Figure H8 Impact Monitoring – Mean Level of Dissolved Oxygen (mg/L) in surface waters during mid-flood tide between 1 February to 31 May 2014 at SR4a.**

*(Weather condition varied between sunny to rainy within the reporting period. Marine works within the reporting period include rockfill platform construction, marine piling platform installation and survey tower erection.)*

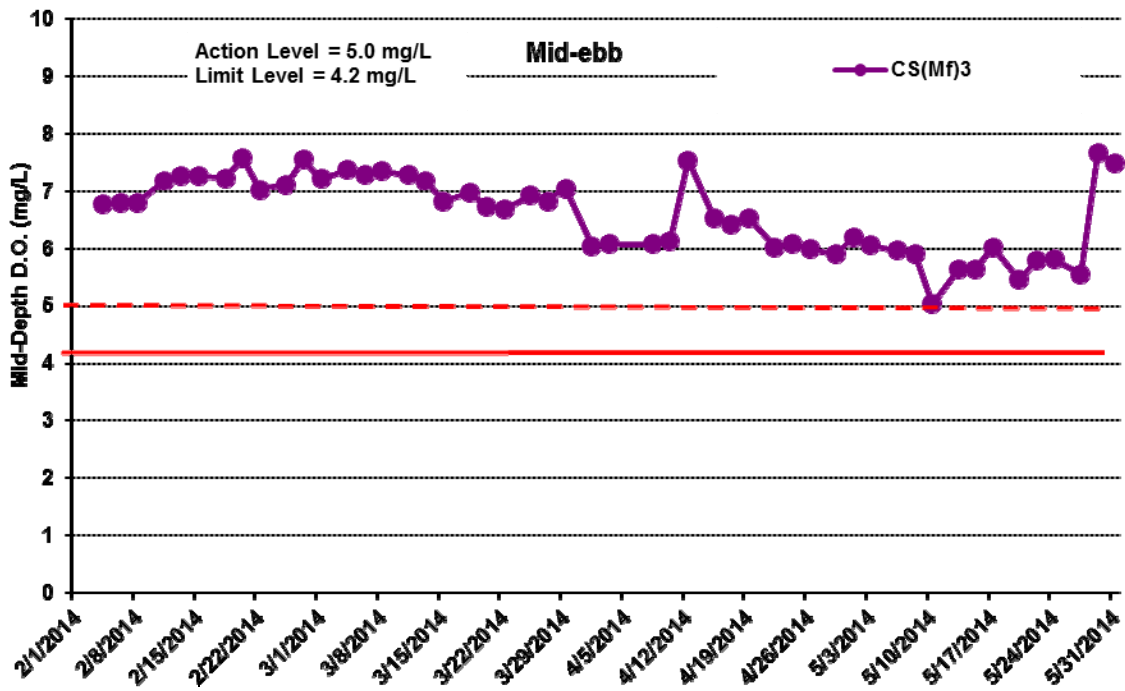
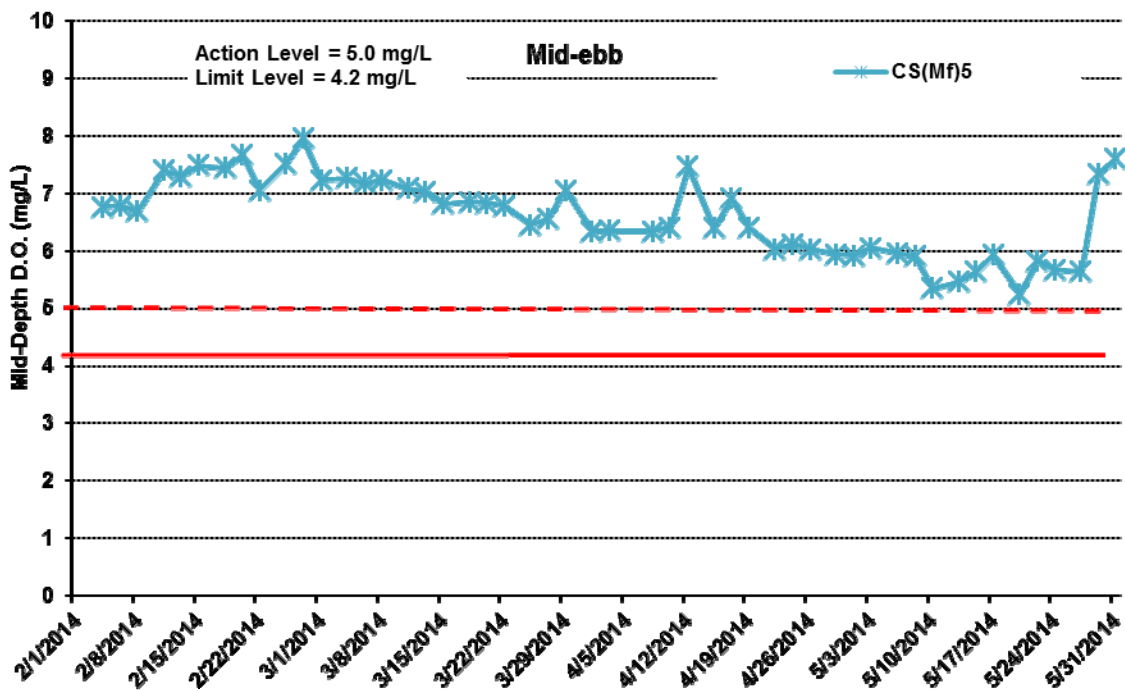
**Figure H9 Impact Monitoring - Mean Level of Dissolved Oxygen (mg/L) in mid-depth waters during mid-ebb tide between 1 February to 31 May 2014 at CS(Mf)3 and IS(Mf)5.**  
*(Weather condition varied between sunny to rainy within the reporting period. Marine works within the reporting period include rockfill platform construction, marine piling platform installation and survey tower erection.)*

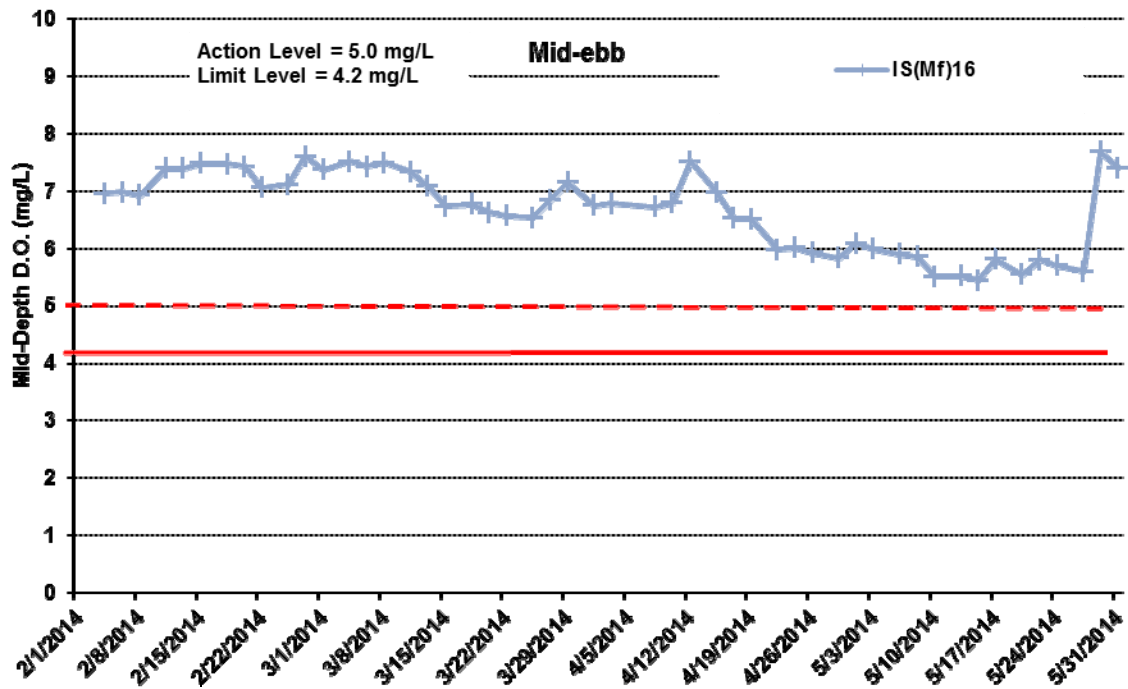
**Figure H10 Impact Monitoring - Mean Level of Dissolved Oxygen (mg/L) in mid-depth waters during mid-ebb tide between 1 February to 31 May 2014 at IS(Mf)16.**

*(Weather condition varied between sunny to rainy within the reporting period. Marine works within the reporting period include rockfill platform construction, marine piling platform installation and survey tower erection.)*

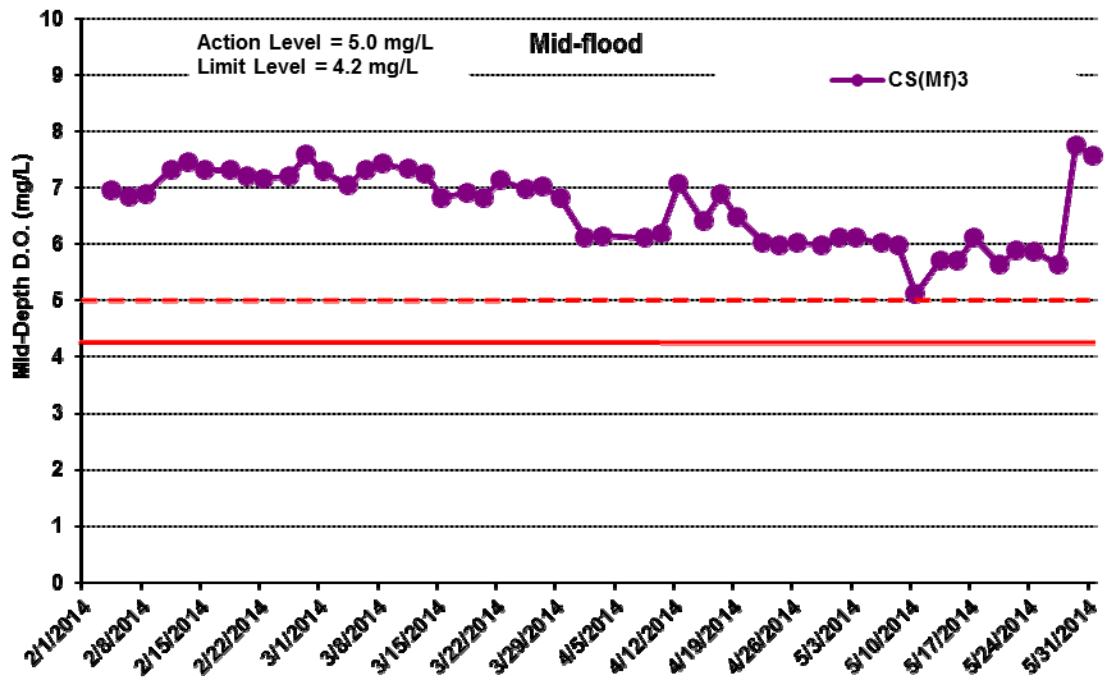
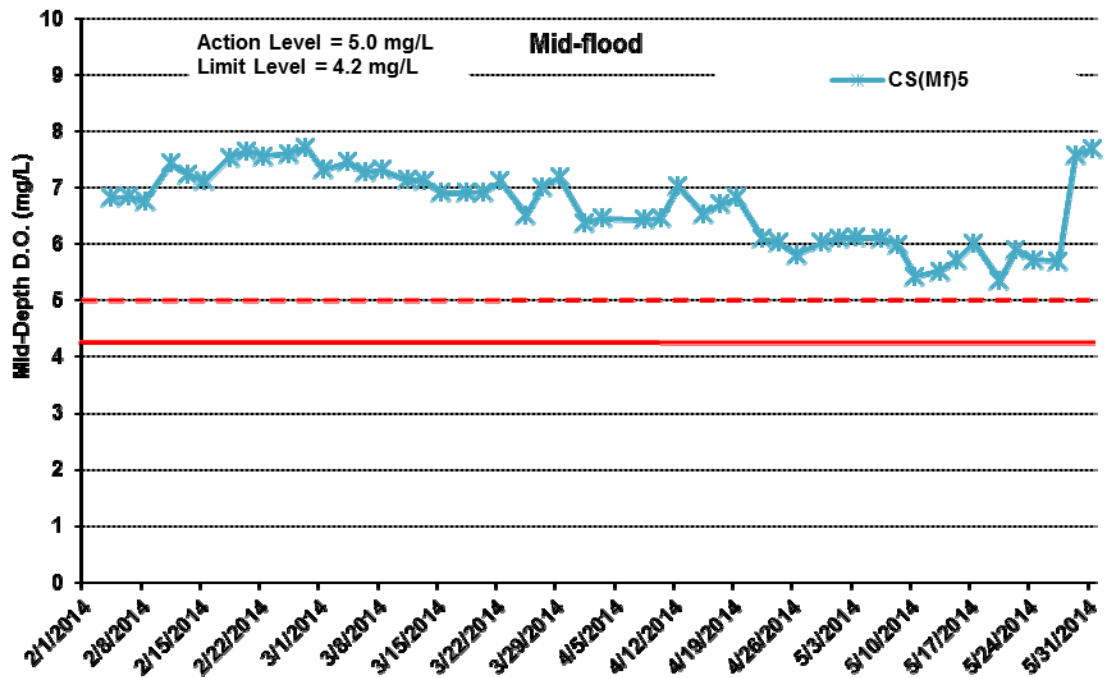
**Figure H11 Impact Monitoring - Mean Level of Dissolved Oxygen (mg/L) in mid-depth waters during mid-flood tide between 1 February to 31 May 2014 at CS(Mf)3 and IS(Mf)5.**

*(Weather condition varied between sunny to rainy within the reporting period. Marine works within the reporting period include rockfill platform construction, marine piling platform installation and survey tower erection.)*

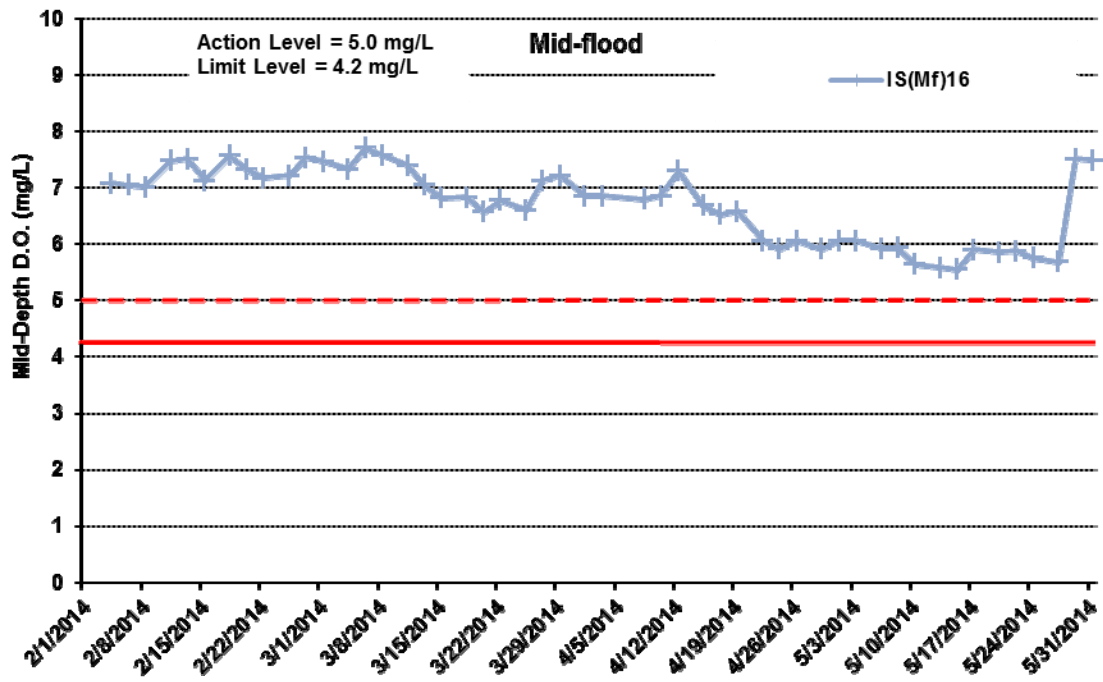
**Figure H12 Impact Monitoring – Mean Level of Dissolved Oxygen (mg/L) in mid-depth waters during mid-flood tide between 1 February to 31 May 2014 at IS(Mf)16.**

*(Weather condition varied between sunny to rainy within the reporting period. Marine works within the reporting period include rockfill platform construction, marine piling platform installation and survey tower erection.)*

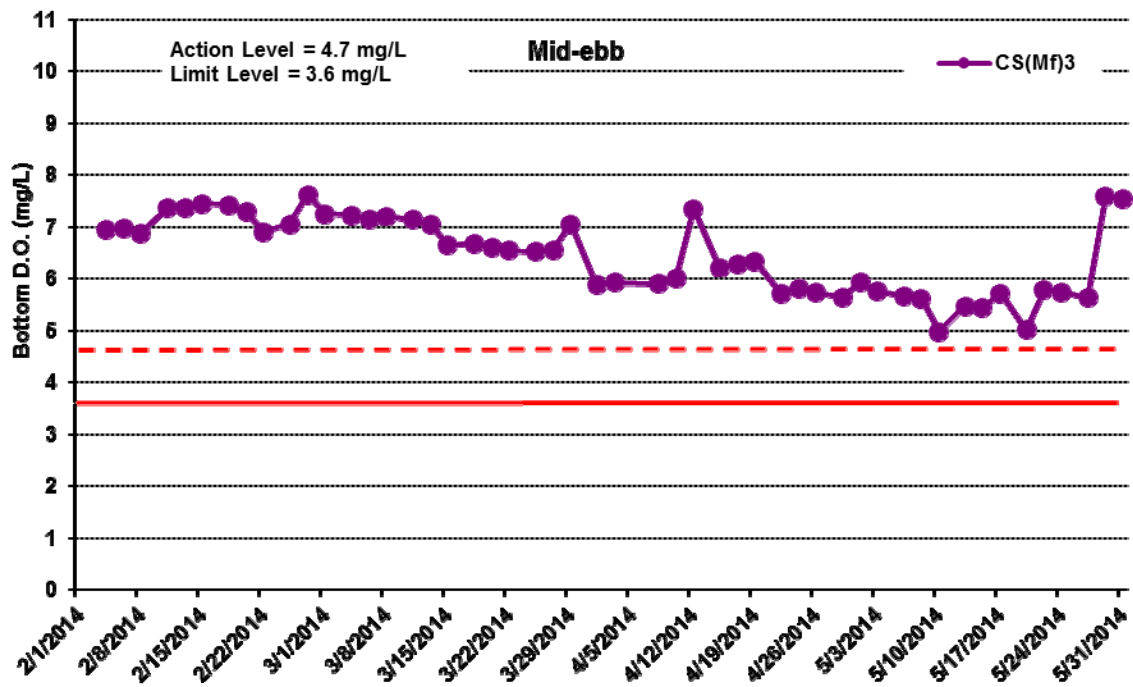
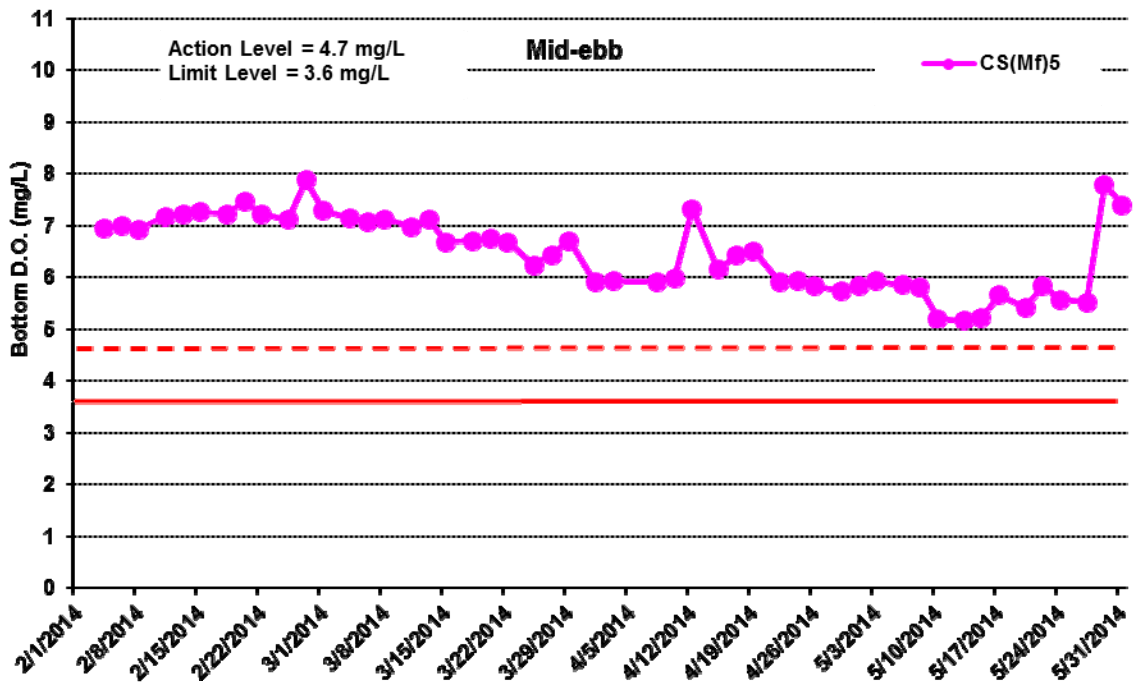
**Figure H13 Impact Monitoring - Mean Level of Dissolved Oxygen (mg/L) in bottom waters during mid-ebb tide between 1 February to 31 May 2014 at CS(Mf)3 and CS(Mf)5.**

*(Weather condition varied between sunny to rainy within the reporting period. Marine works within the reporting period include rockfill platform construction, marine piling platform installation and survey tower erection.)*
