**Contract No. HY/2012/07**  
**Tuen Mun – Chek Lap Kok Link –**  
**Southern Connection Viaduct Section**

*Second Quarterly Environmental Monitoring &  
Audit (EM&A) Report*

04 August 2014

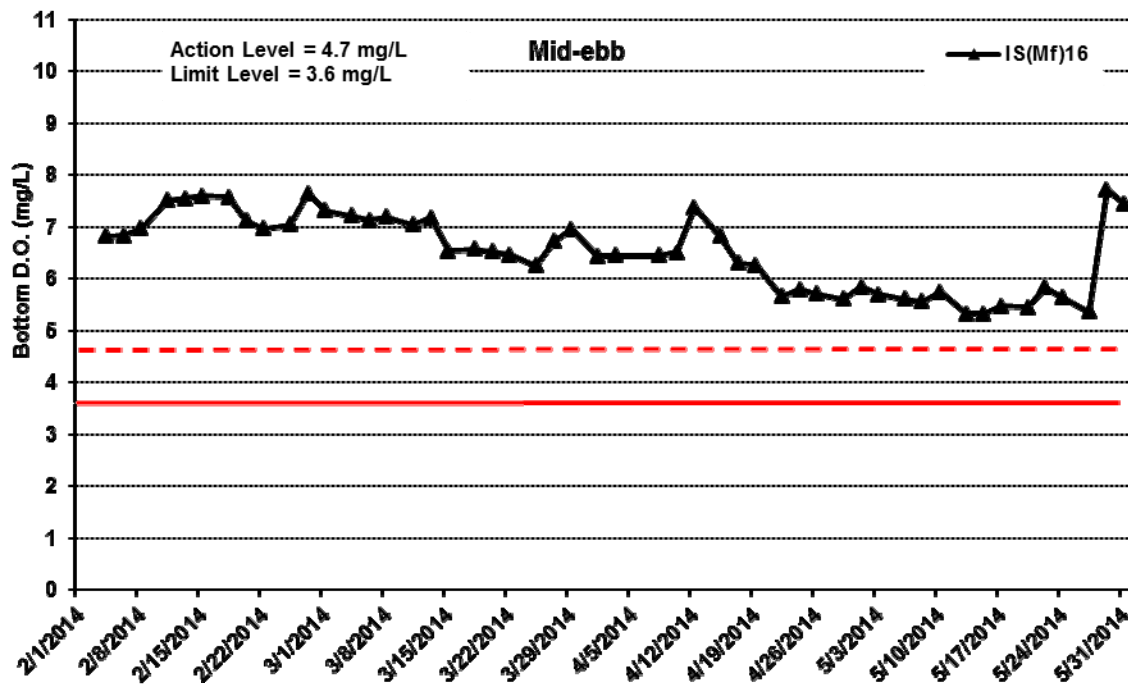
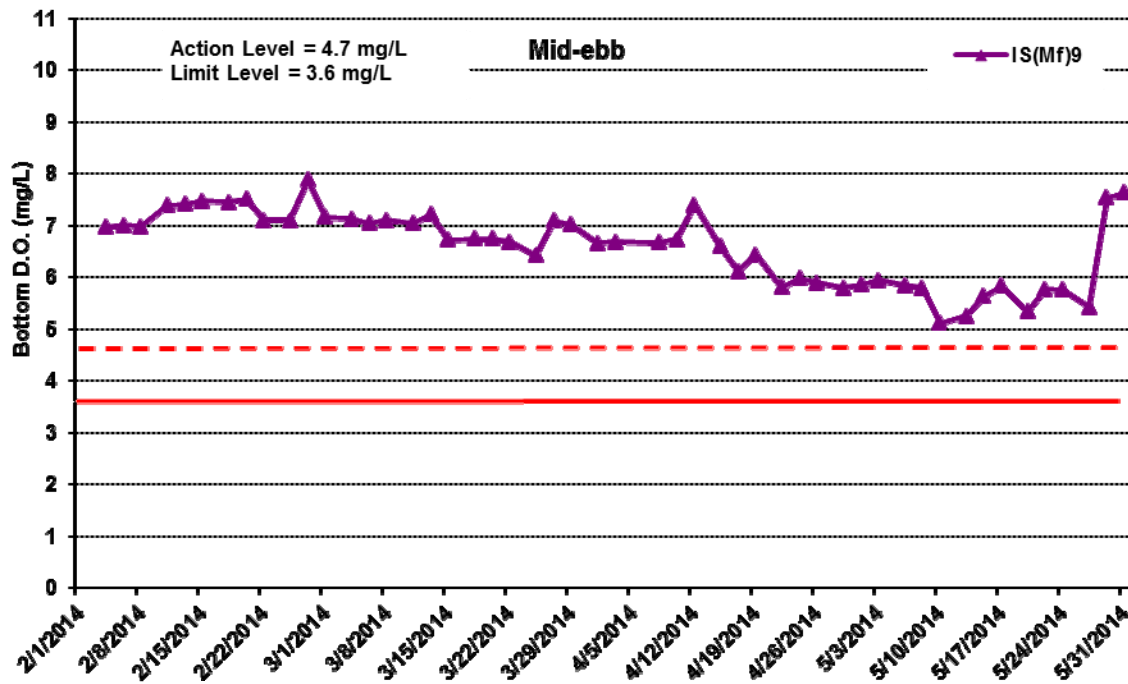
**Figure H14 Impact Monitoring - Mean Level of Dissolved Oxygen (mg/L) in bottom waters during mid-ebb tide between 1 to 28 February 2014 at IS(Mf)16 and IS(Mf)9.**

*(Weather condition varied between sunny to rainy within the reporting period. Marine works within the reporting period include rockfill platform construction, marine piling platform installation and survey tower erection.)*

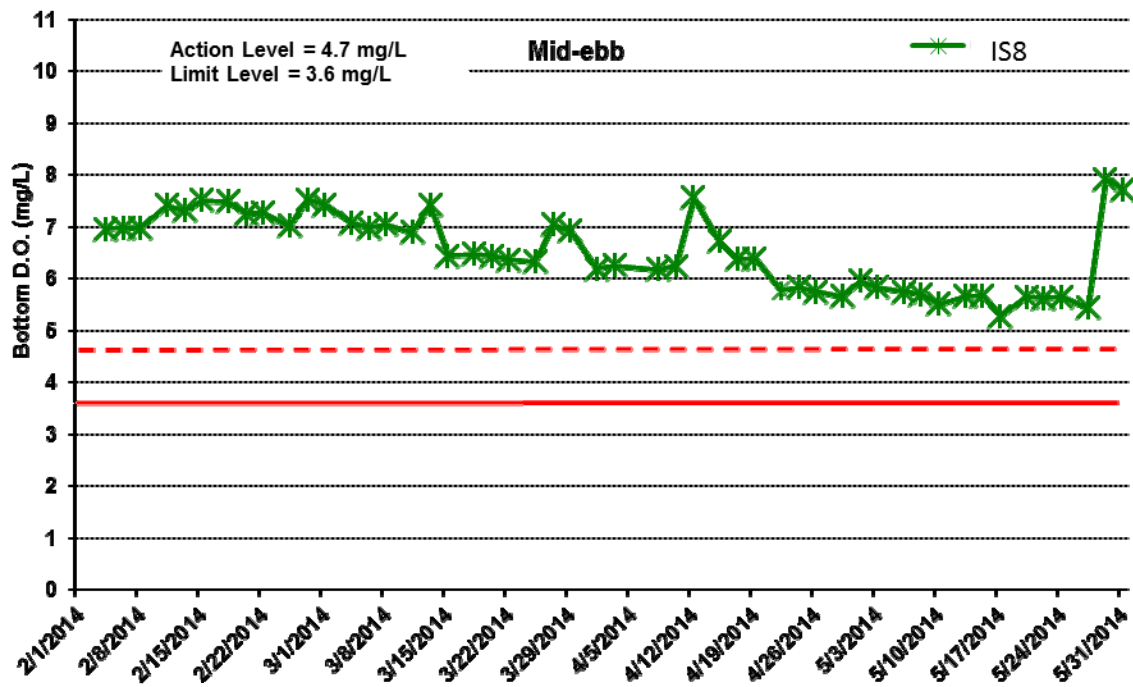
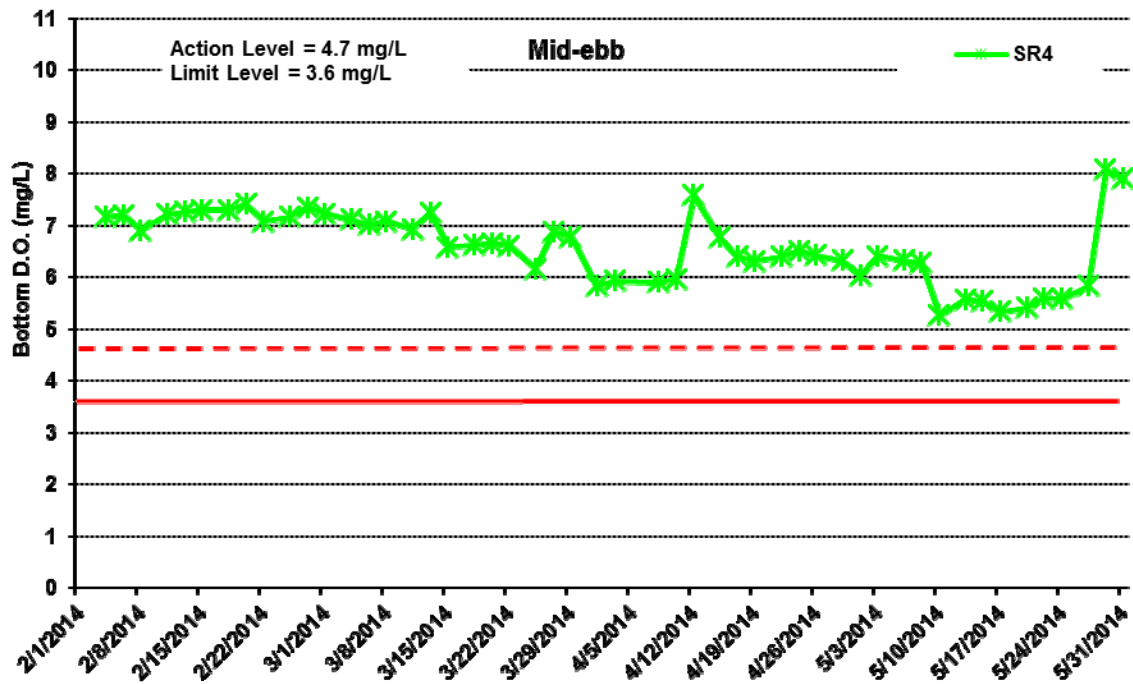
**Figure H15 Impact Monitoring - Mean Level of Dissolved Oxygen (mg/L) in bottom waters during mid-ebb tide between 1 February to 31 May 2014 at IS8 and SR4.**

*(Weather condition varied between sunny to rainy within the reporting period. Marine works within the reporting period include rockfill platform construction, marine piling platform installation and survey tower erection.)*

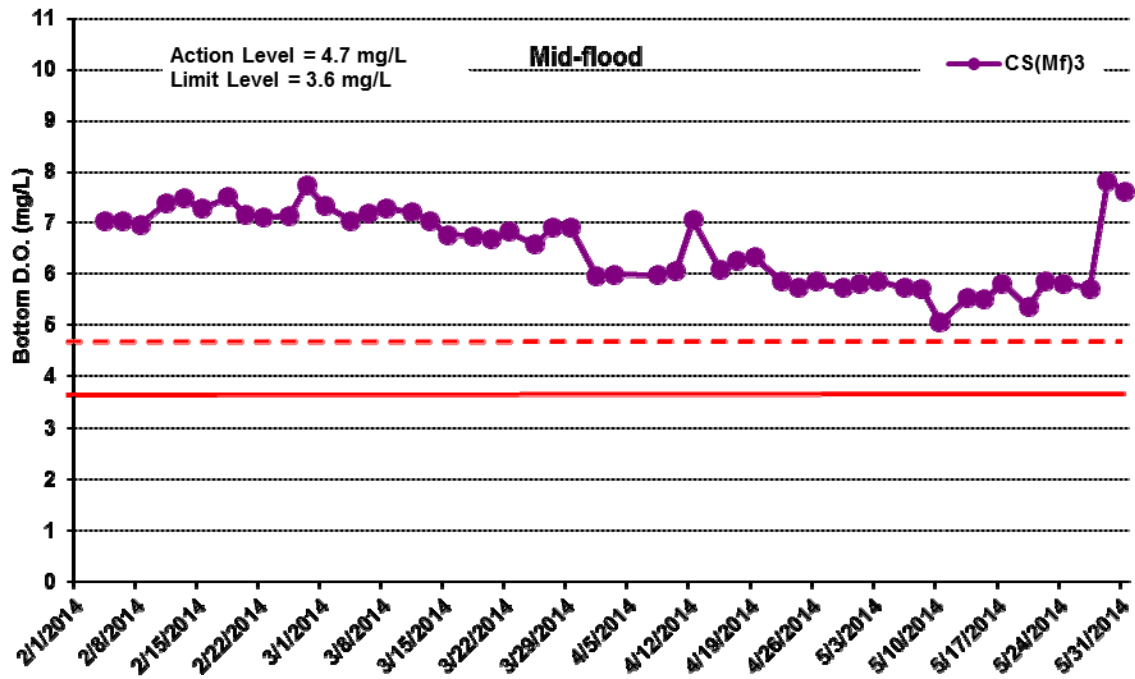
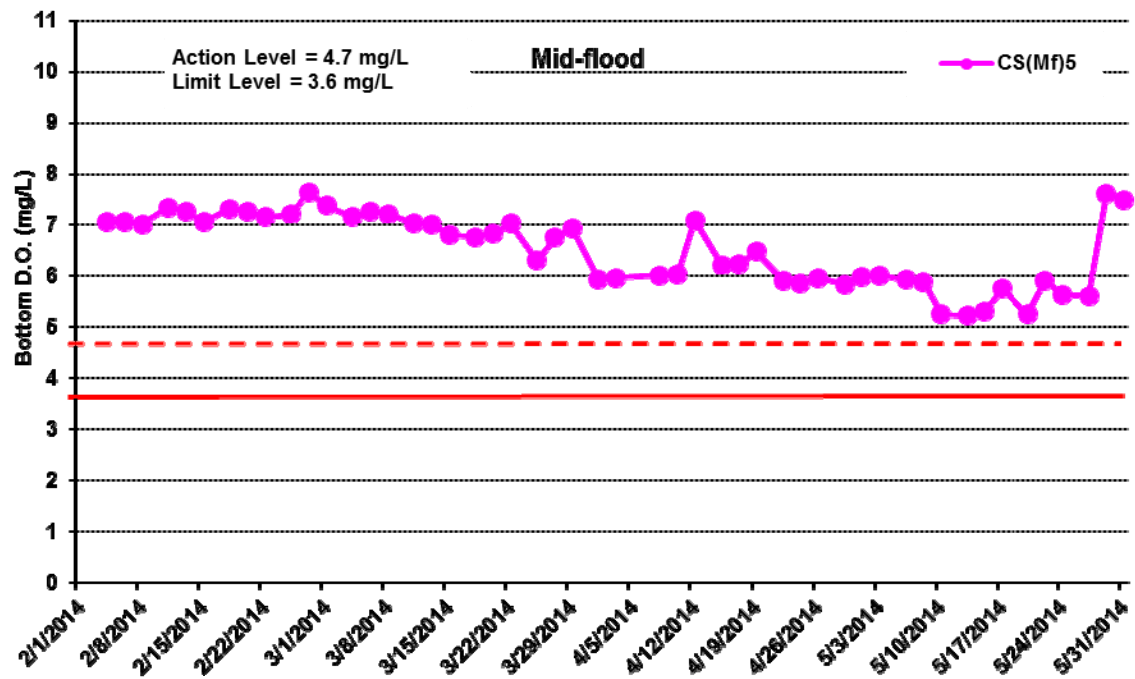
Figure H17 Impact Monitoring – Mean Level of Dissolved Oxygen (mg/L) in bottom waters during mid-flood tide between 1 February to 31 May 2014 at CS(Mf)3 and CS(Mf)5.

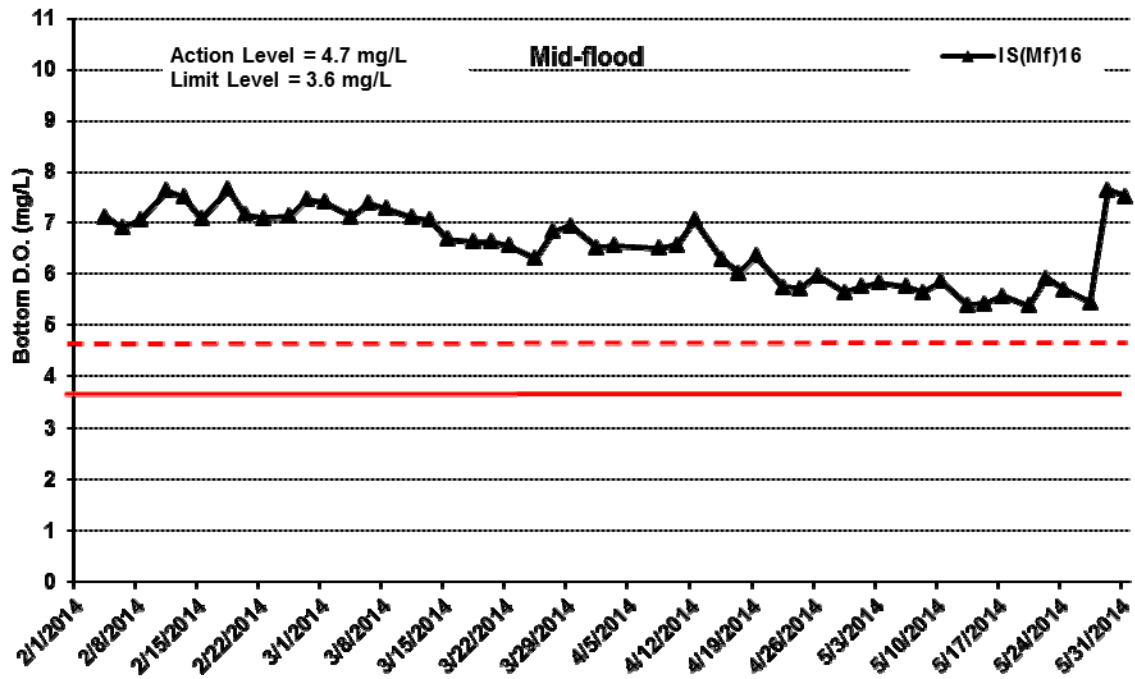
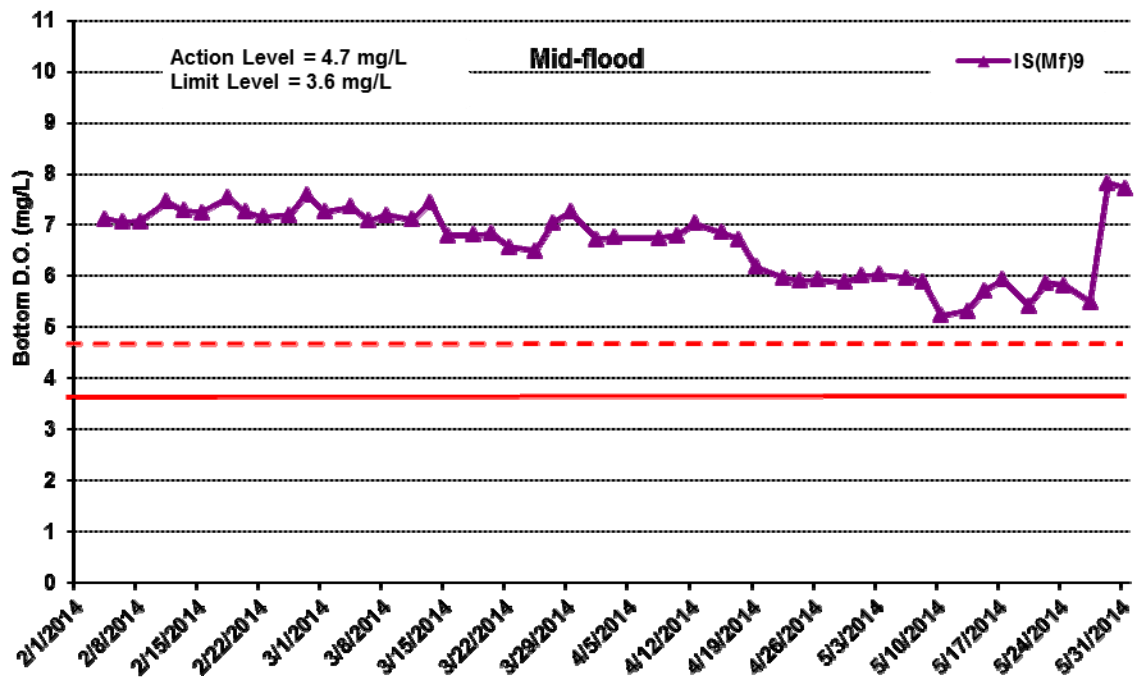
**Figure H18 Impact Monitoring – Mean Level of Dissolved Oxygen (mg/L) in bottom waters during mid-flood tide between 1 February to 31 May 2014 at IS(Mf)16 and IS(Mf)9.**

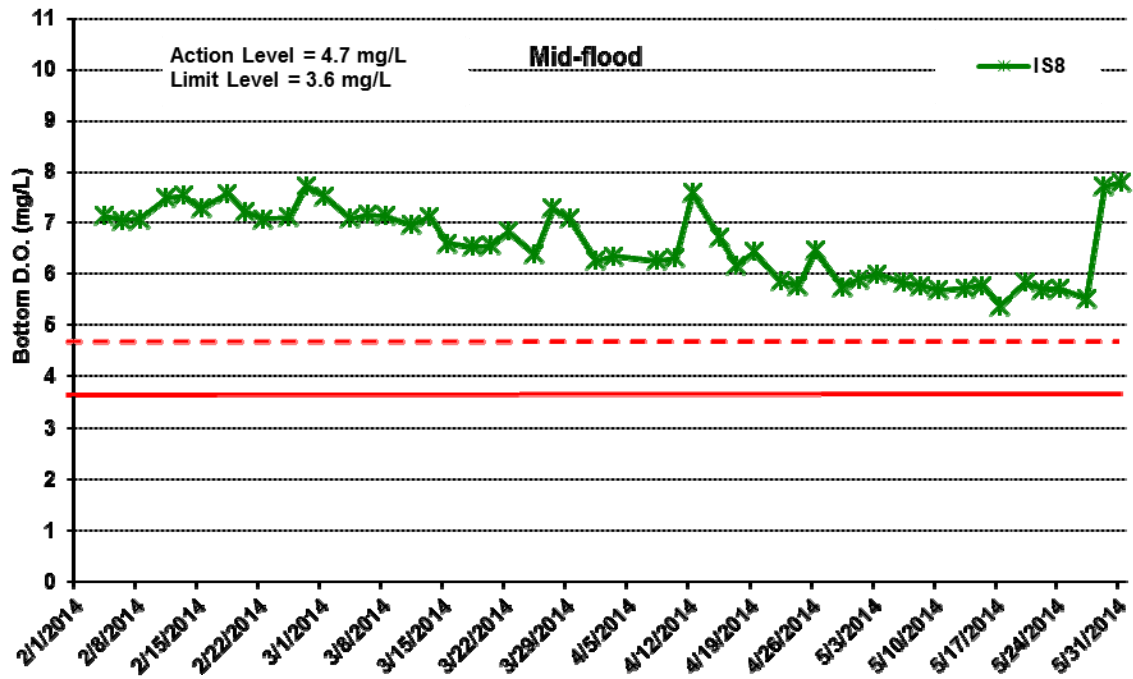
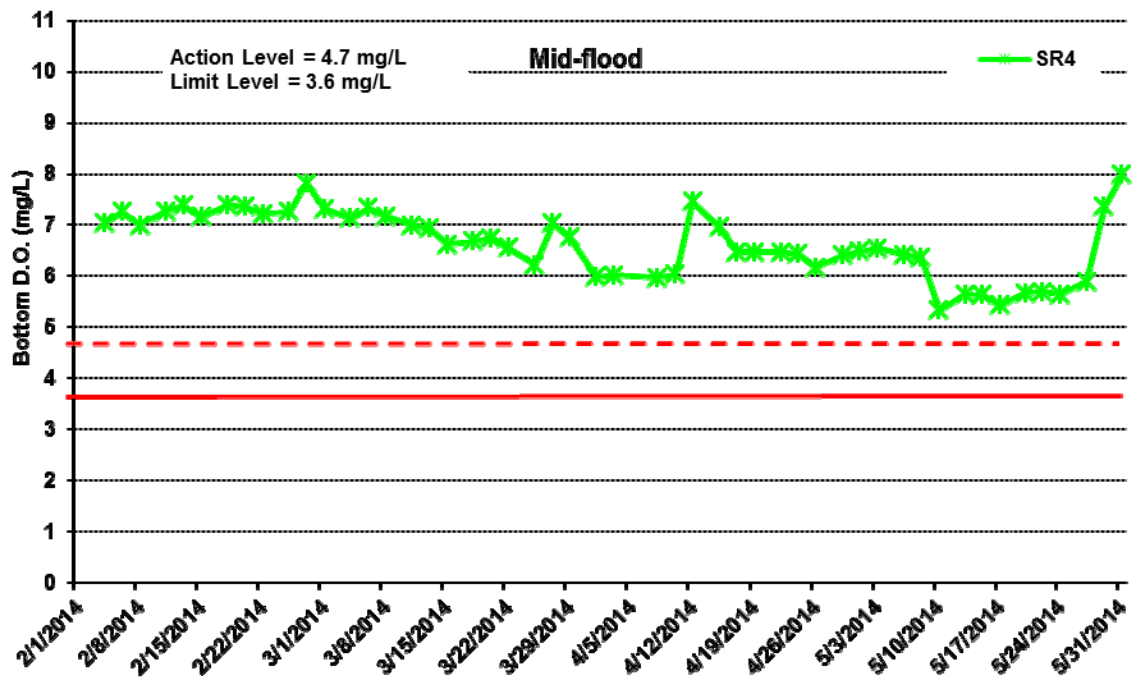
**Figure H19 Impact Monitoring - Mean Level of Dissolved Oxygen (mg/L) in bottom waters during mid-flood tide between 1 February to 31 May 2014 at IS8 and SR4.**

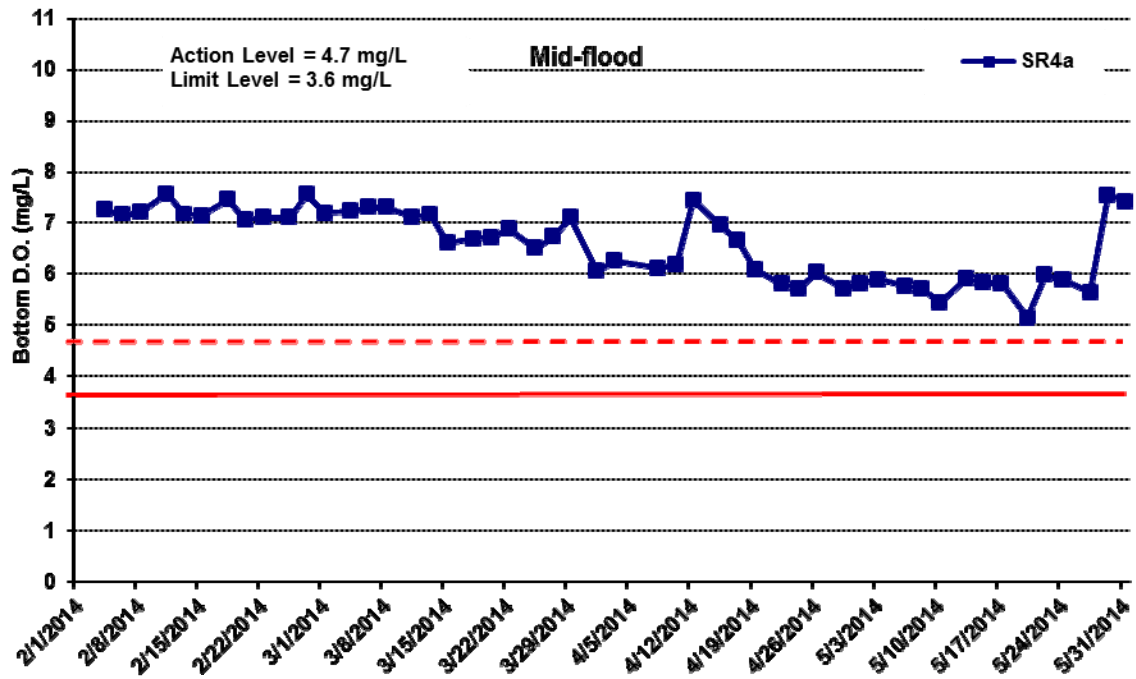
**Figure H20 Impact Monitoring - Mean Level of Dissolved Oxygen (mg/L) in bottom waters during mid-flood tide between 1 February to 31 May 2014 at SR4a.**

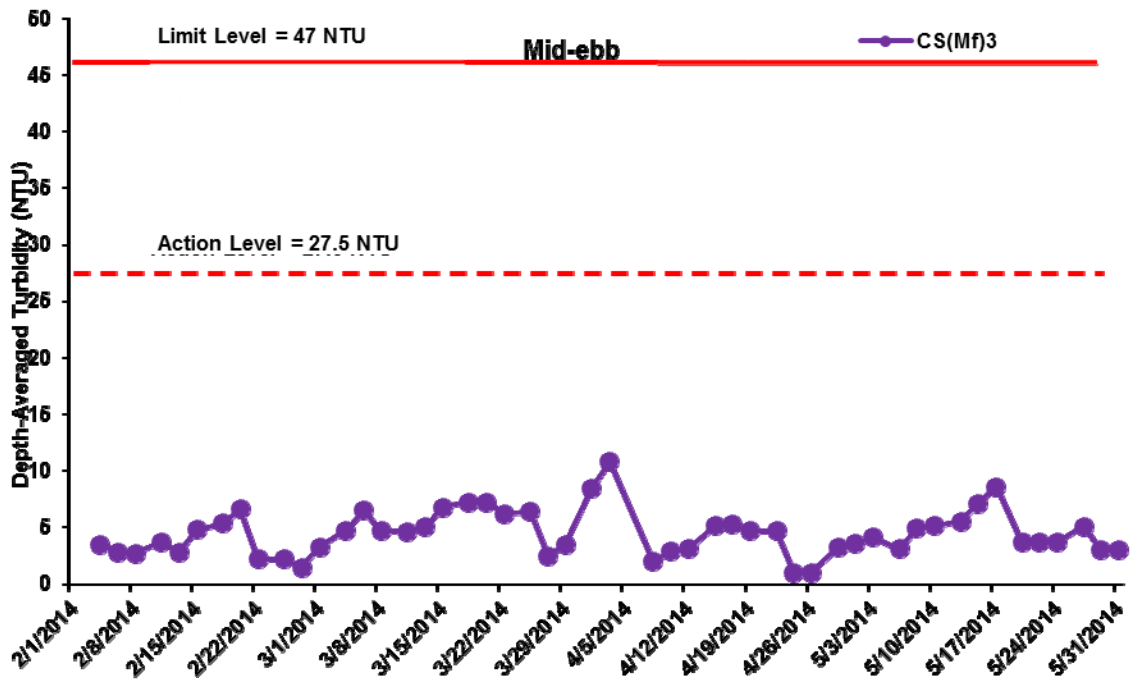
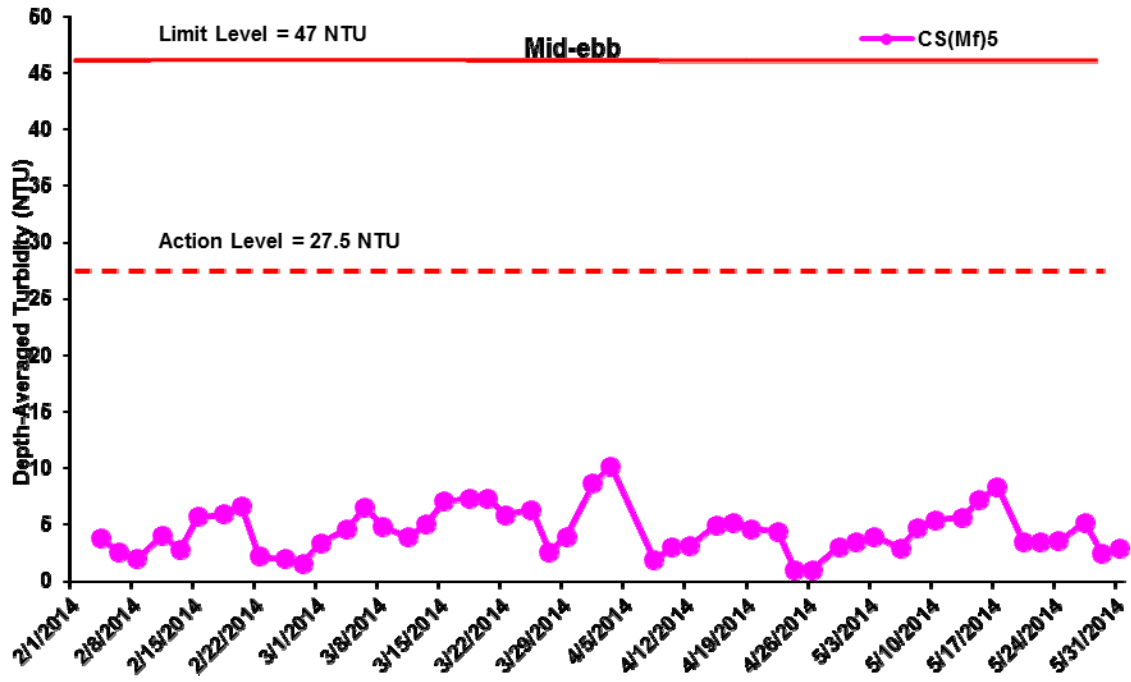
**Figure H21 Impact Monitoring – Mean Level of depth-averaged Turbidity (NTU) during mid-ebb tide between 1 February to 31 May 2014 at CS(Mf)3 and CS(Mf)5.**

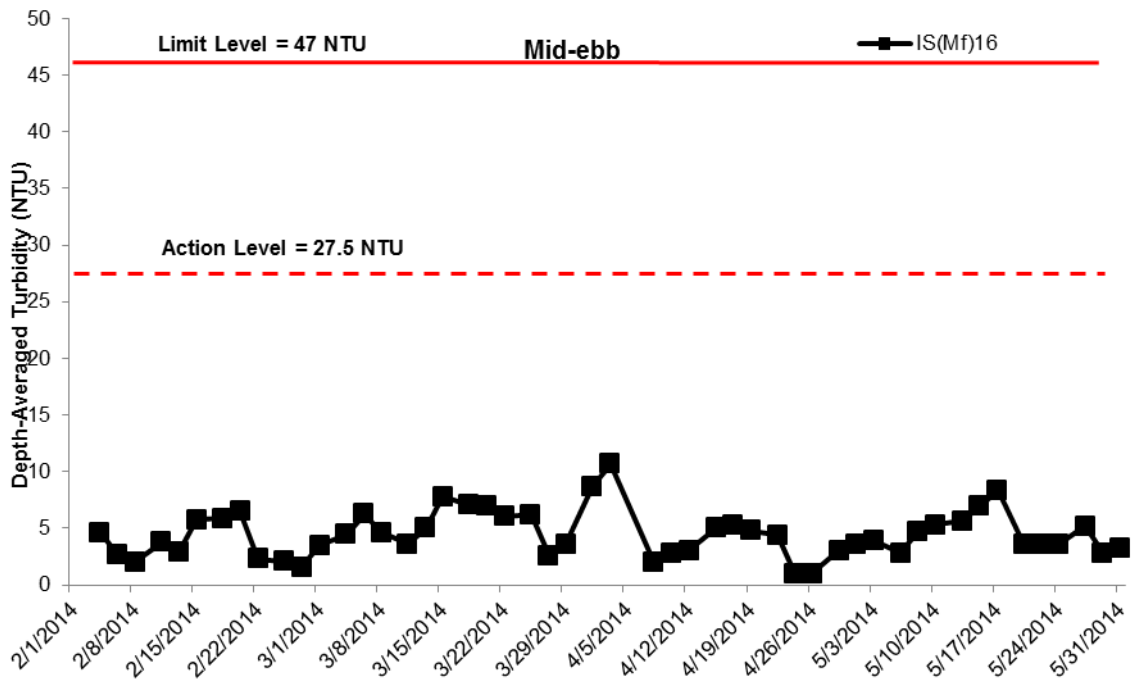
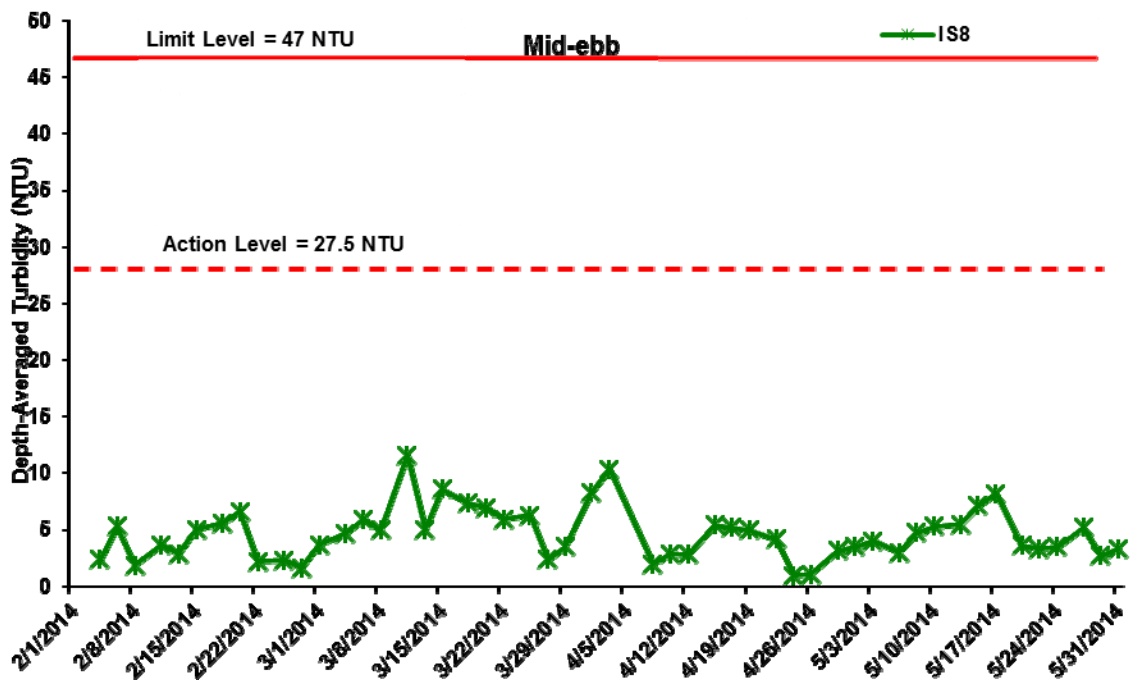
**Figure H22 Impact Monitoring – Mean Level of depth-averaged Turbidity (NTU) during mid-ebb tide between 1 February to 31 May 2014 at IS(Mf)16 and IS(Mf)9.**

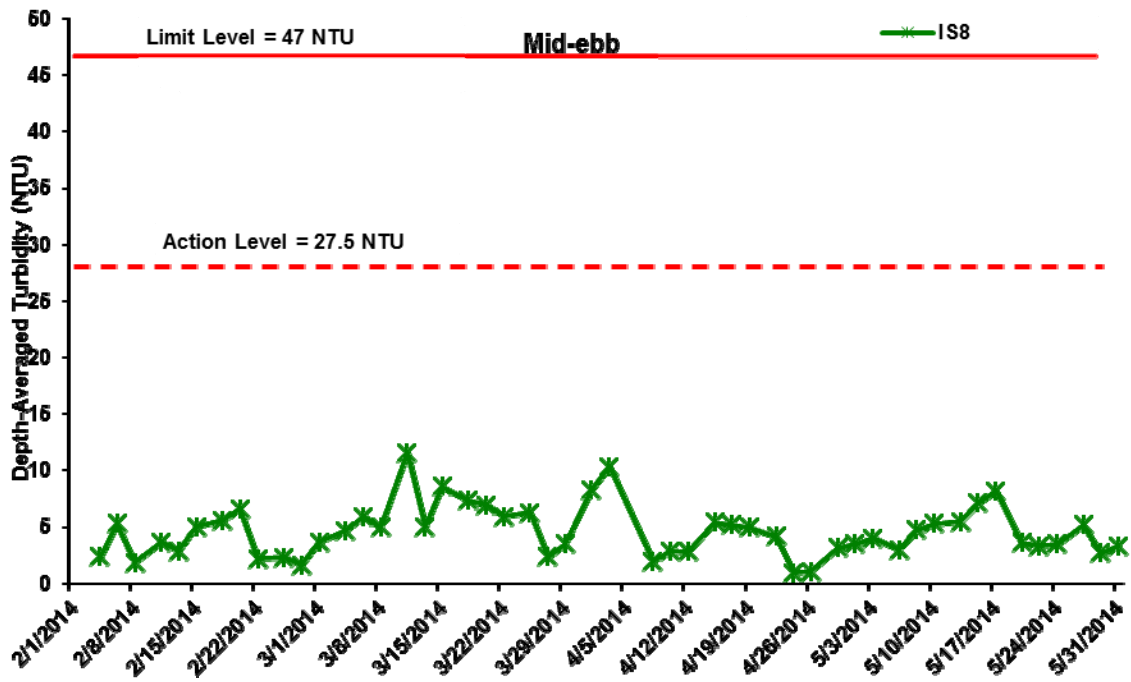
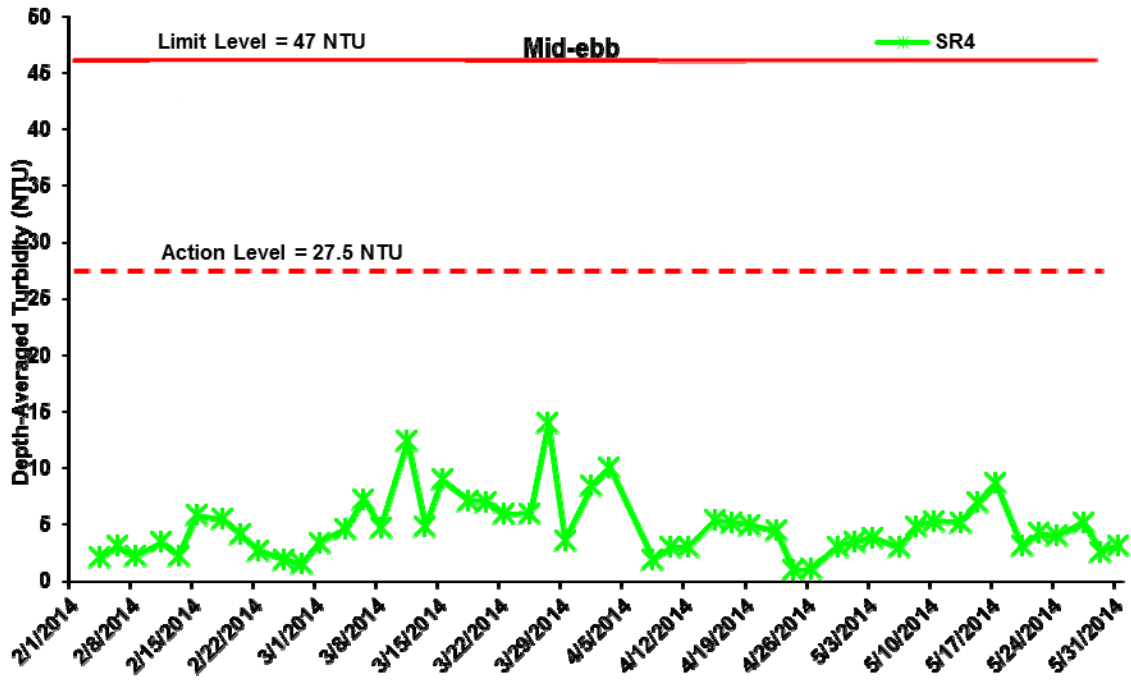
**Figure H23 Impact Monitoring – Mean Level of depth-averaged Turbidity (NTU) during mid-ebb tide between 1 February to 31 May 2014 at IS8 and SR4.**

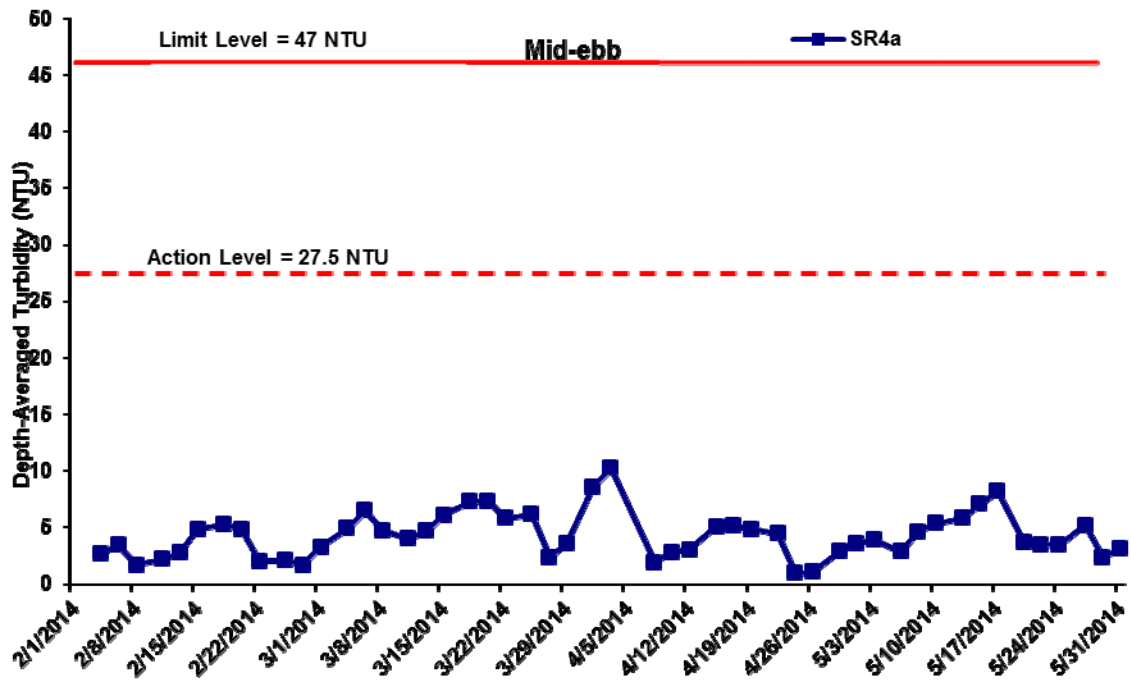
**Figure H24 Impact Monitoring - Mean Level of depth-averaged Turbidity (NTU) during mid-ebb tide between 1 February to 31 May 2014 at SR4a.**

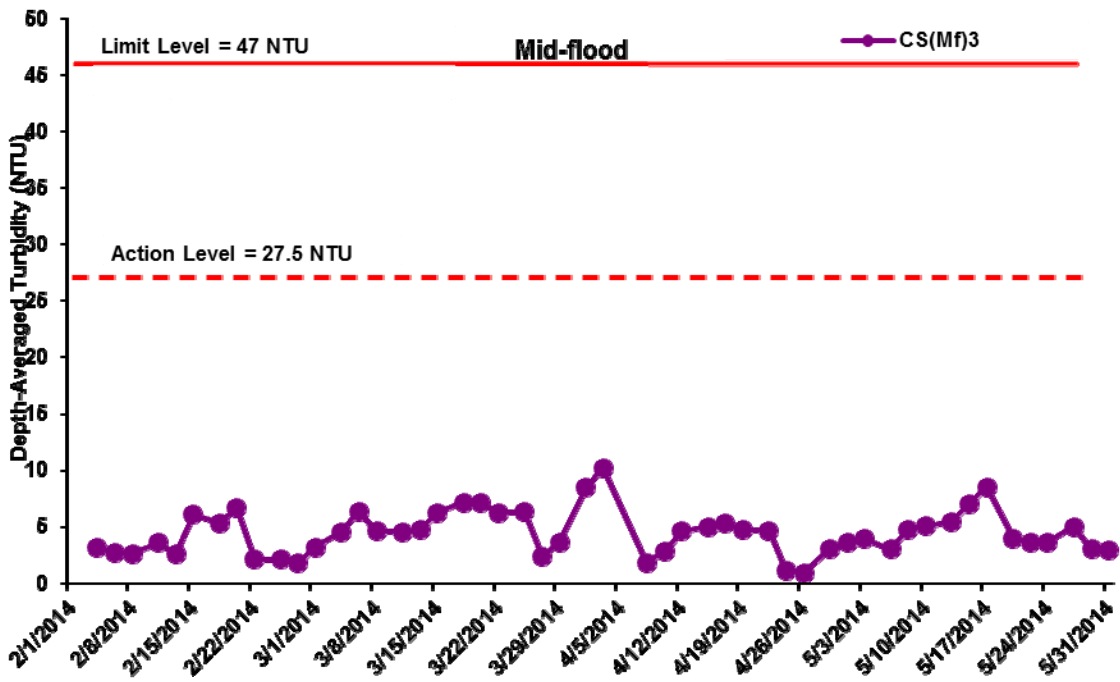
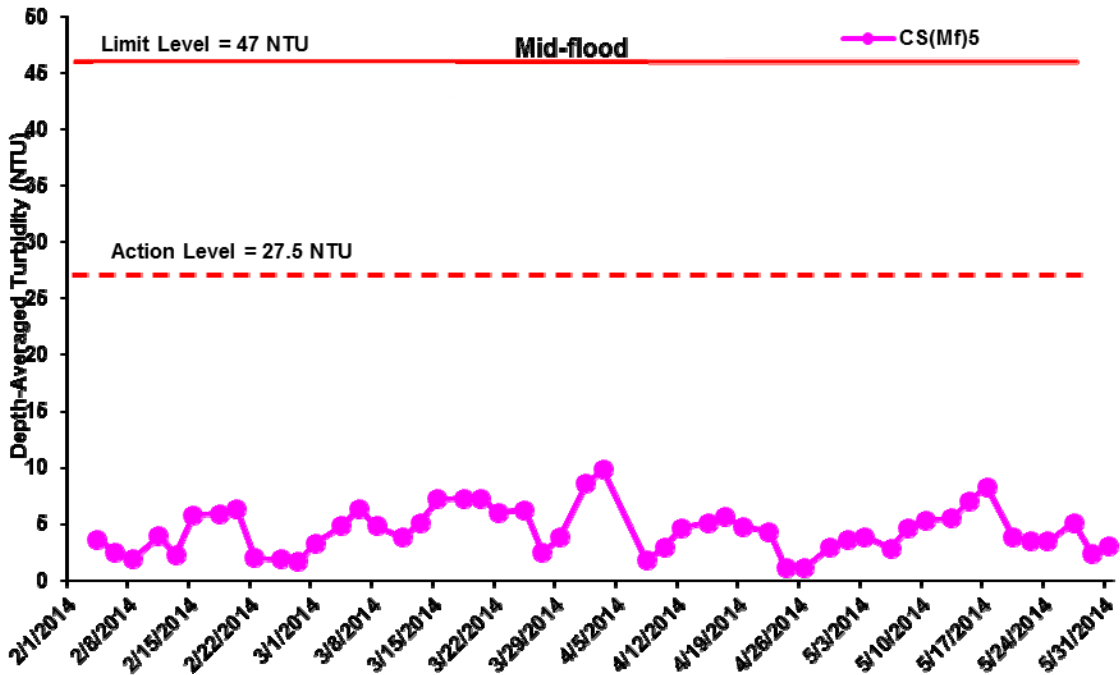
**Figure H25 Impact Monitoring - Mean Level of depth-averaged Turbidity (NTU) during mid-flood tide between 1 February to 31 May 2014 at CS(Mf)3 and CS(MF)5.**

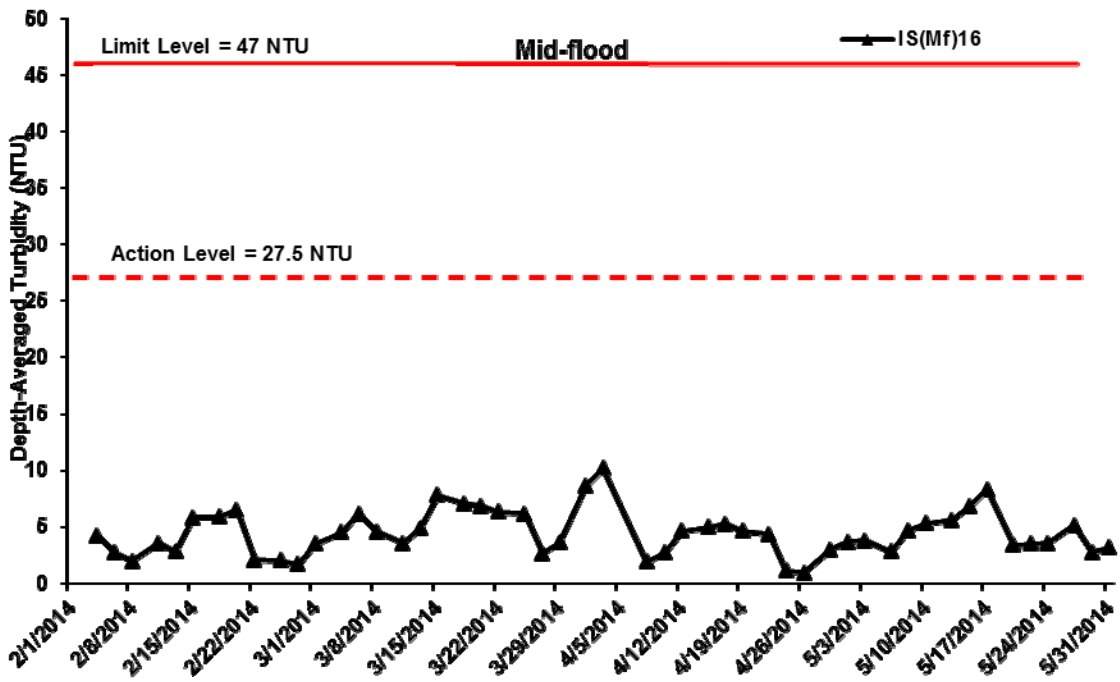
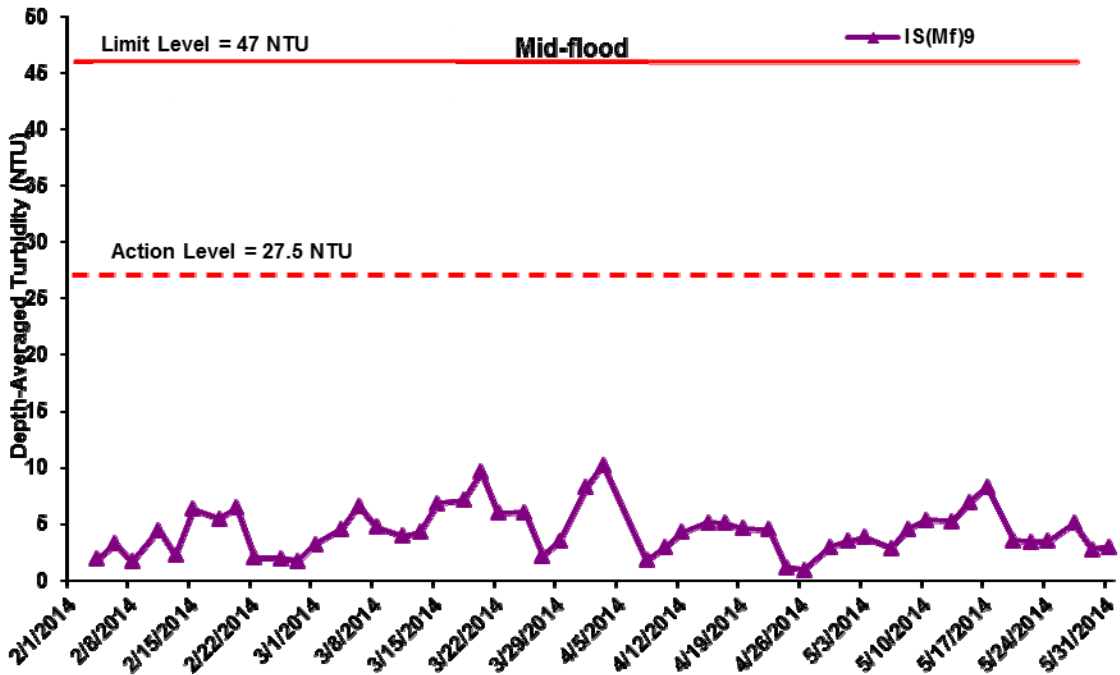
**Figure H26 Impact Monitoring - Mean Level of depth-averaged Turbidity (NTU) during mid-flood tide between 1 February to 31 May 2014 at IS(Mf)16 and IS(Mf)9.**

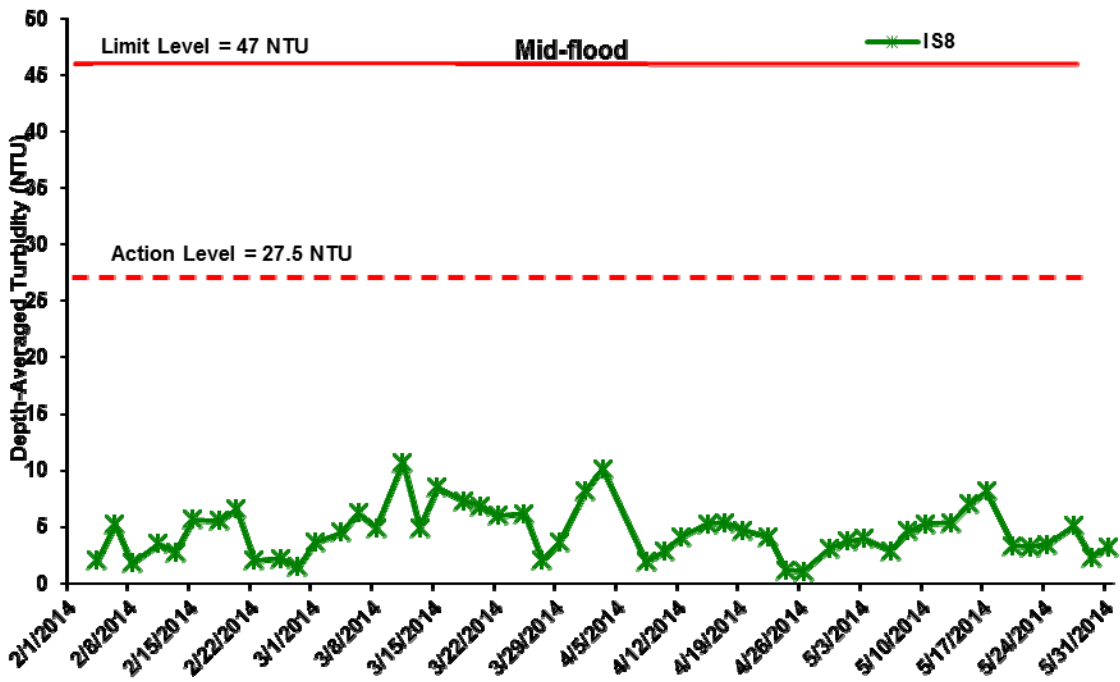
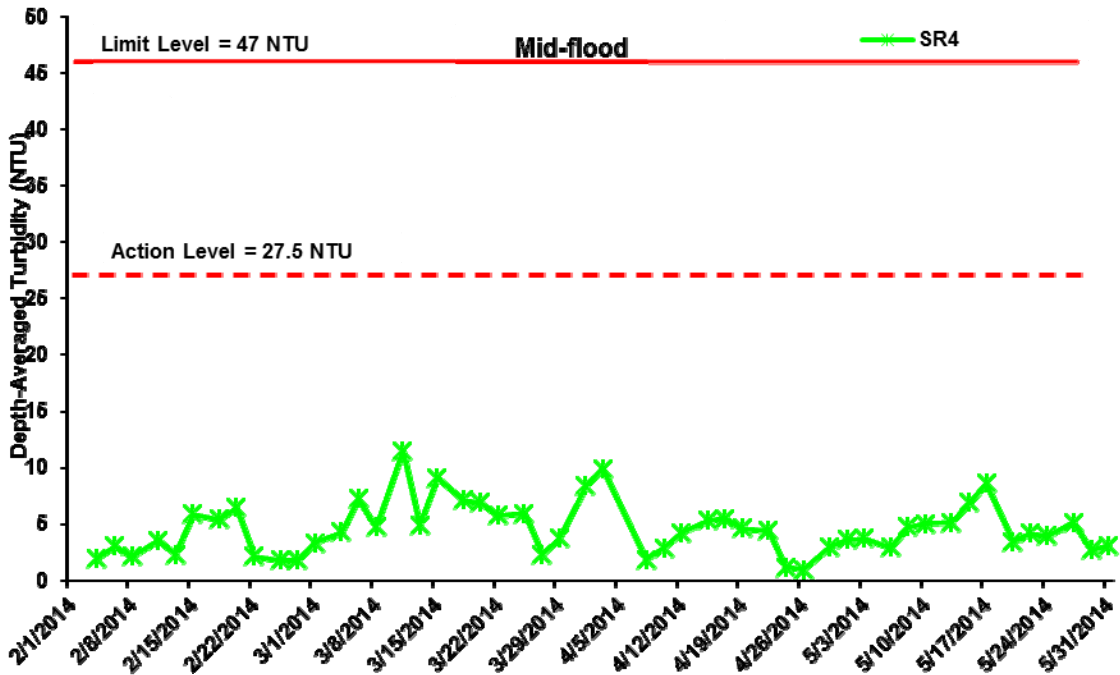
**Figure H27 Impact Monitoring - Mean Level of depth-averaged Turbidity (NTU) during mid-flood tide between 1 February to 31 May 2014 at IS8 and SR4.**

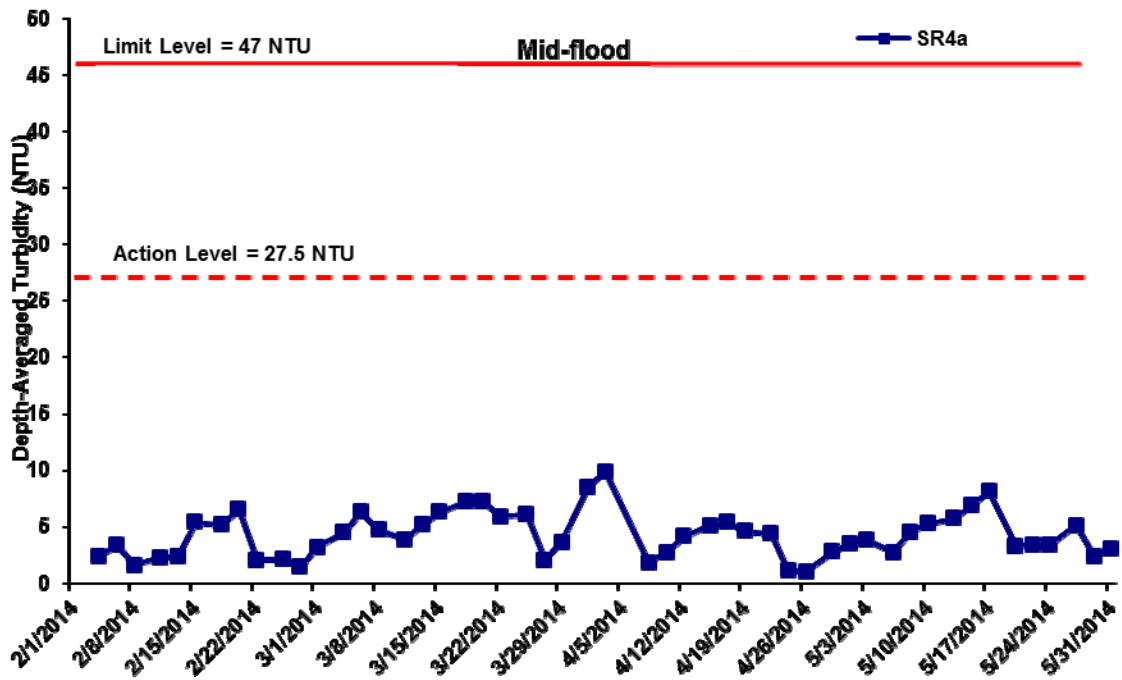
**Figure H28 Impact Monitoring - Mean Level of depth-averaged Turbidity (NTU) during mid-flood tide between 1 February to 31 May 2014 at SR4a.**

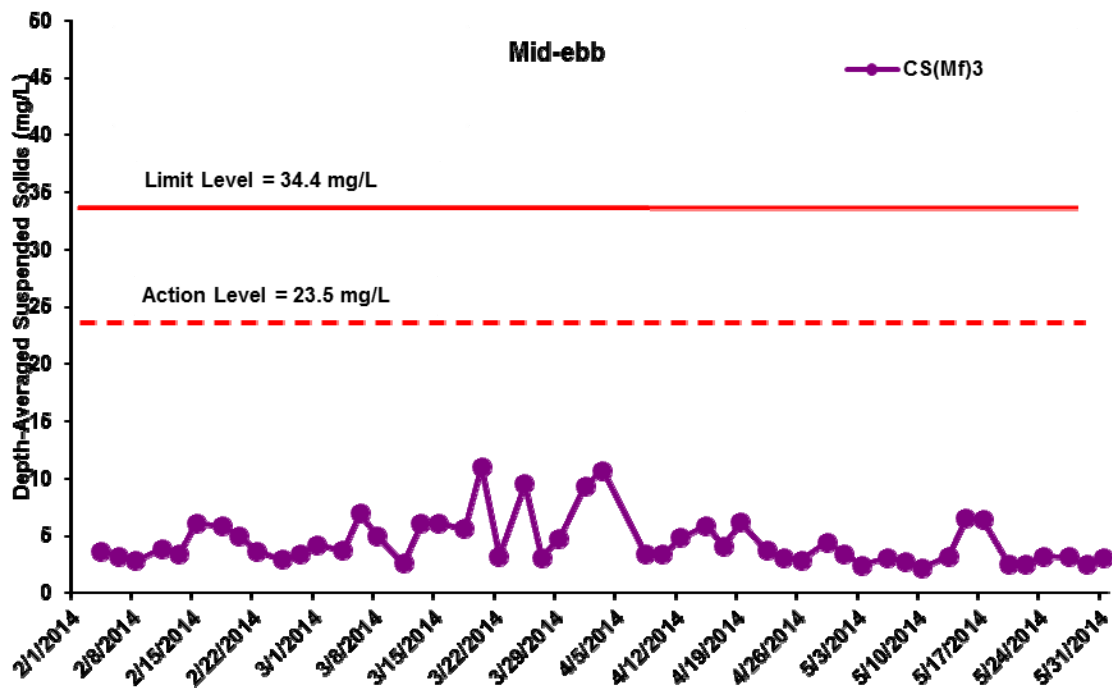
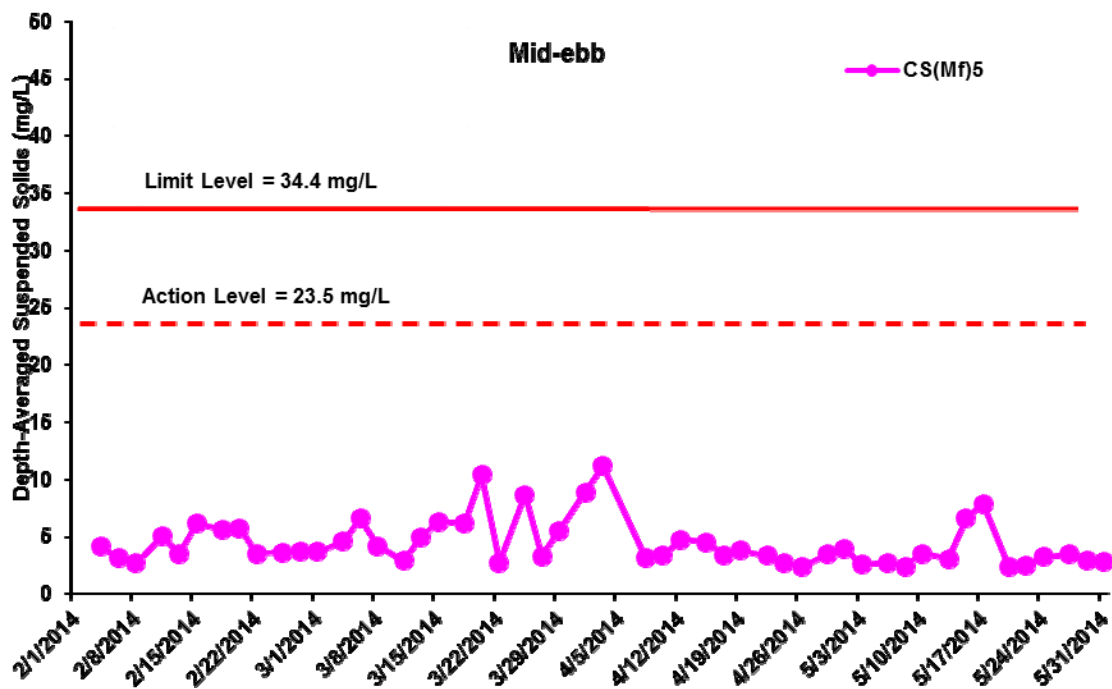
**Figure H29 Impact Monitoring - Mean Level of depth-averaged Suspended Solids (mg/L) during mid-ebb tide between 1 February to 31 May 2014 at CS(Mf)3 and CS(Mf)5.**

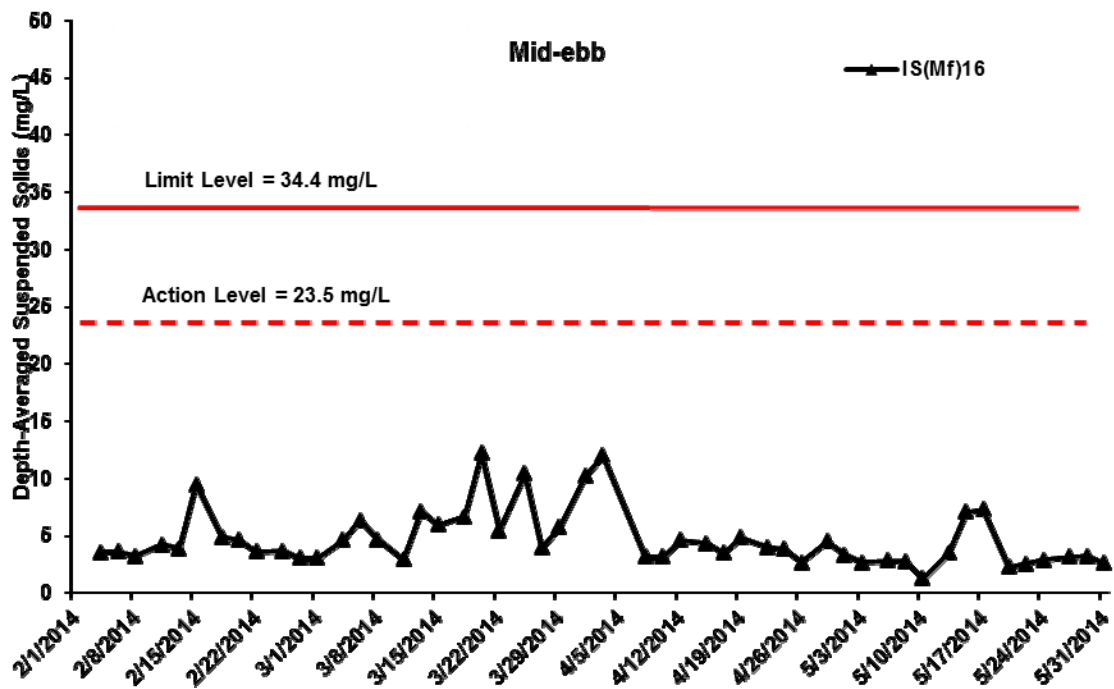
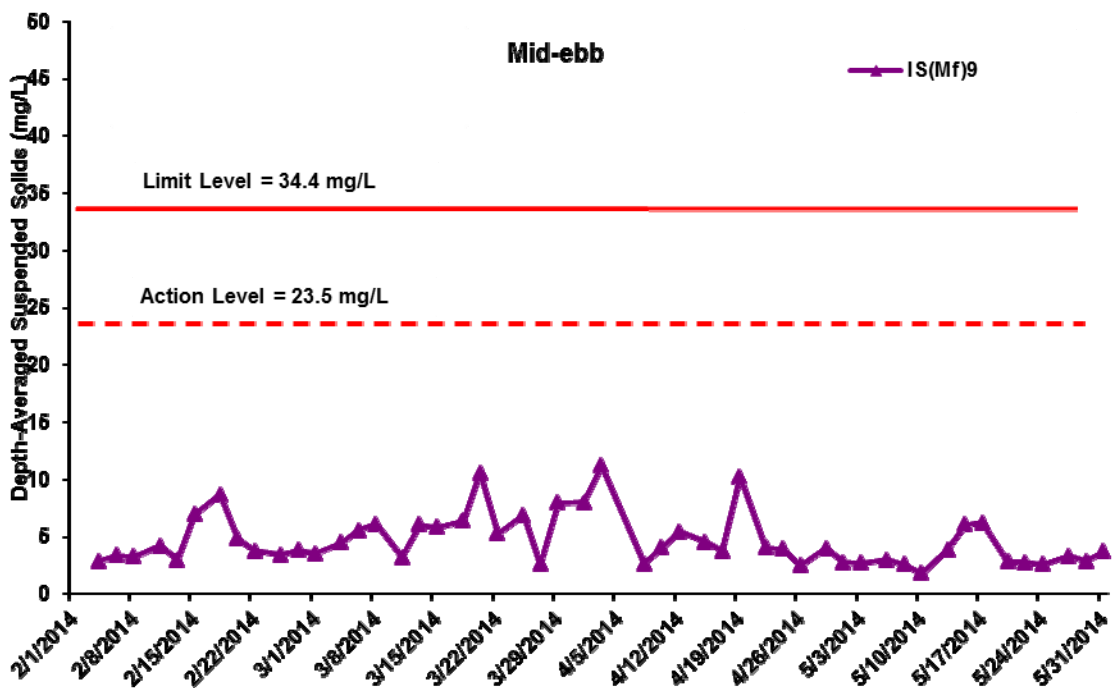
**Figure H30 Impact Monitoring - Mean Level of depth-averaged Suspended Solids (mg/L) during mid-ebb tide between 1 February to 31 May 2014 at IS(Mf)16 and IS(Mf)9.**
