**Contract No. HY/2012/07**  
**Tuen Mun – Chek Lap Kok Link –**  
**Southern Connection Viaduct Section**

*Second Quarterly Environmental Monitoring &  
Audit (EM&A) Report*

04 August 2014

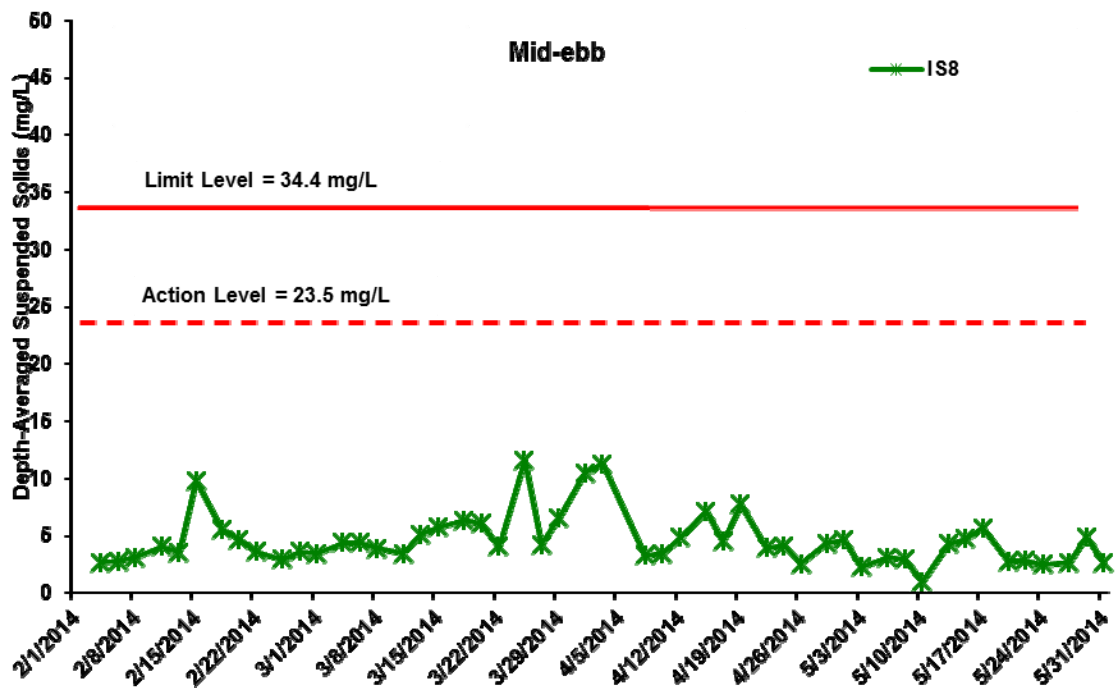
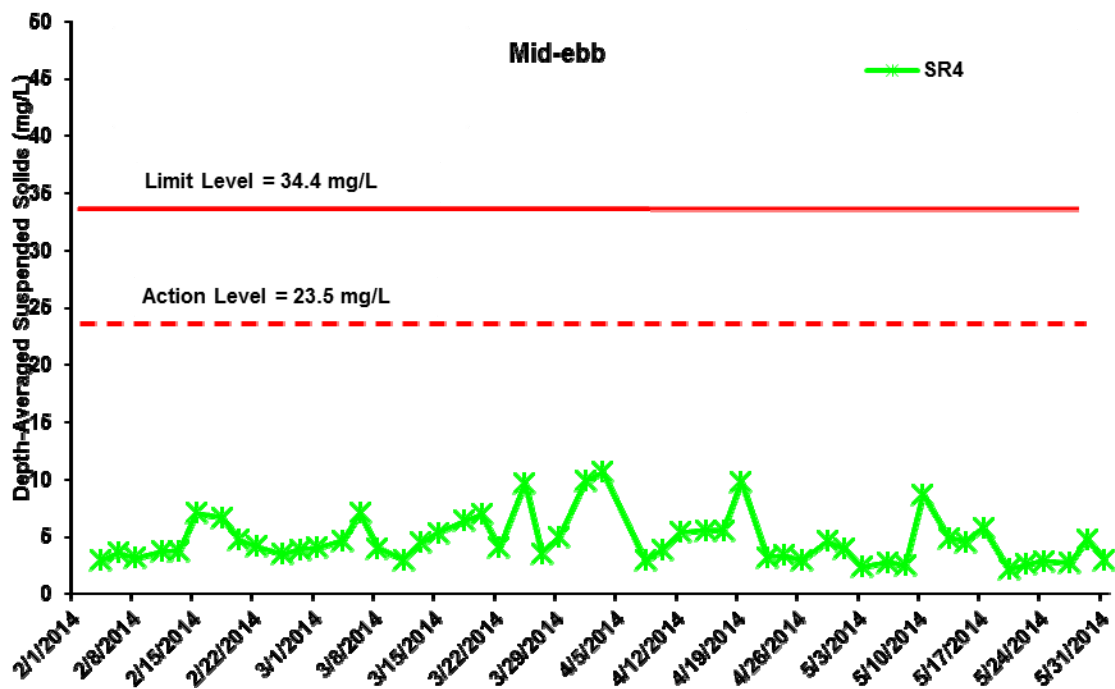
**Figure H31 Impact Monitoring - Mean Level of depth-averaged Suspended Solids (mg/L) during mid-ebb tide between 1 February to 31 May 2014 at IS8 and SR4.**

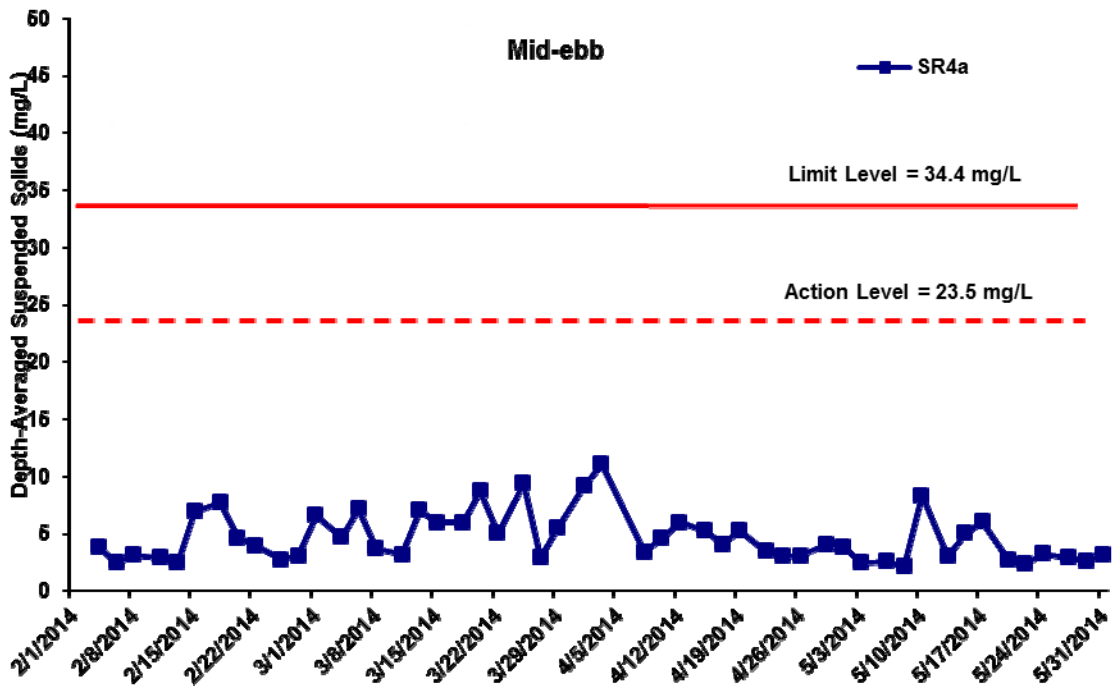
**Figure H32 Impact Monitoring - Mean Level of depth-averaged Suspended Solids (mg/L) during mid-ebb tide between 1 February to 31 May 2014 at SR4a.**

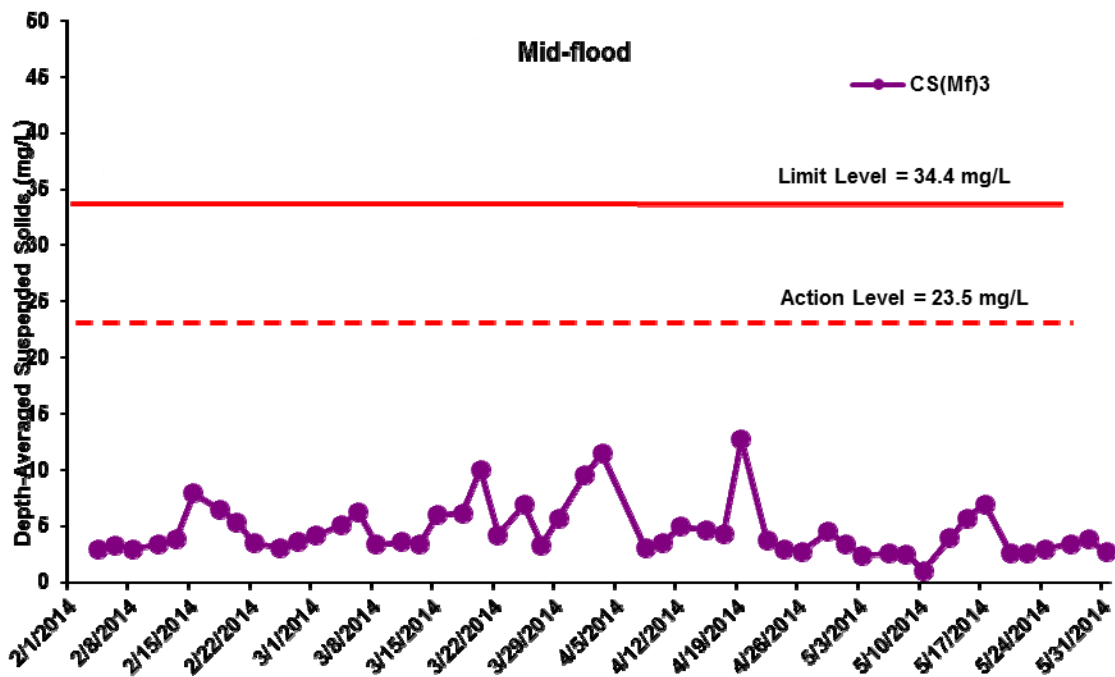
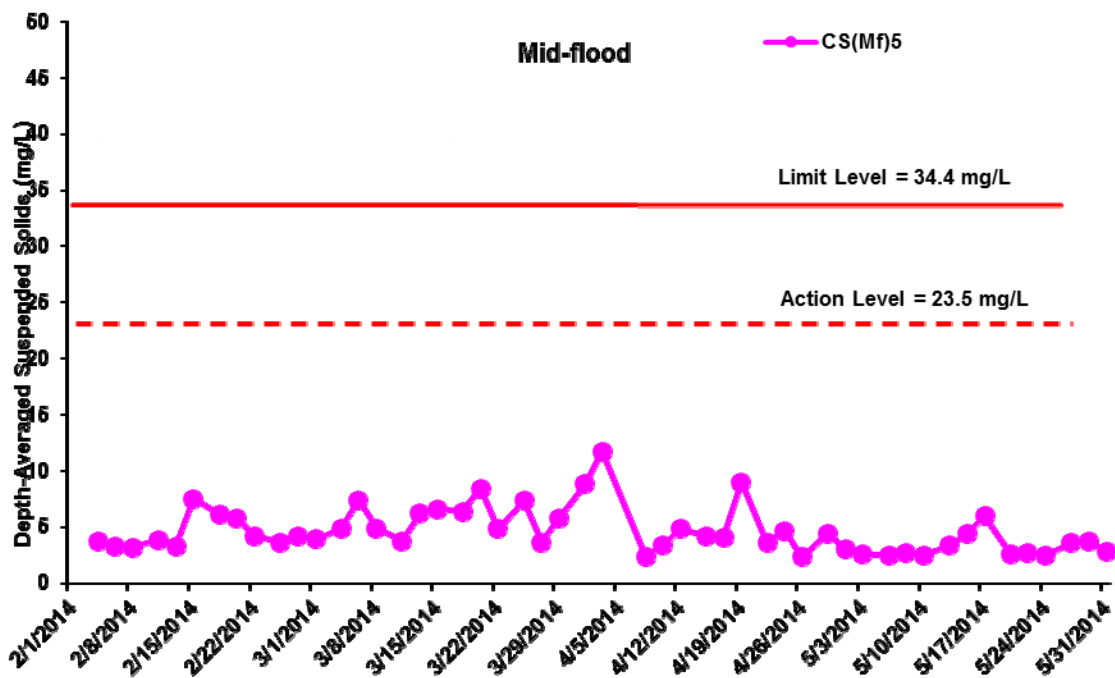
**Figure H33 Impact Monitoring - Mean Level of depth-averaged Suspended Solids (mg/L) during mid-flood tide between 1 February to 31 May 2014 at CS(Mf)3 and CS(Mf)5.**

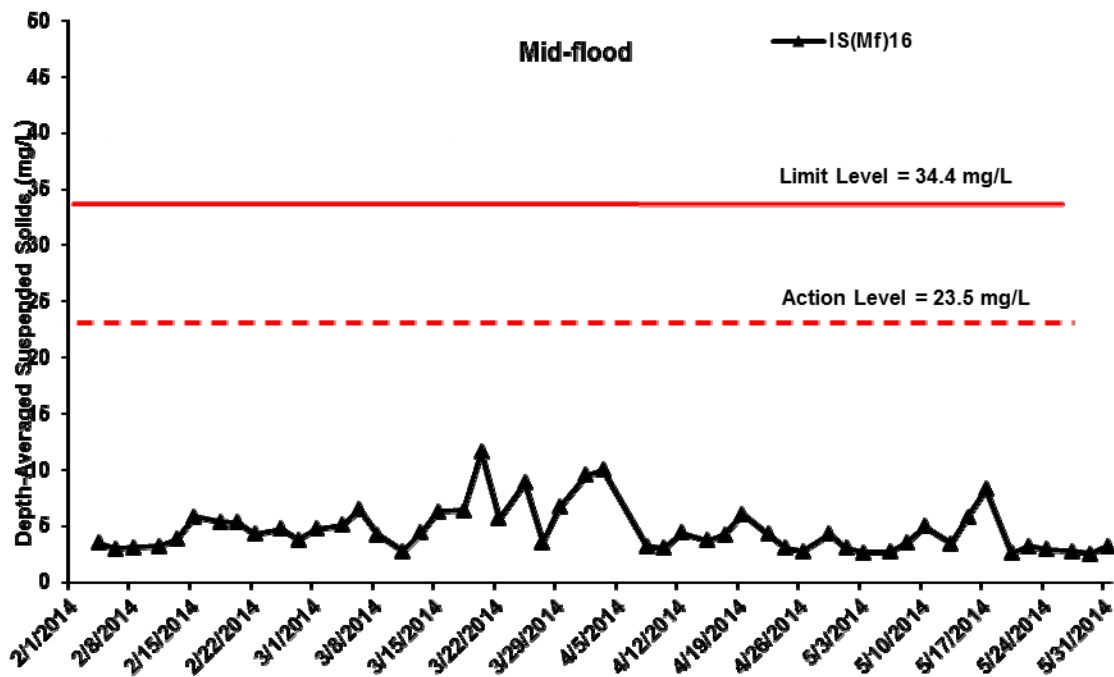
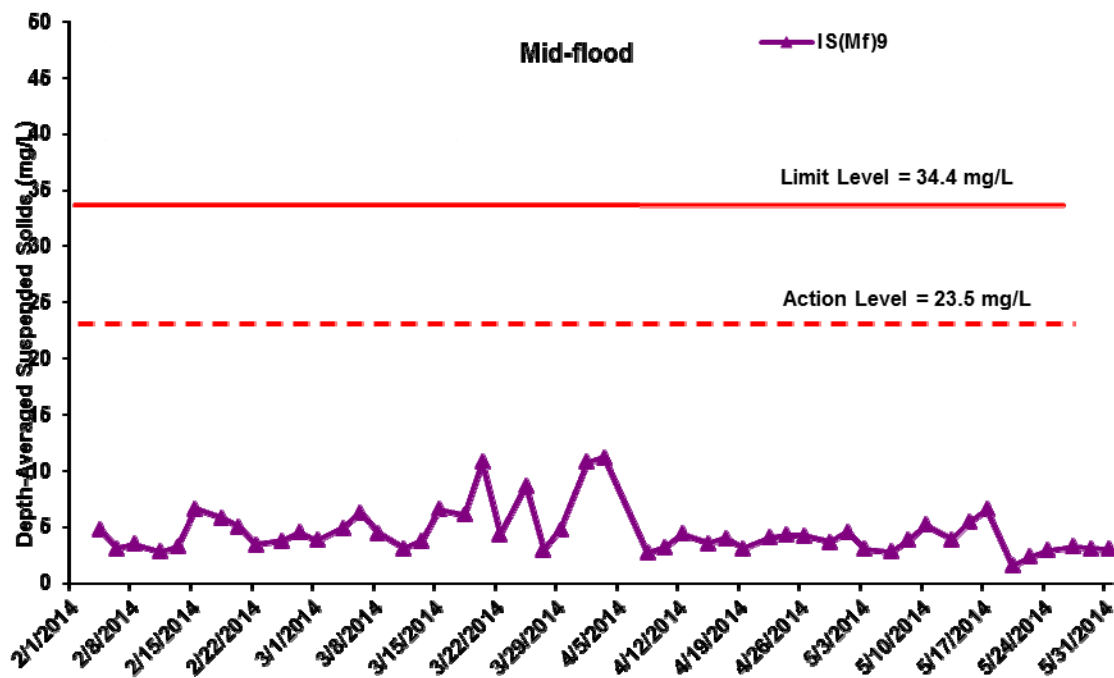
**Figure H34 Impact Monitoring - Mean Level of depth-averaged Suspended Solids (mg/L) during mid-flood tide between 1 February to 31 May 2014 at IS(Mf)16 and IS(Mf)9 .**

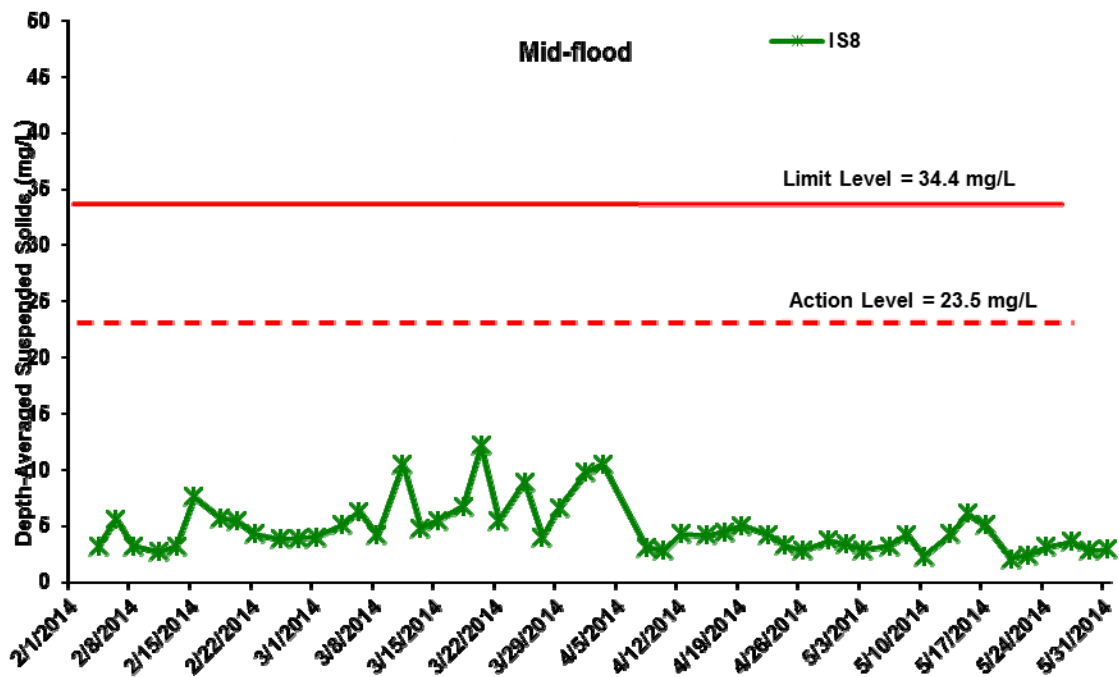
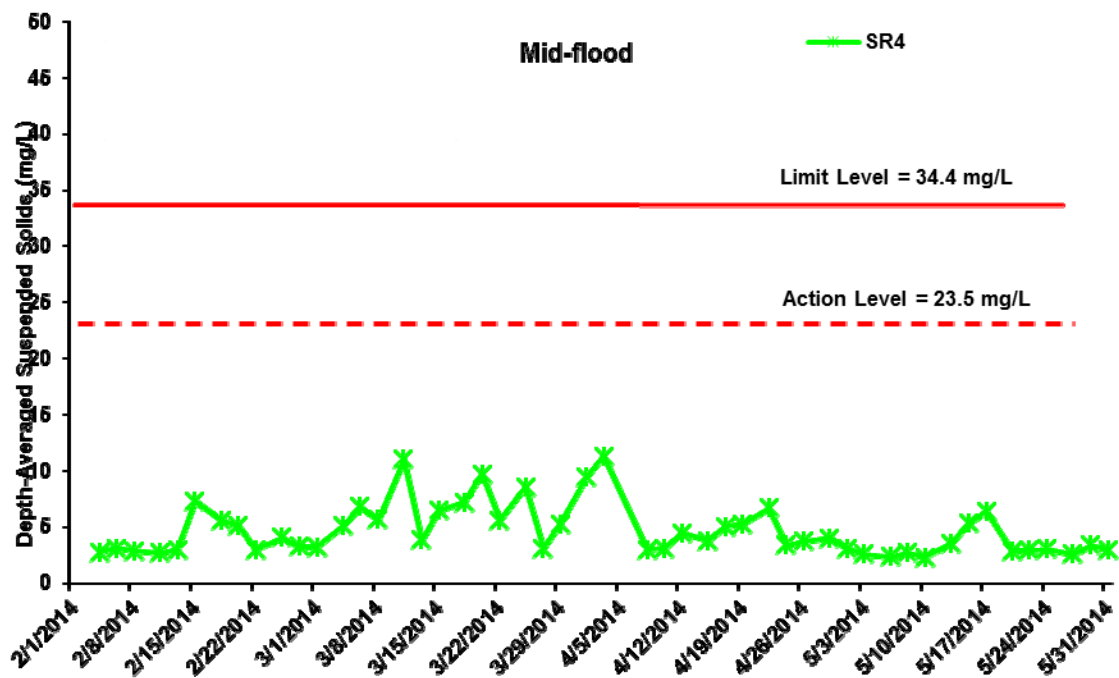
**Figure H35 Impact Monitoring - Mean Level of depth-averaged Suspended Solids (mg/L) during mid-flood tide between 1 February to 31 May 2014 at IS8 and SR4.**

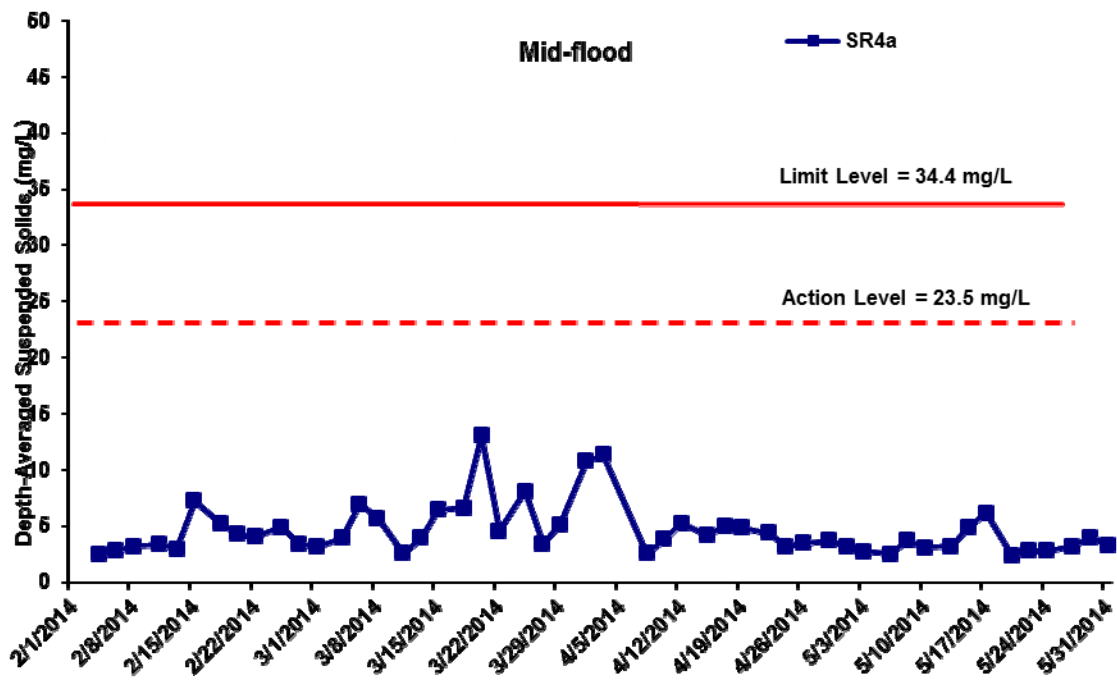
**Figure H36 Impact Monitoring - Mean Level of depth-averaged Suspended Solids (mg/L) during mid-flood tide between 1 February to 31 May 2014 at SR4a.**

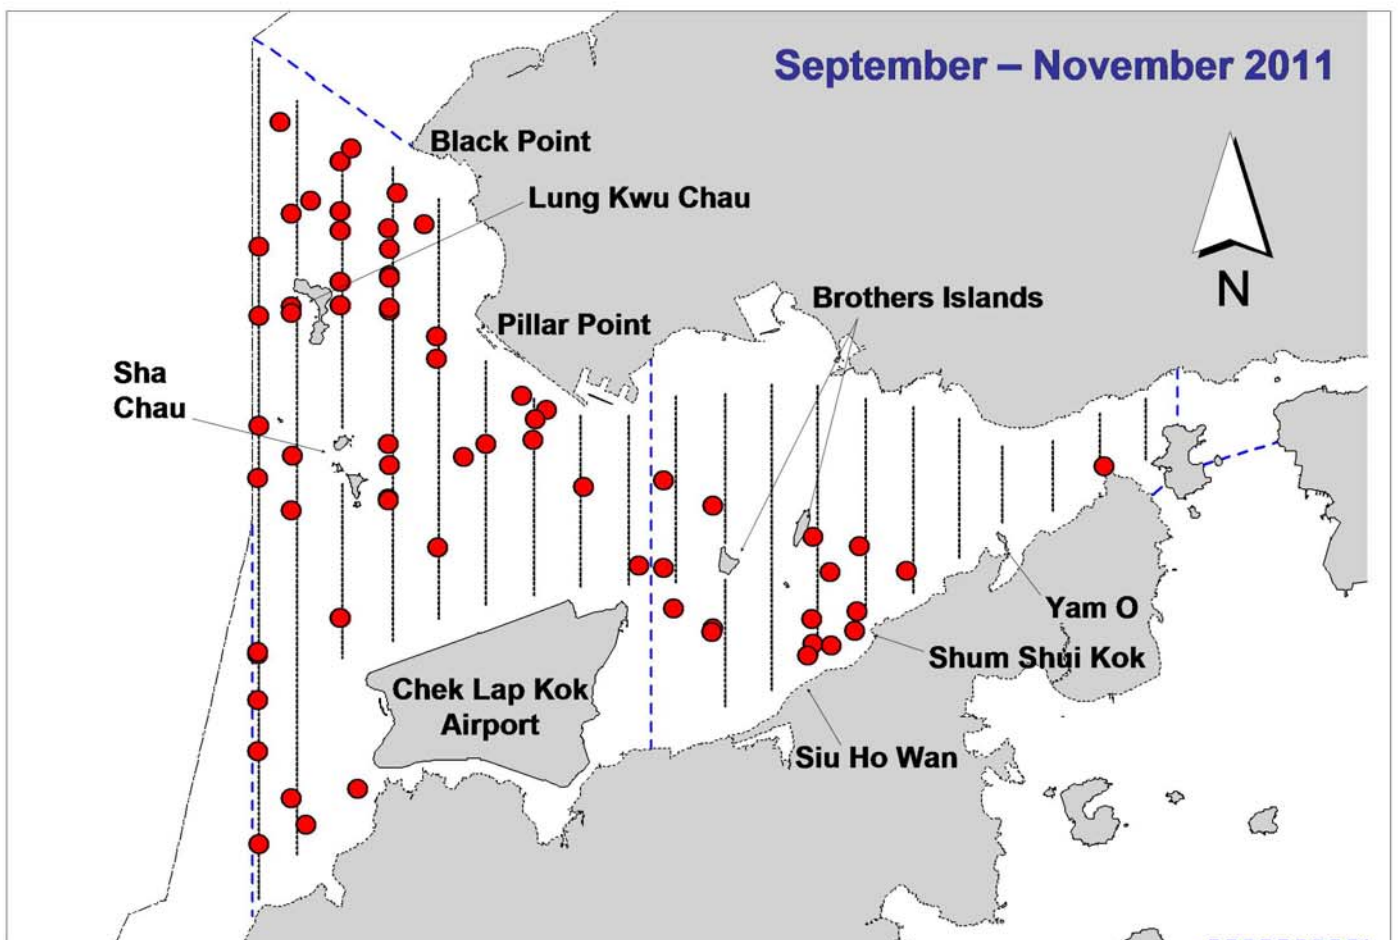
Figure 1. Distribution of Chinese white dolphin sighting in Northwest and Northeast Lantau during HKLR03 impact phase (top) and baseline monitoring surveys (bottom)
