**Contract No. HY/2012/07
Tuen Mun – Chek Lap Kok Link –
Southern Connection Viaduct Section**

***Fourth Quarterly Environmental Monitoring &
Audit (EM&A) Report***

13 July 2015

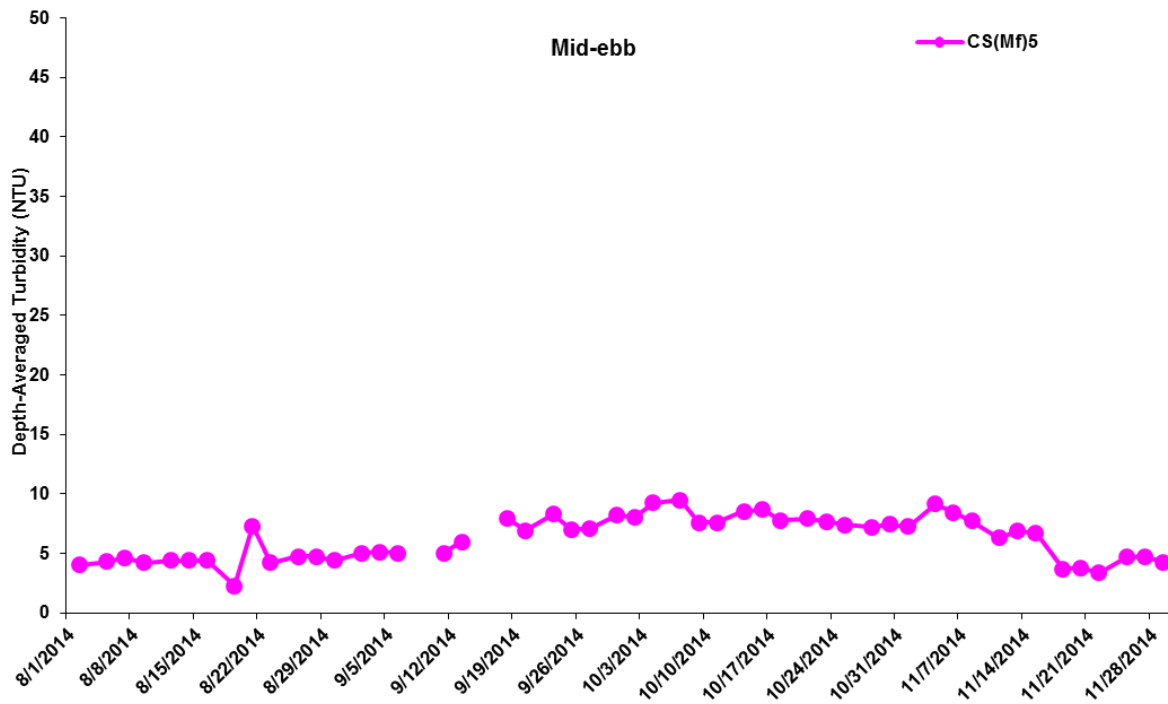
Figure H21 Impact Monitoring - Mean Level of depth-averaged Turbidity (NTU) during mid-ebb tide between 1 August and 30 November 2014 at CS(Mf)3 and CS(Mf)5.

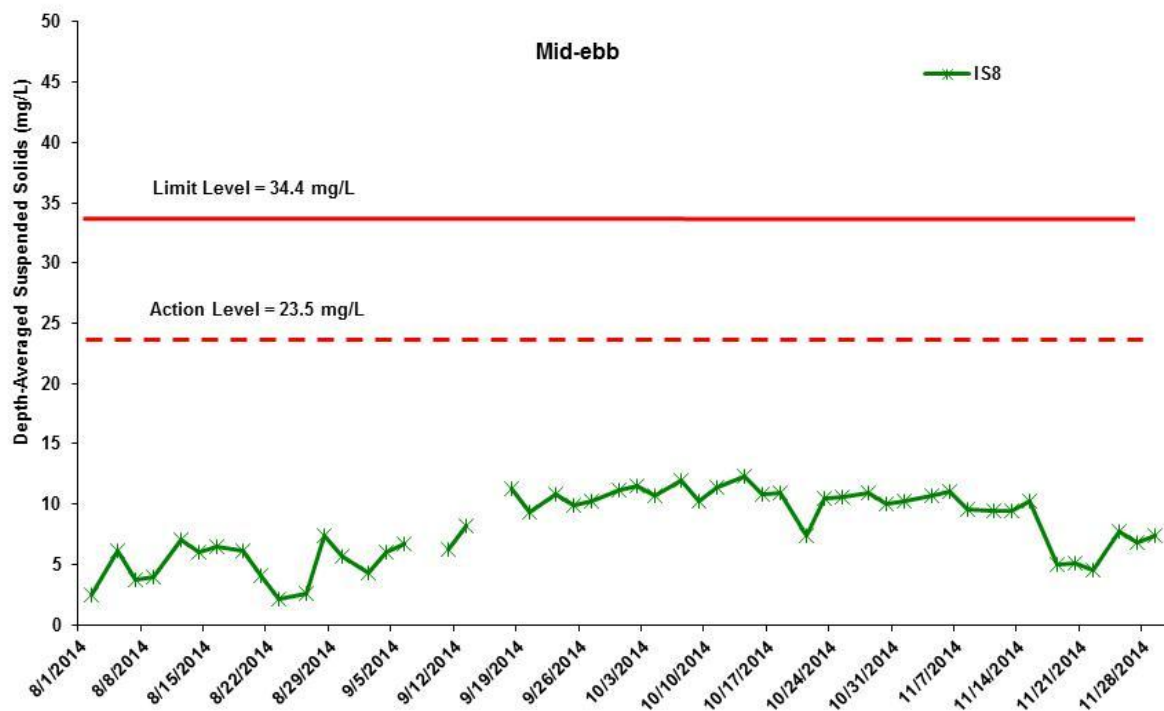
Figure H31 Impact Monitoring - Mean depth-averaged level of Suspended Solids (mg/L) during mid-ebb tide between 1 August and 30 November 2014 at IS8 and SR4.

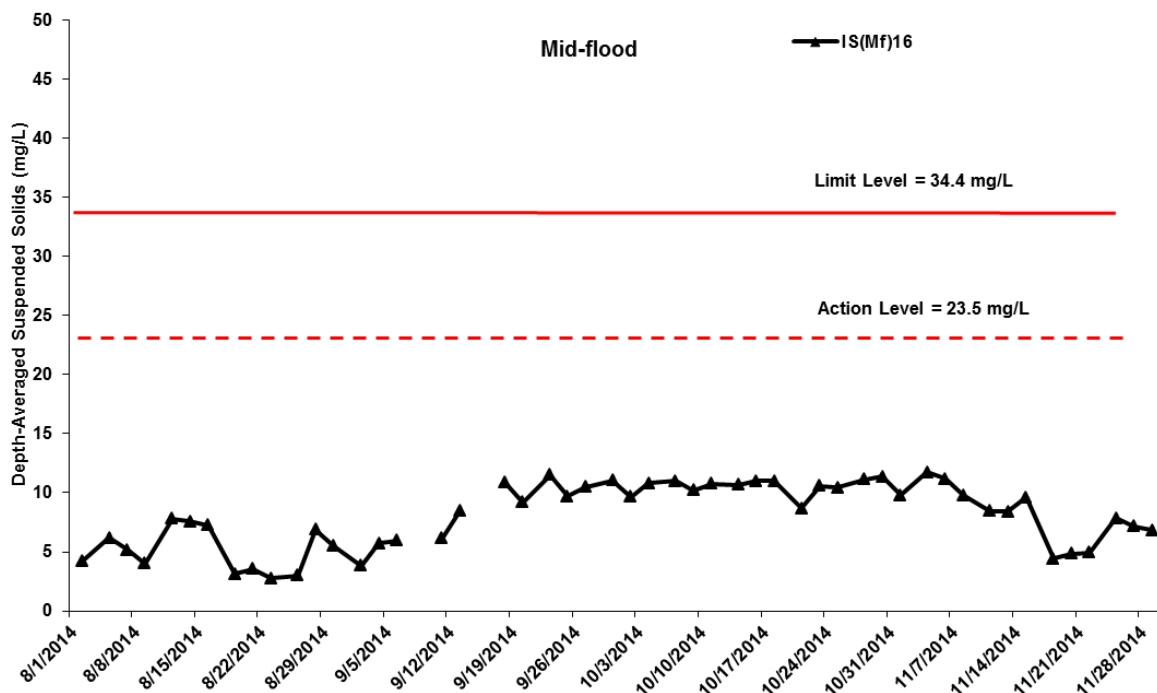
Figure H34 Impact Monitoring - Mean depth-averaged level of Suspended Solids (mg/L) during mid-flood tide between 1 August and 30 November 2014 at IS(Mf)16 and IS(Mf)9.
