**Contract No. HY/2012/08  
Tuen Mun - Chek Lap Kok Link -  
Northern Connection Sub-sea Tunnel  
Section**

*Twenty-seventh Quarterly Environmental  
Monitoring & Audit (EM&A) Report*

05 January 2021

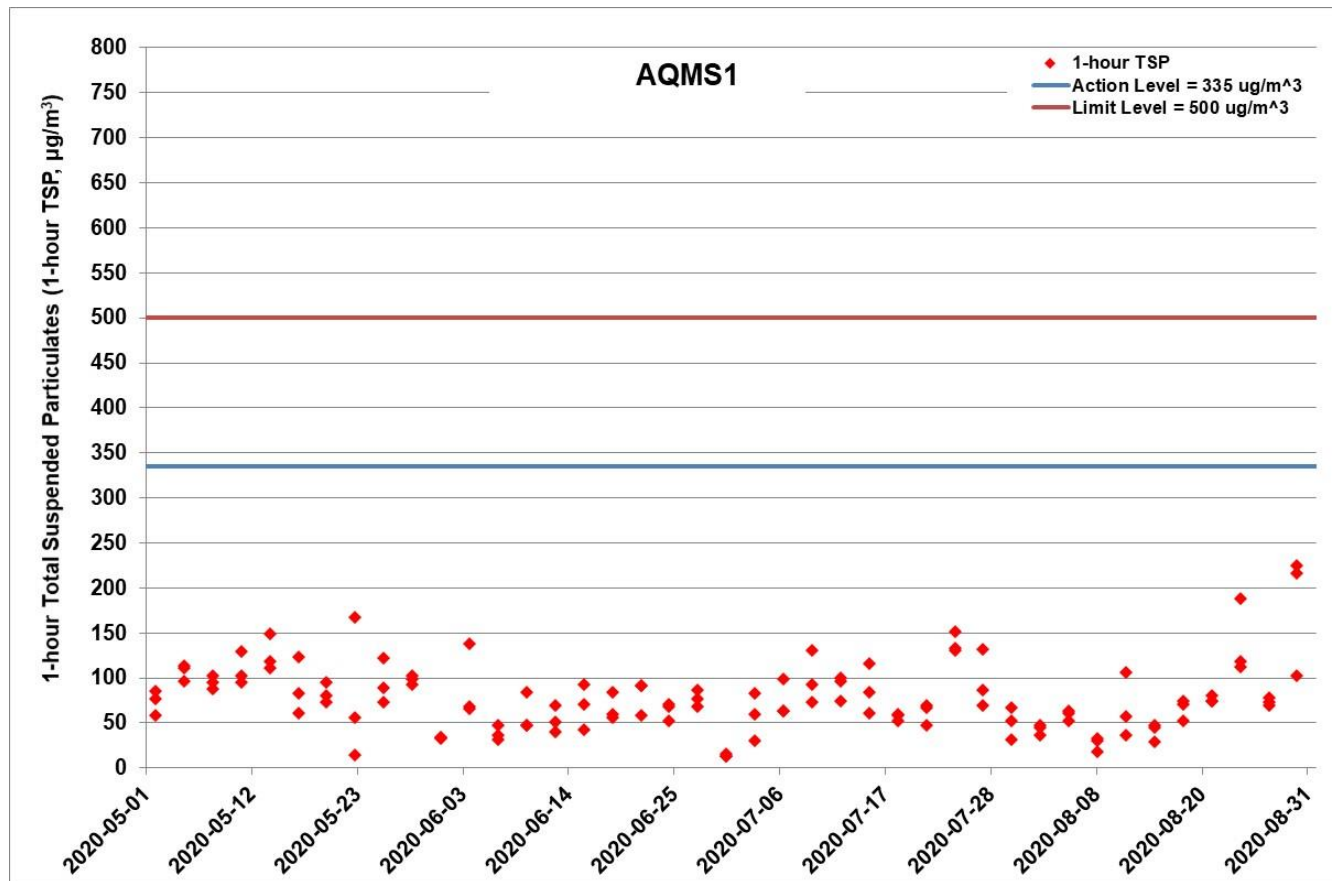
- Figure F.1 Impact Monitoring - 1-hour Total Suspended Particulates ( $\mu\text{g}/\text{m}^3$ ) at AQMS1 between 1 May 2020 and 31 August 2020 during impact monitoring period. The weather conditions during the monitoring period varied from sunny to cloudy. Major land-based construction activities included Road & Drainage works - Portion S-A, S-B & S-C and Northern Landfall; UU installation - Portion S-A, S-B & S-C and Northern Landfall; and Carpark Formation - Portion S-A, S-B & S-C and Northern Landfall and Hard Paving and Footpath - Pump Sump Area at Northern Landfall (1/5/2020 - 31/8/2020)

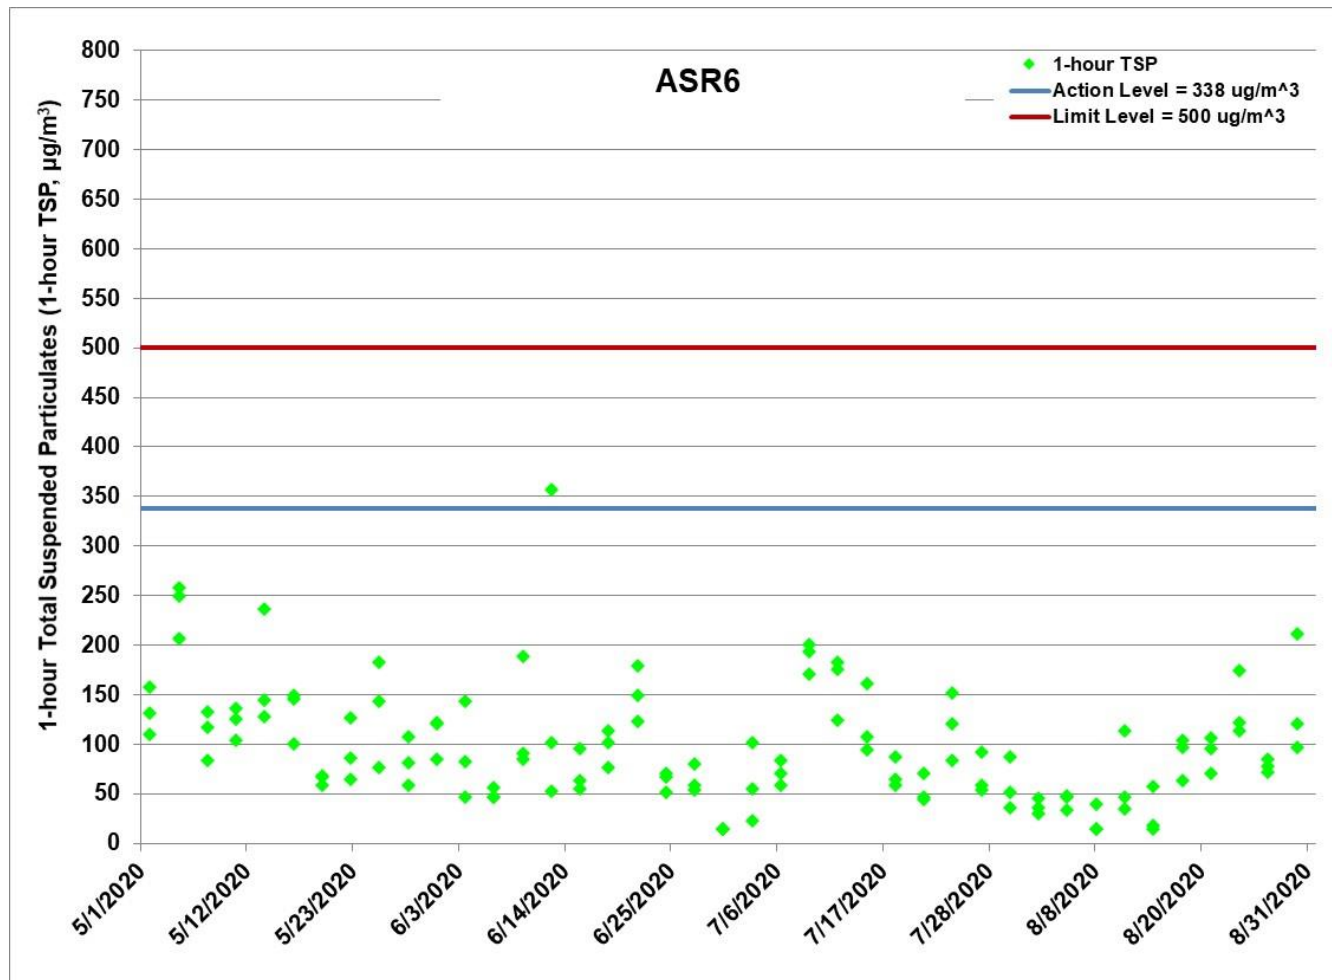
Figure F.2 Impact Monitoring - 1-hour Total Suspended Particulates ( $\mu\text{g}/\text{m}^3$ ) at ASR6 between 1 May 2020 and 31 August 2020 during impact monitoring period. The weather conditions during the monitoring period varied from sunny to cloudy. Major land-based construction activities included Road & Drainage works - Portion S-A, S-B & S-C and Northern Landfall; UU installation - Portion S-A, S-B & S-C and Northern Landfall; and Carpark Formation - Portion S-A, S-B & S-C and Northern Landfall and Hard Paving and Footpath - Pump Sump Area at Northern Landfall (1/5/2020 - 31/8/2020)

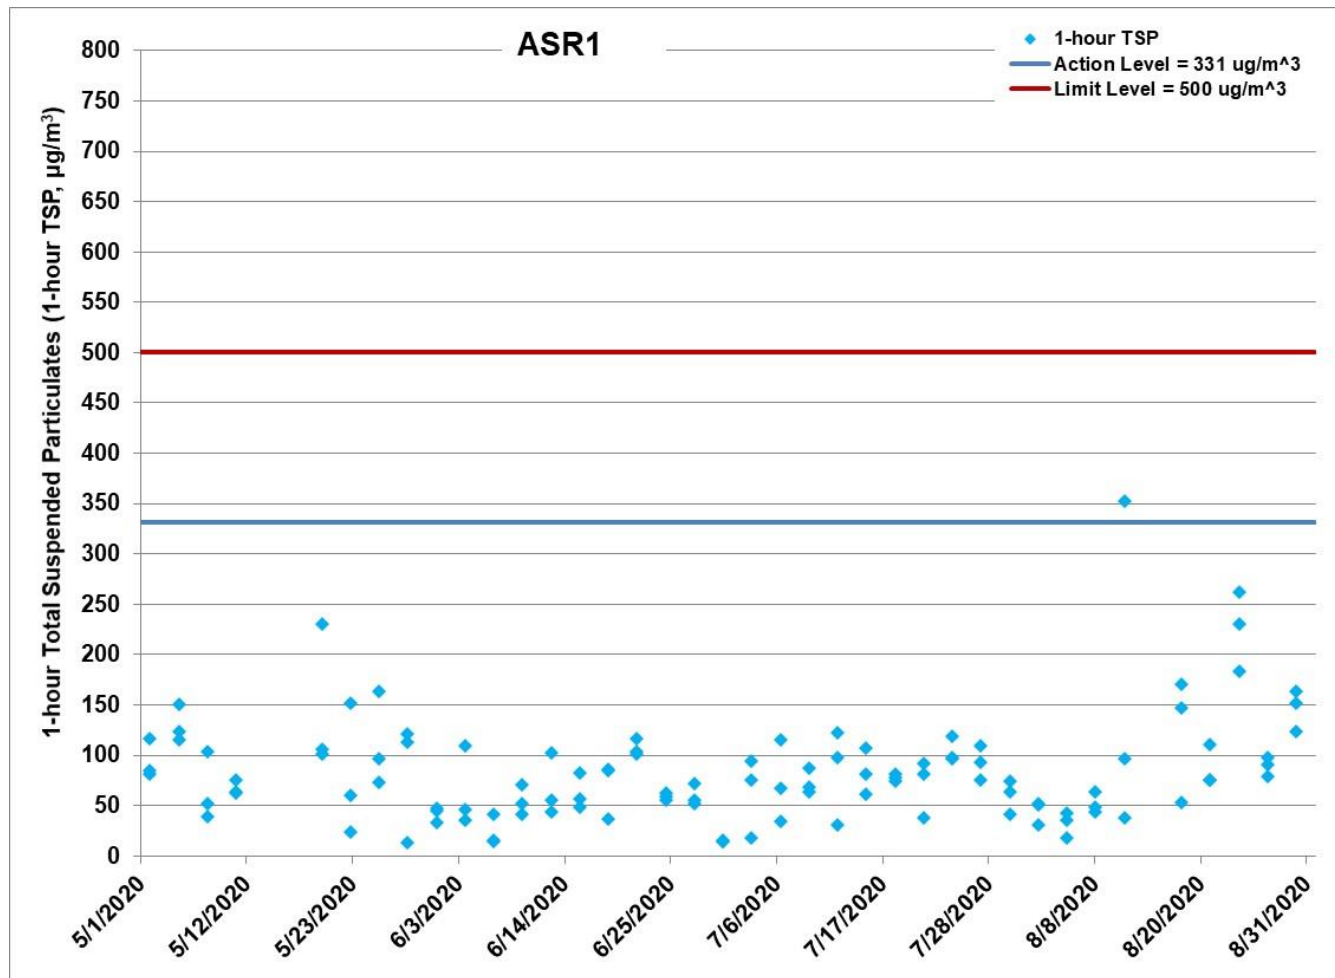
Figure F.3 Impact Monitoring - 1-hour Total Suspended Particulates ( $\mu\text{g}/\text{m}^3$ ) at ASR1 between 1 May 2020 and 31 August 2020 during impact monitoring period. The weather conditions during the monitoring period varied from sunny to cloudy. Major land-based construction activities included Road & Drainage works - Portion S-A, S-B & S-C and Northern Landfall; UU installation - Portion S-A, S-B & S-C and Northern Landfall; and Carpark Formation - Portion S-A, S-B & S-C and Northern Landfall and Hard Paving and Footpath - Pump Sump Area at Northern Landfall (1/5/2020 - 31/8/2020)

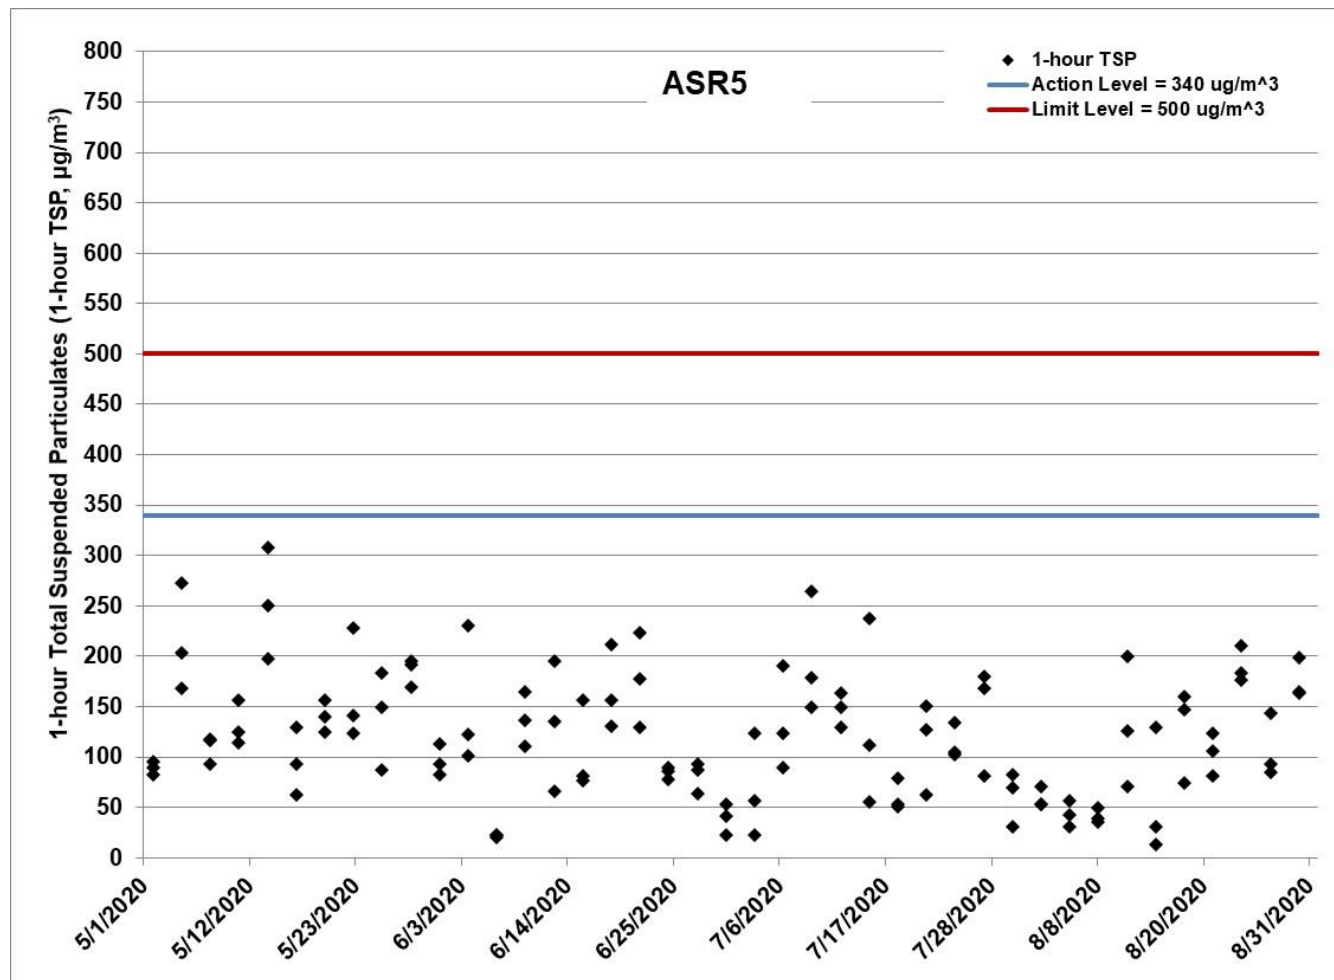
Figure F.4 Impact Monitoring - 1-hour Total Suspended Particulates ( $\mu\text{g}/\text{m}^3$ ) at ASR5 between 1 May 2020 and 31 August 2020 during impact monitoring period. The weather conditions during the monitoring period varied from sunny to cloudy. Major land-based construction activities included Road & Drainage works - Portion S-A, S-B & S-C and Northern Landfall; UU installation - Portion S-A, S-B & S-C and Northern Landfall; and Carpark Formation - Portion S-A, S-B & S-C and Northern Landfall and Hard Paving and Footpath - Pump Sump Area at Northern Landfall (1/5/2020 - 31/8/2020)

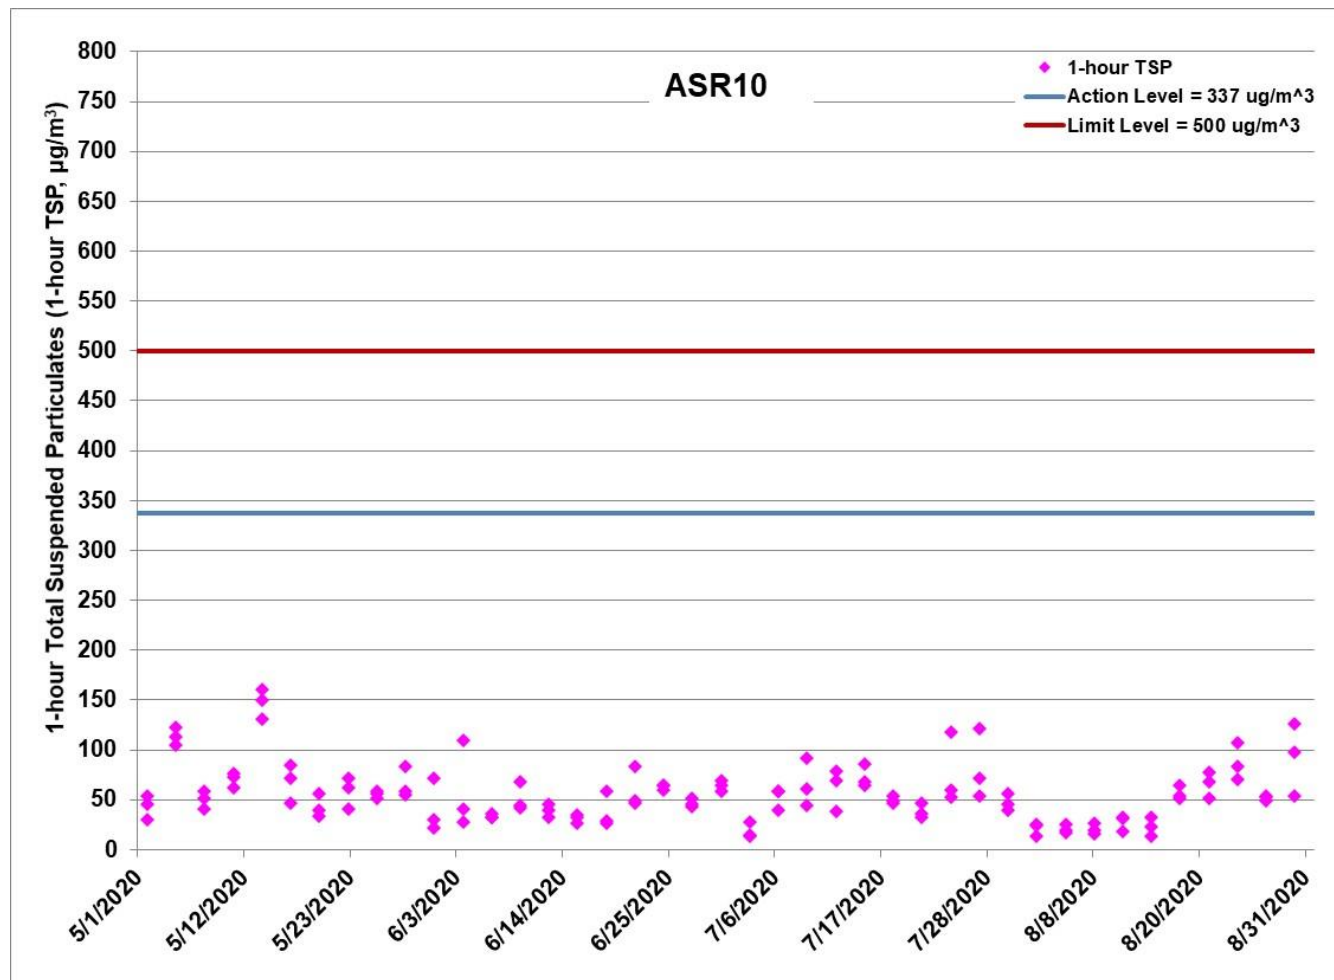
Figure F.5 Impact Monitoring - 1-hour Total Suspended Particulates ( $\mu\text{g}/\text{m}^3$ ) at ASR10 between 1 May 2020 and 31 August 2020 during impact monitoring period. The weather conditions during the monitoring period varied from sunny to cloudy. Major land-based construction activities included Road & Drainage works - Portion S-A, S-B & S-C and Northern Landfall; UU installation - Portion S-A, S-B & S-C and Northern Landfall; and Carpark Formation - Portion S-A, S-B & S-C and Northern Landfall and Hard Paving and Footpath - Pump Sump Area at Northern Landfall (1/5/2020 - 31/8/2020)

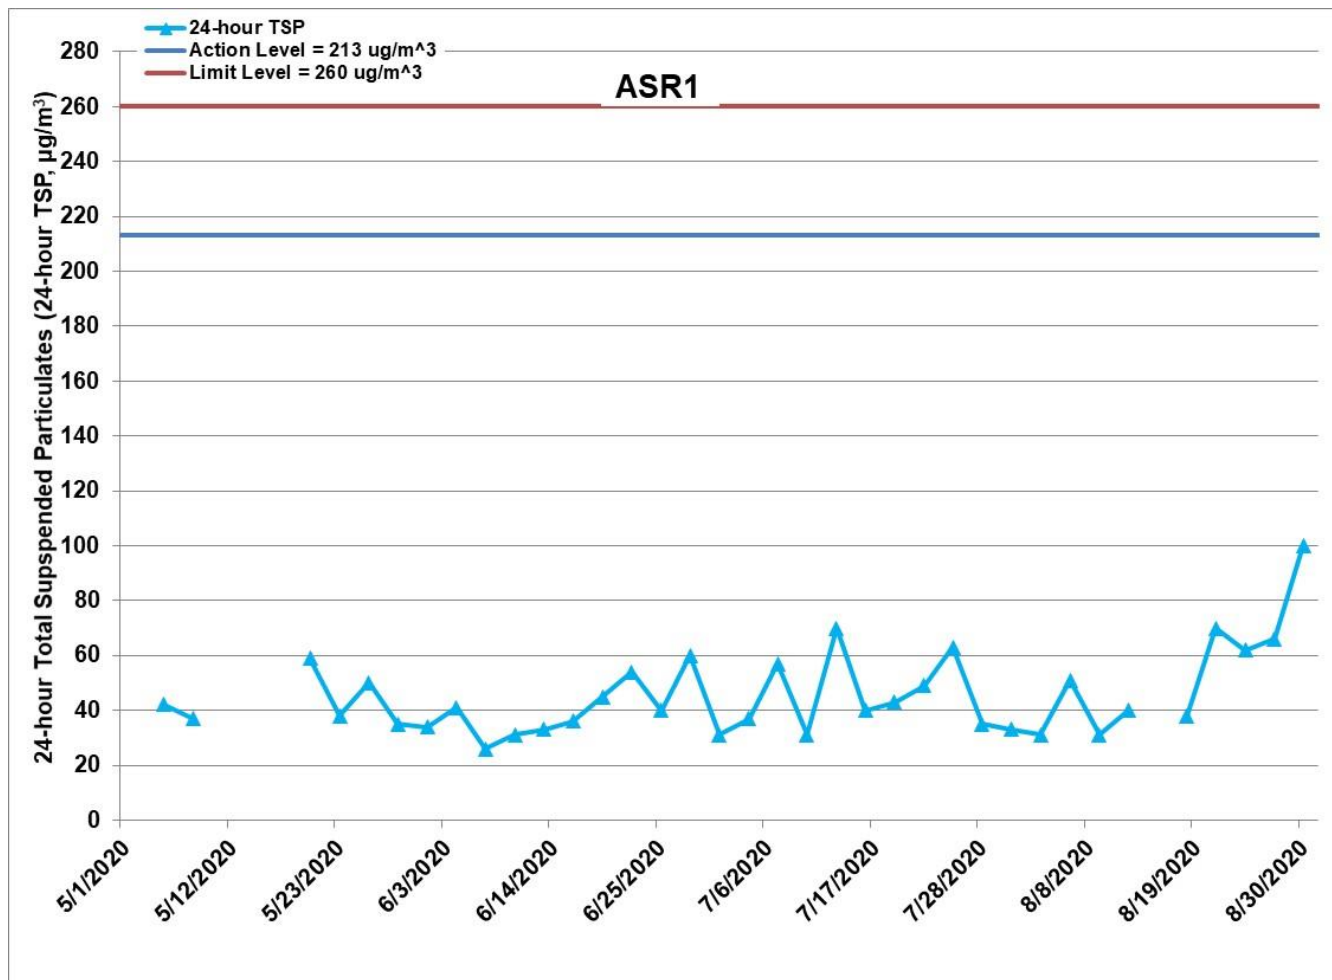
Figure F.6 Impact Monitoring - 24-hour Total Suspended Particulates ( $\mu\text{g}/\text{m}^3$ ) at ASR1 between 1 May 2020 and 31 August 2020 during impact monitoring period. The weather conditions during the monitoring period varied from sunny to cloudy. Major land-based construction activities included Road & Drainage works - Portion S-A, S-B & S-C and Northern Landfall; UU installation - Portion S-A, S-B & S-C and Northern Landfall; and Carpark Formation - Portion S-A, S-B & S-C and Northern Landfall and Hard Paving and Footpath - Pump Sump Area at Northern Landfall (1/5/2020 - 31/8/2020)

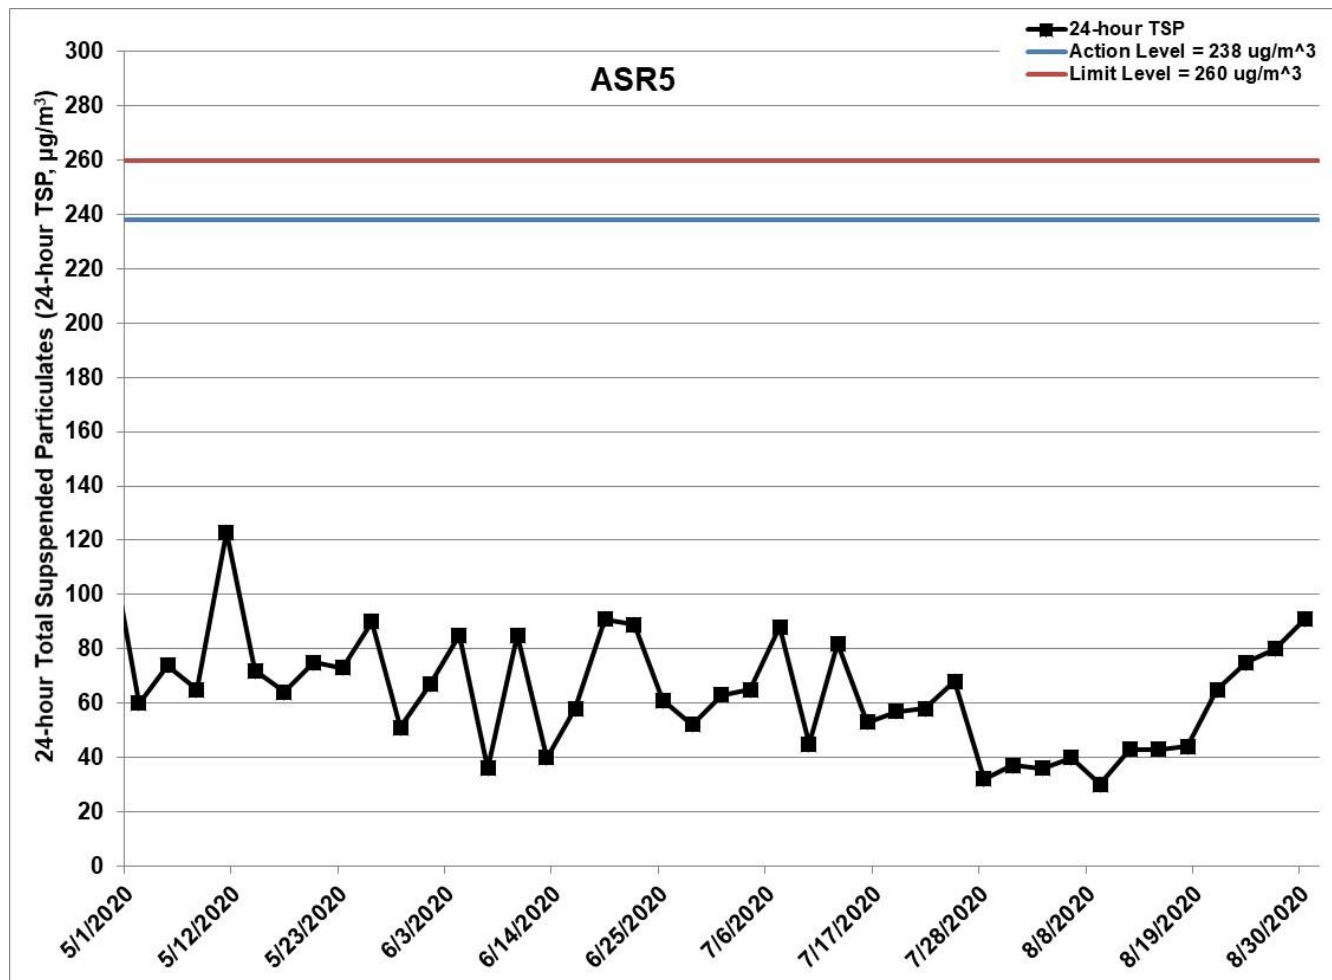
Figure F.7 Impact Monitoring - 24-hour Total Suspended Particulates ( $\mu\text{g}/\text{m}^3$ ) at ASR5 between 1 May 2020 and 31 August 2020 during impact monitoring period. The weather conditions during the monitoring period varied from sunny to cloudy. Major land-based construction activities included Road & Drainage works - Portion S-A, S-B & S-C and Northern Landfall; UU installation - Portion S-A, S-B & S-C and Northern Landfall; and Carpark Formation - Portion S-A, S-B & S-C and Northern Landfall and Hard Paving and Footpath - Pump Sump Area at Northern Landfall (1/5/2020 - 31/8/2020)

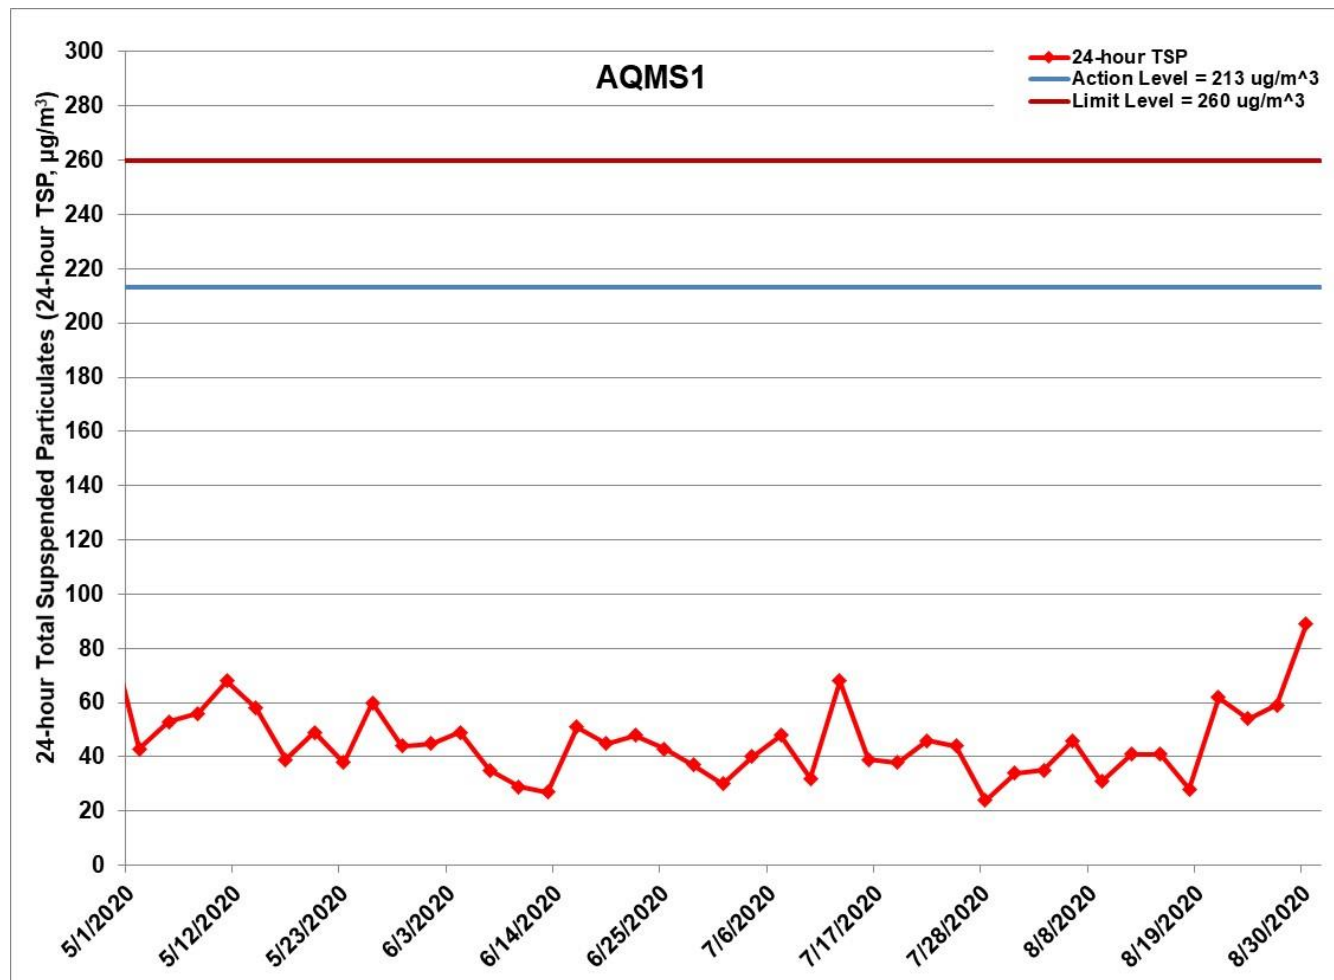
Figure F.8 Impact Monitoring - 24-hour Total Suspended Particulates ( $\mu\text{g}/\text{m}^3$ ) at AQMS1 between 1 May 2020 and 31 August 2020 during impact monitoring period. The weather conditions during the monitoring period varied from sunny to cloudy. Major land-based construction activities included Road & Drainage works - Portion S-A, S-B & S-C and Northern Landfall; UU installation - Portion S-A, S-B & S-C and Northern Landfall; and Carpark Formation - Portion S-A, S-B & S-C and Northern Landfall and Hard Paving and Footpath - Pump Sump Area at Northern Landfall (1/5/2020 - 31/8/2020)

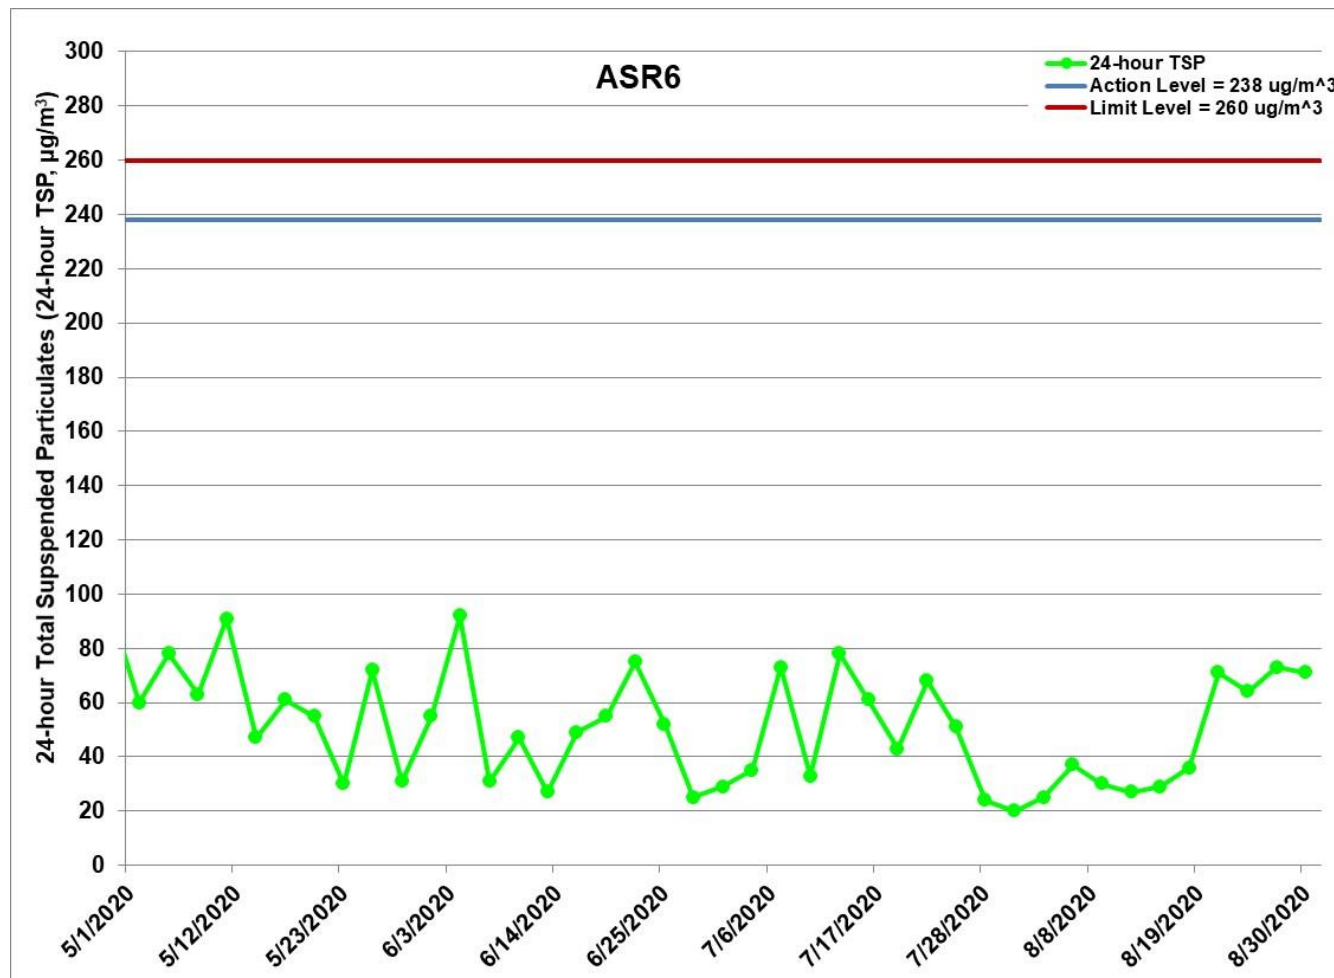
Figure F.9 Impact Monitoring - 24-hour Total Suspended Particulates ( $\mu\text{g}/\text{m}^3$ ) at ASR6 between 1 May 2020 and 31 August 2020 during impact monitoring period. The weather conditions during the monitoring period varied from sunny to cloudy. Major land-based construction activities included Road & Drainage works - Portion S-A, S-B & S-C and Northern Landfall; UU installation - Portion S-A, S-B & S-C and Northern Landfall; and Carpark Formation - Portion S-A, S-B & S-C and Northern Landfall and Hard Paving and Footpath - Pump Sump Area at Northern Landfall (1/5/2020 - 31/8/2020)

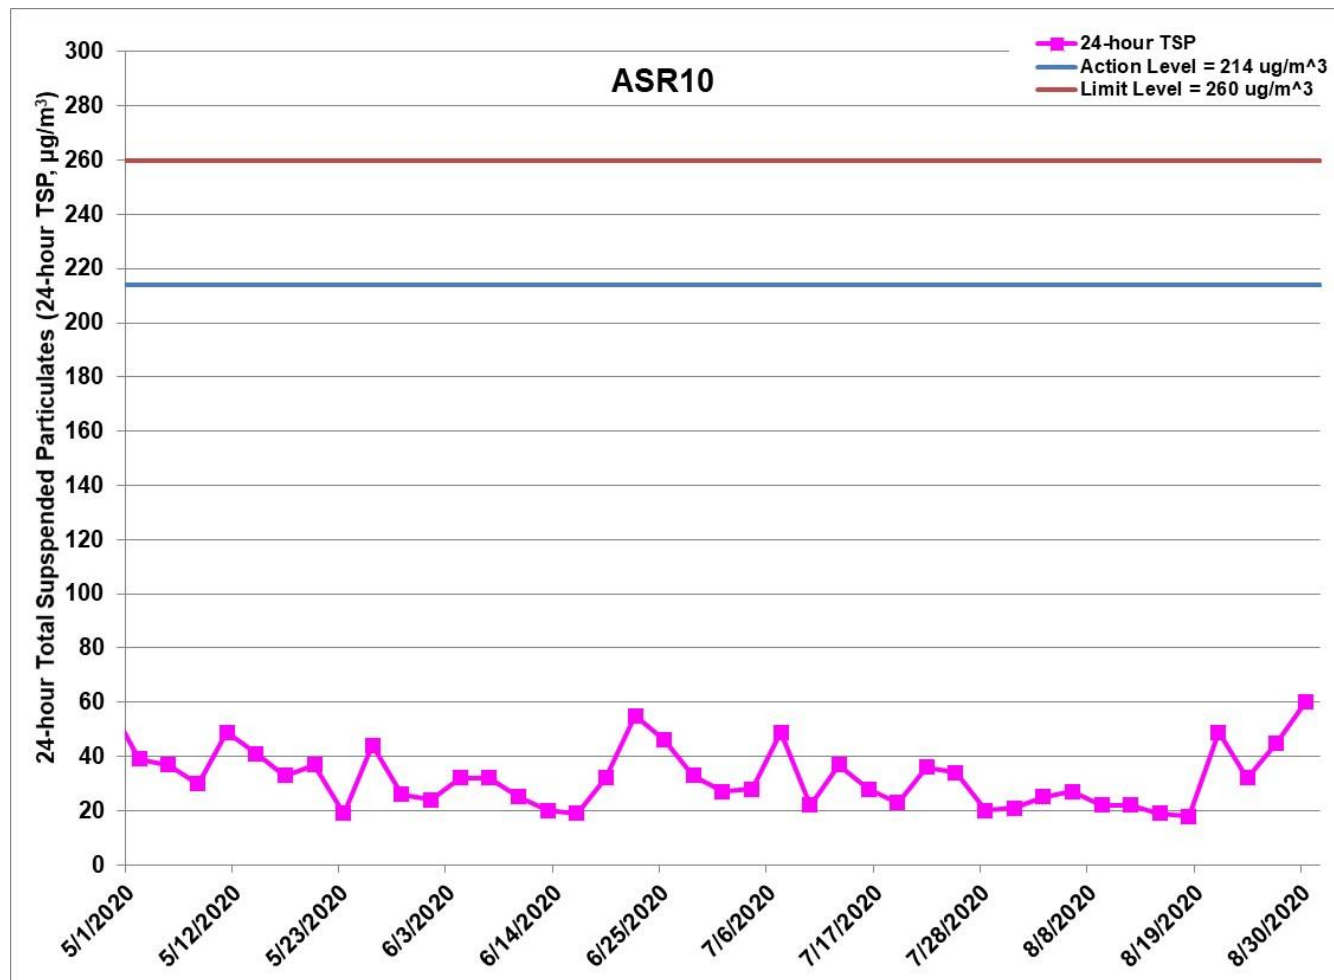
Figure F.10 Impact Monitoring – 24-hour Total Suspended Particulates ( $\mu\text{g}/\text{m}^3$ ) at ASR10 between 1 May 2020 and 31 August 2020 during impact monitoring period. The weather conditions during the monitoring period varied from sunny to cloudy. Major land-based construction activities included Road & Drainage works – Portion S-A, S-B & S-C and Northern Landfall; UU installation – Portion S-A, S-B & S-C and Northern Landfall; and Carpark Formation – Portion S-A, S-B & S-C and Northern Landfall and Hard Paving and Footpath – Pump Sump Area at Northern Landfall (1/5/2020 – 31/8/2020)

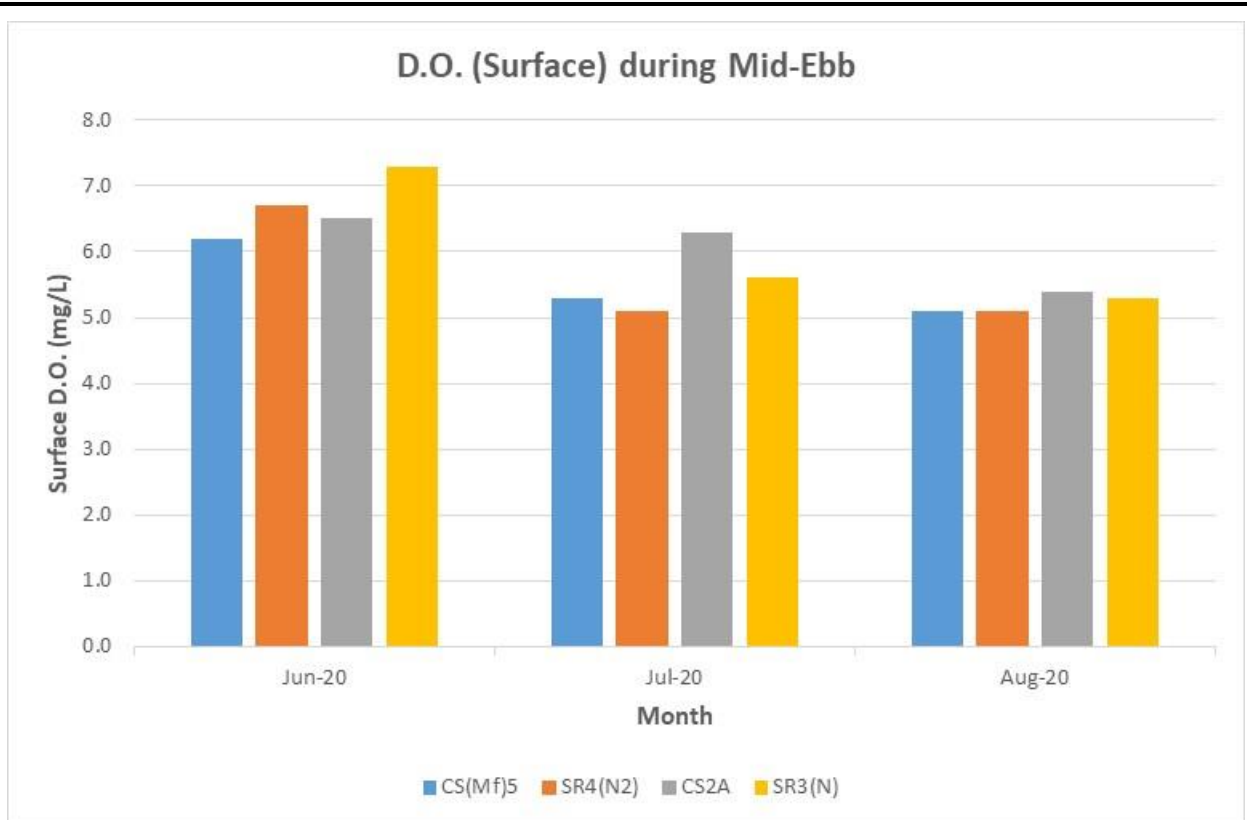
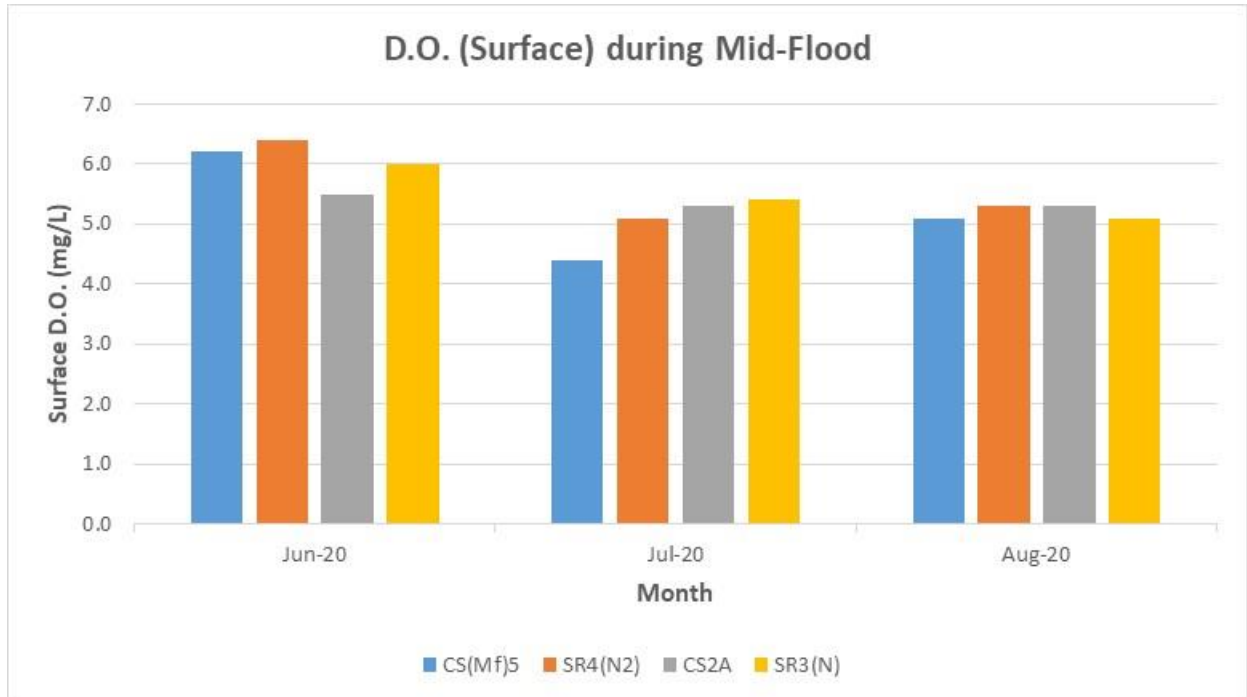
**Figure G1 Operational Phase Monitoring - Mean Level of Dissolved Oxygen (mg/L) in surface waters between 1 June 2020 and 31 August 2020. The weather conditions during the monitoring period varied mostly from sunny to cloudy.**

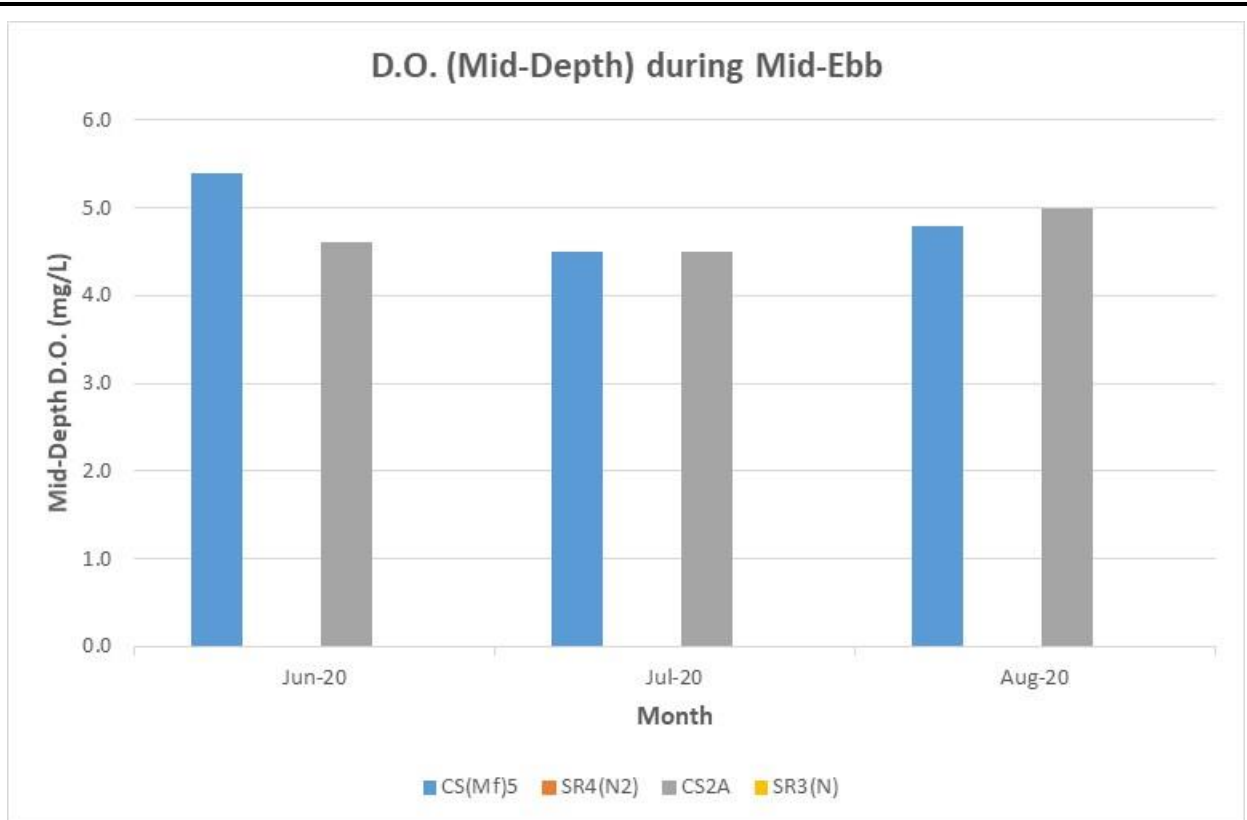
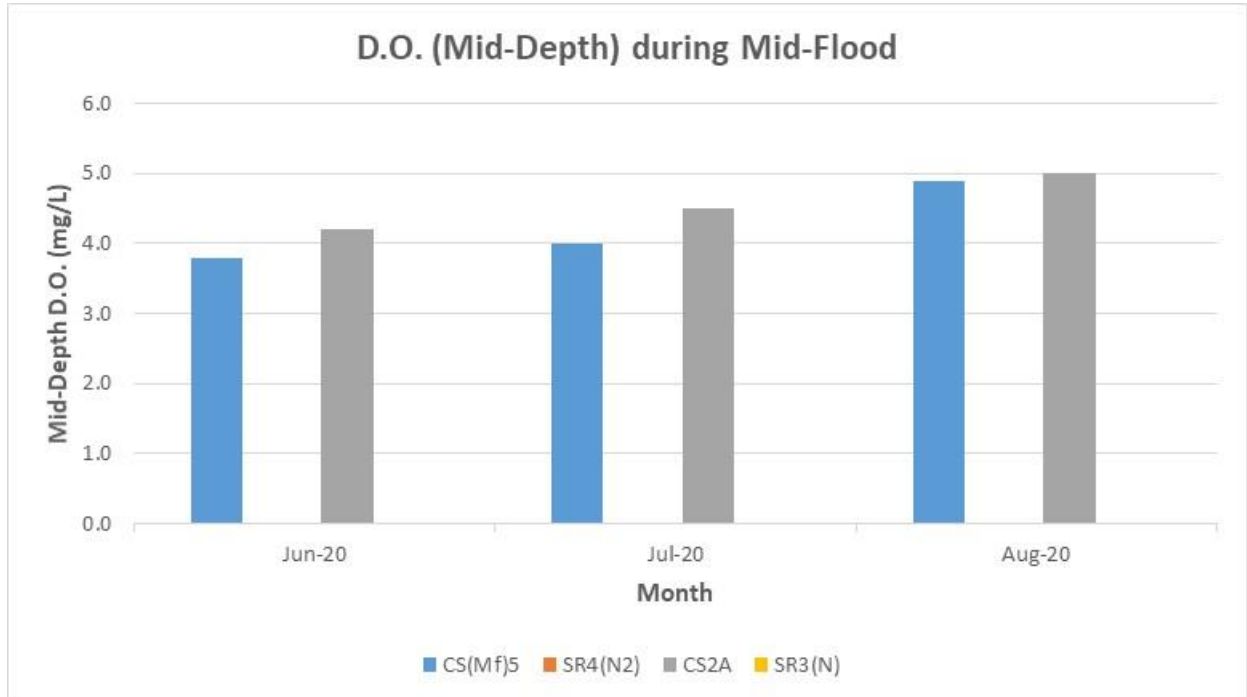
**Figure G2 Operational Phase Monitoring - Mean Level of Dissolved Oxygen (mg/L) in mid-depth waters between 1 June 2020 and 31 August 2020. The weather conditions during the monitoring period varied mostly from sunny to cloudy.**

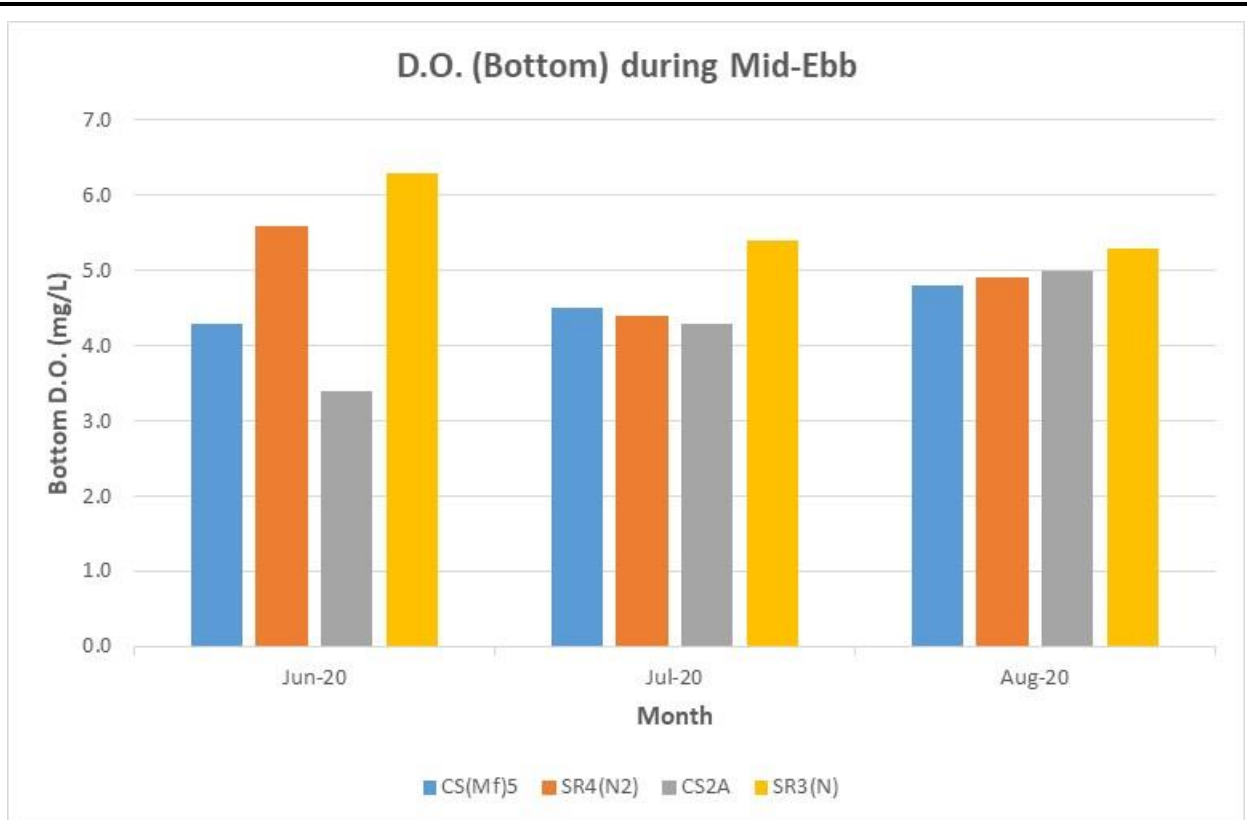
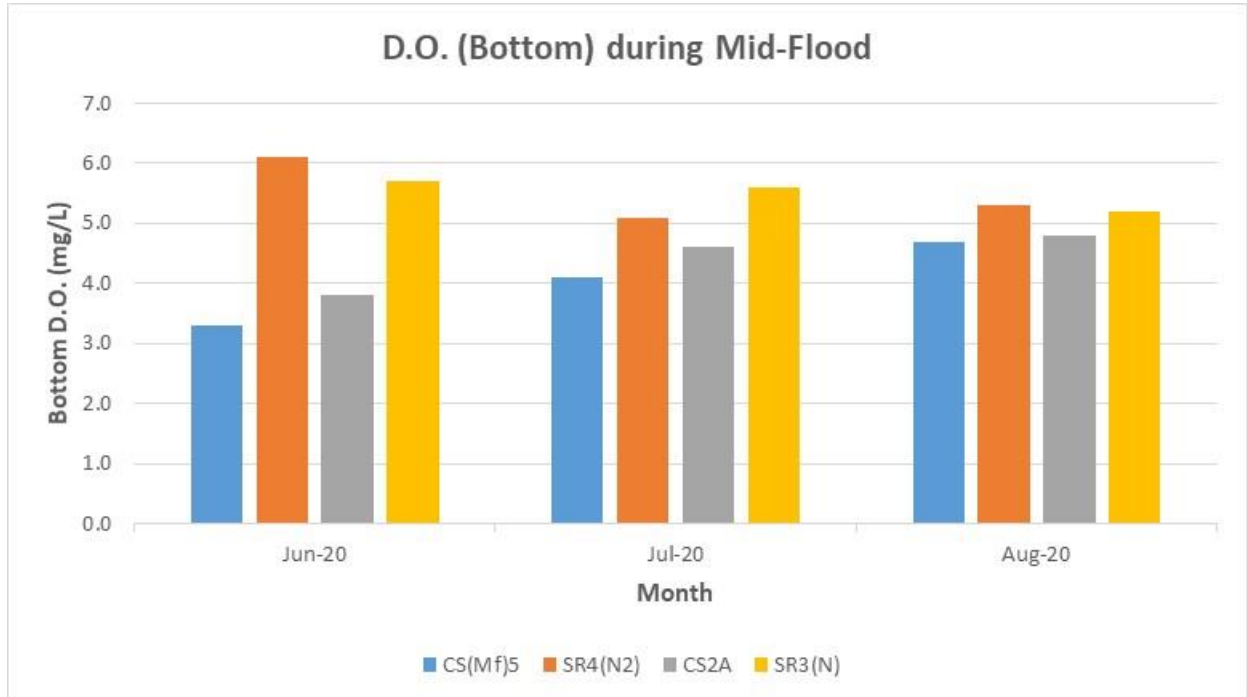
**Figure G3 Operational Phase Monitoring - Mean Level of Dissolved Oxygen (mg/L) in bottom waters between 1 June 2020 and 31 August 2020. The weather conditions during the monitoring period varied mostly from sunny to cloudy.**

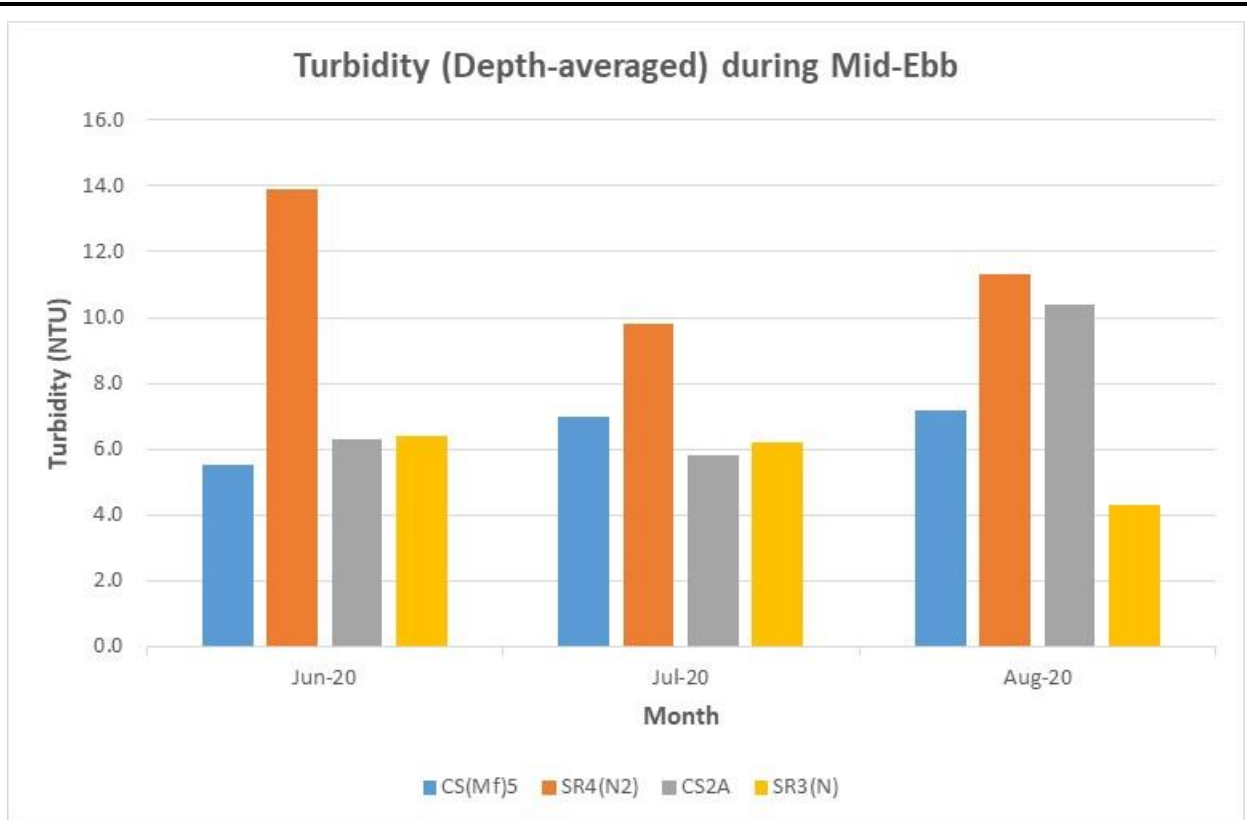
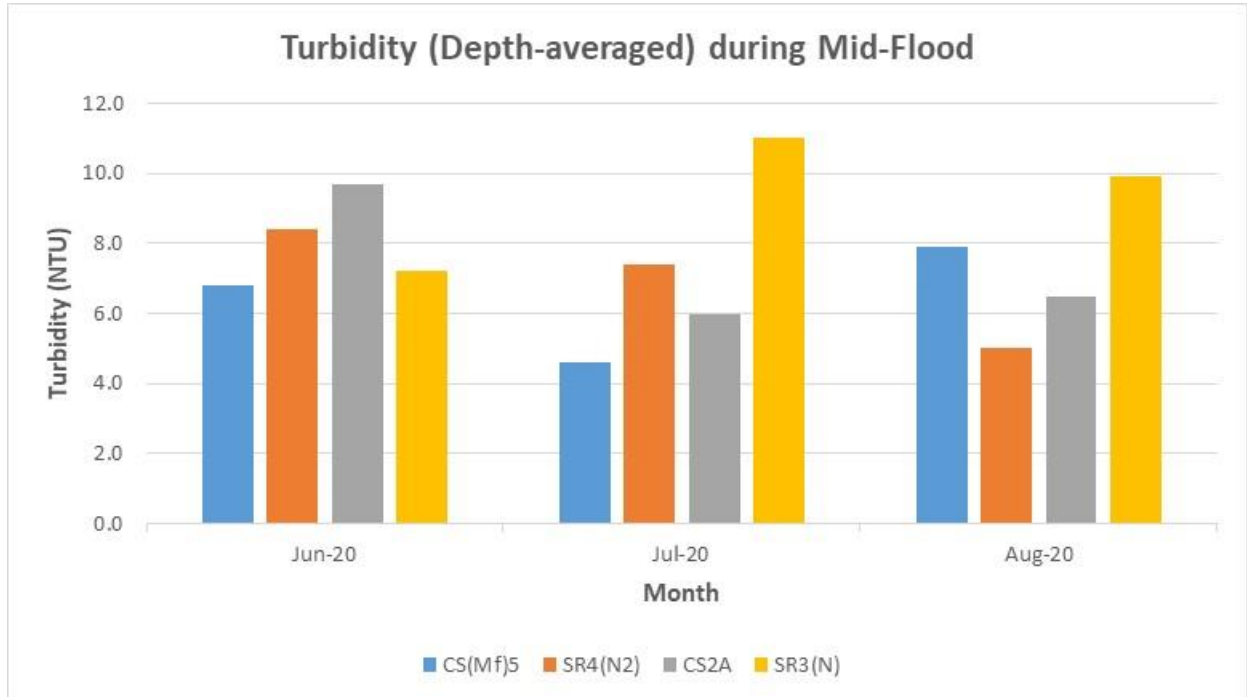
**Figure G4 Operational Phase Monitoring - Mean Depth-averaged Level of Turbidity (NTU) between 1 June 2020 and 31 August 2020. The weather conditions during the monitoring period varied mostly from sunny to cloudy.**
