**Contract No. HY/2012/08  
Tuen Mun - Chek Lap Kok Link -  
Northern Connection Sub-sea Tunnel  
Section**

*Twenty-seventh Quarterly Environmental  
Monitoring & Audit (EM&A) Report*

05 January 2021

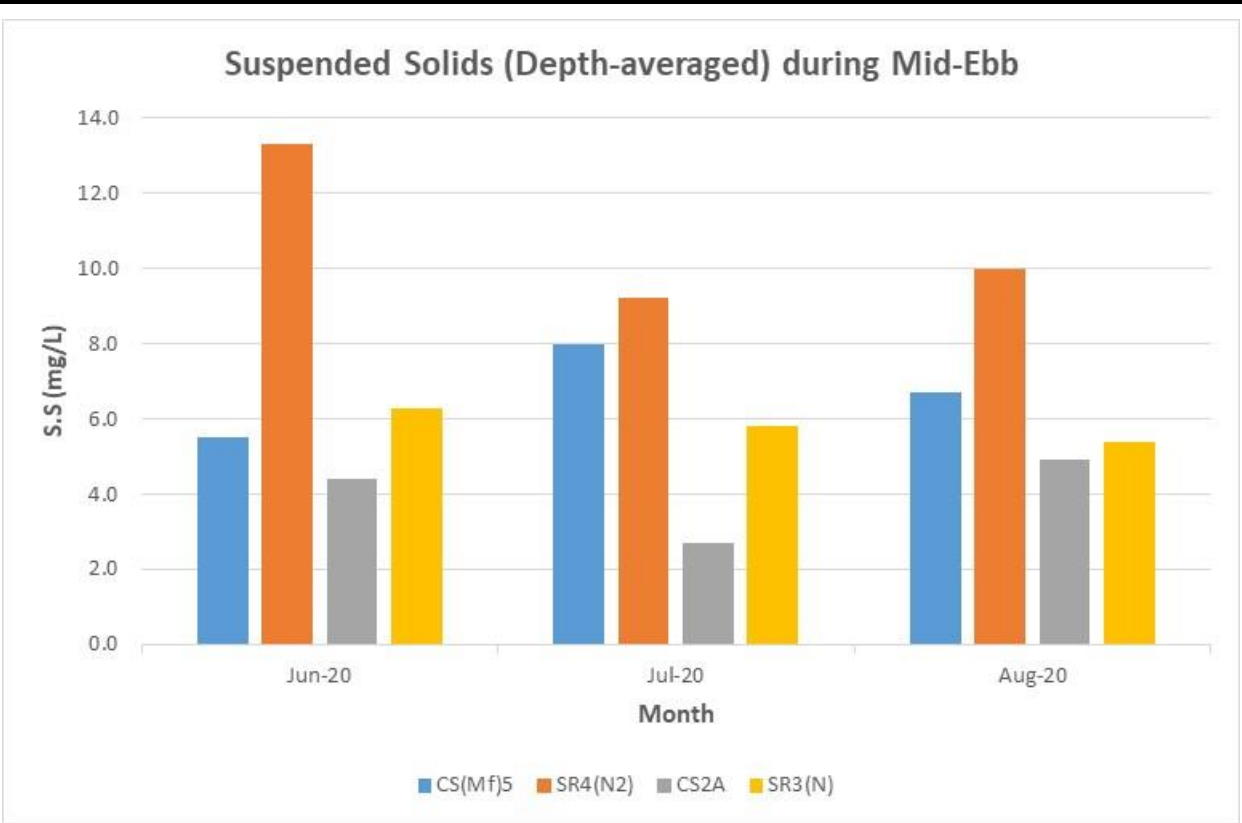
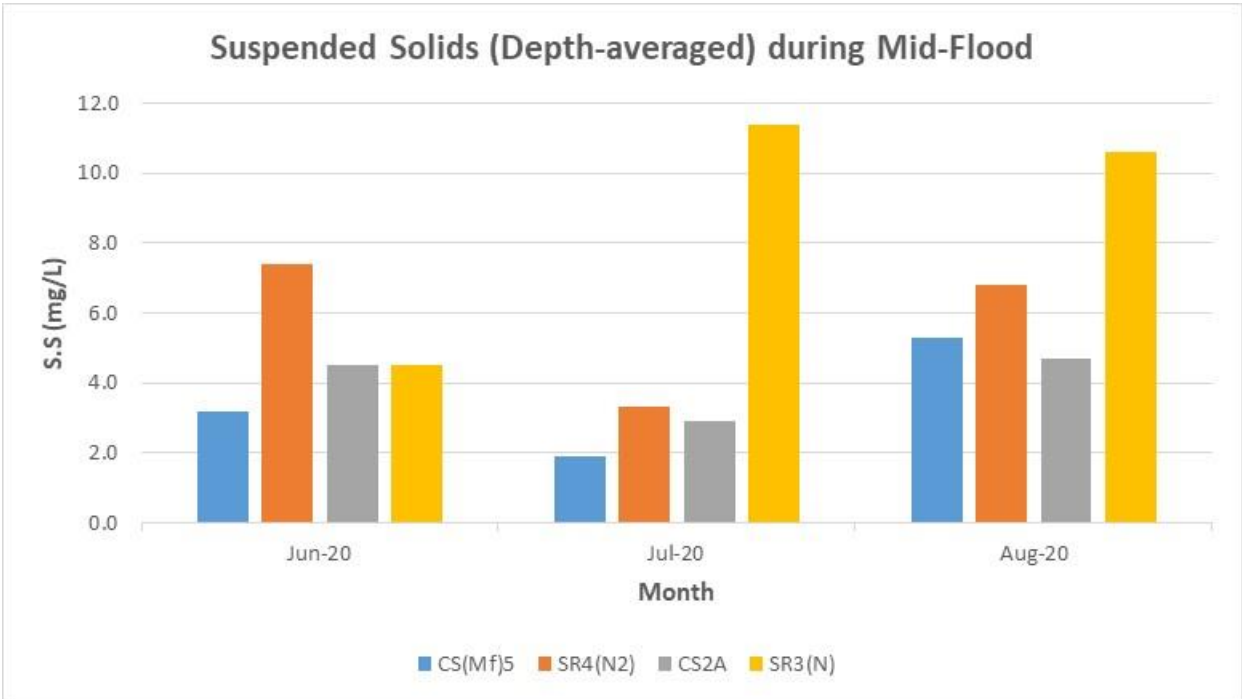
**Figure G5 Operational Phase Monitoring - Mean Depth-averaged Level of Suspended Solids (mg/L) between 1 June 2020 and 31 August 2020. The weather conditions during the monitoring period varied mostly from sunny to cloudy.**

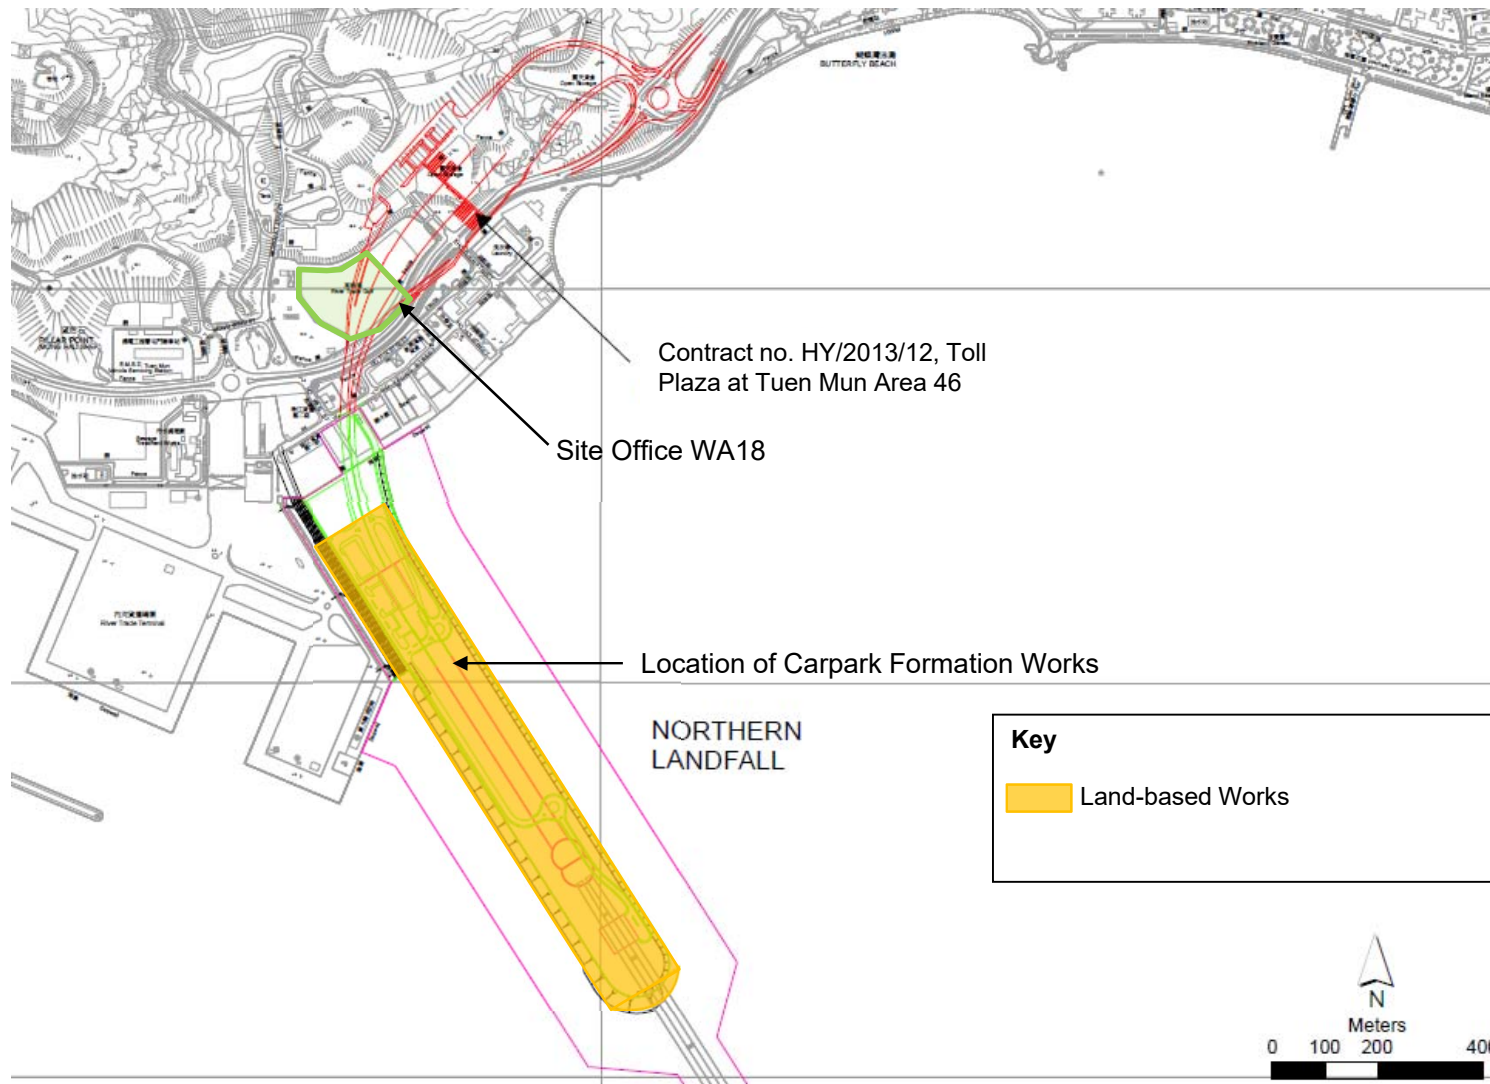
Figure 2

HY/2012/08 TM-CLKL Northern Connection Sub-sea Tunnel Section  
 Work Location

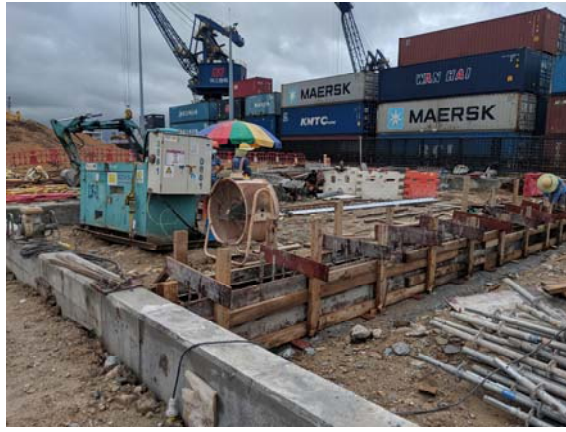
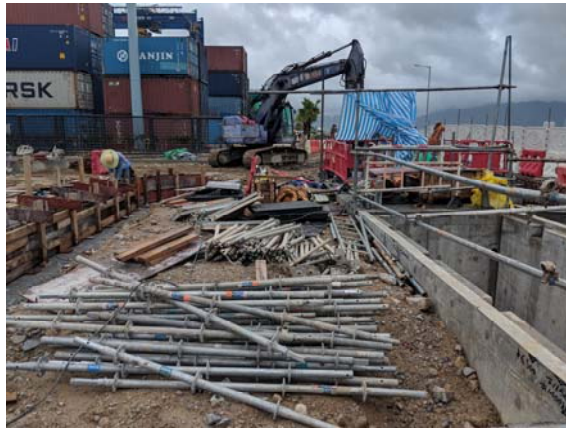
Photo 1&2 - Pump Sump Area
