**Contract No. HY/2012/08
Tuen Mun – Chek Lap Kok Link –
Northern Connection Sub-sea Tunnel
Section**

*Second Quarterly Environmental Monitoring &
Audit (EM&A) Report*

05 August 2014

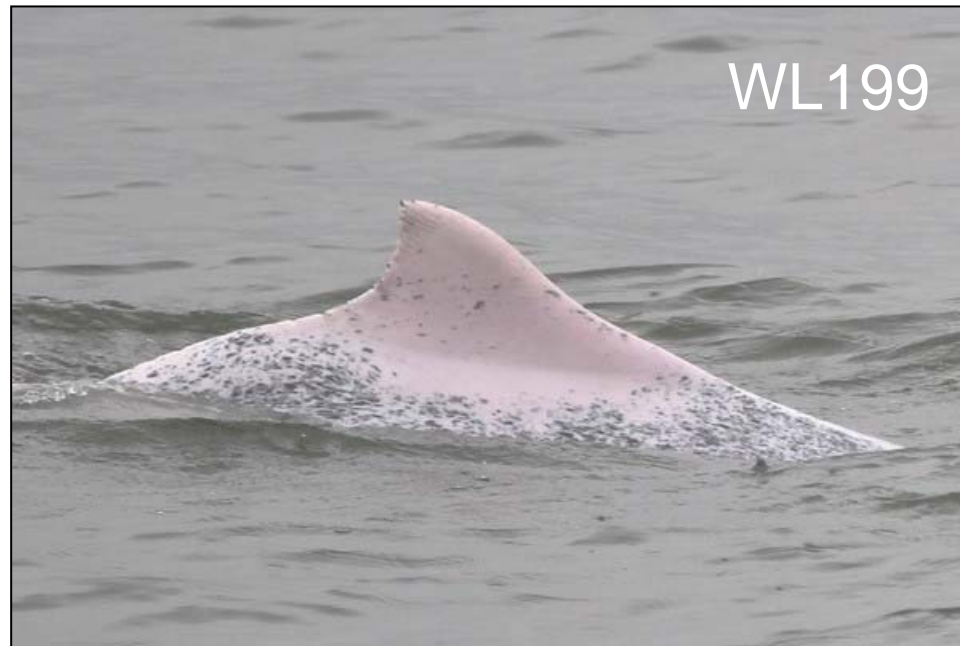
Appendix V. Ranging patterns (95% kernel ranges) of 45 individual dolphins that were sighted during HKLR03 impact phase monitoring period (note: yellow dots indicates sightings made in March-May 2014)
