Monthly Environmental Monitoring & Audit Report

(June 2014)

Contract No. : CV/2012/01

Project : Sediment Removal at Yim Tin Tsai (East)
Fish Culture Zone

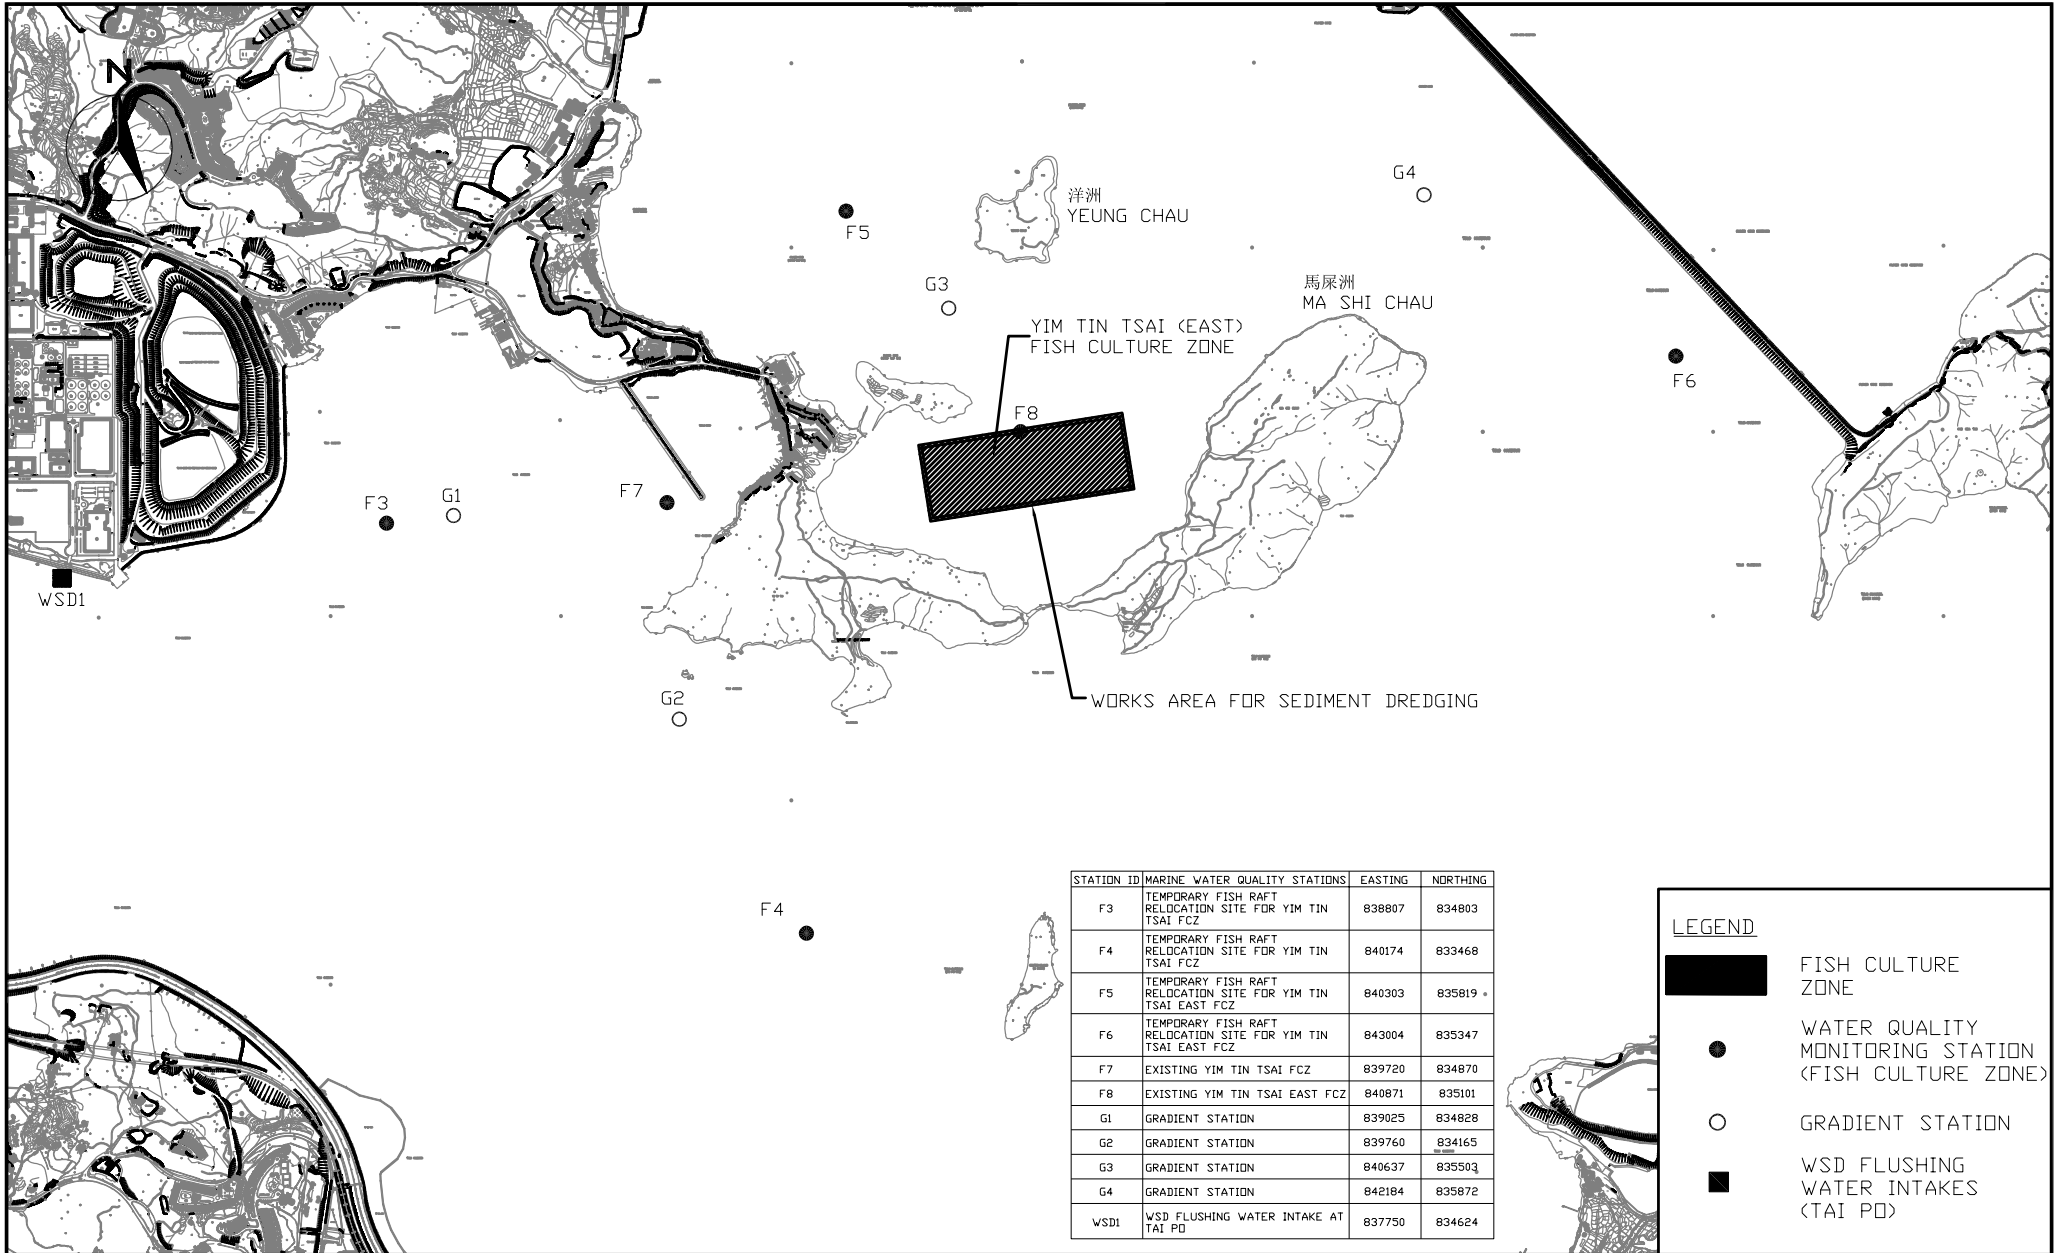
STATION ID	MARINE WATER QUALITY STATIONS	EASTING	NORTHING
F3	TEMPORARY FISH RAFT RELOCATION SITE FOR YIM TIN TSAI FCZ	838807	834803
F4	TEMPORARY FISH RAFT RELOCATION SITE FOR YIM TIN TSAI FCZ	840174	833468
F5	TEMPORARY FISH RAFT RELOCATION SITE FOR YIM TIN TSAI EAST FCZ	840303	835819
F6	TEMPORARY FISH RAFT RELOCATION SITE FOR YIM TIN TSAI EAST FCZ	843004	835347
F7	EXISTING YIM TIN TSAI FCZ	839720	834870
F8	EXISTING YIM TIN TSAI EAST FCZ	840871	835101
G1	GRADIENT STATION	839025	834828
G2	GRADIENT STATION	839760	834165
G3	GRADIENT STATION	840637	835503
G4	GRADIENT STATION	842184	835872
WSD1	WSD FLUSHING WATER INTAKE AT TAI PD	837750	834624

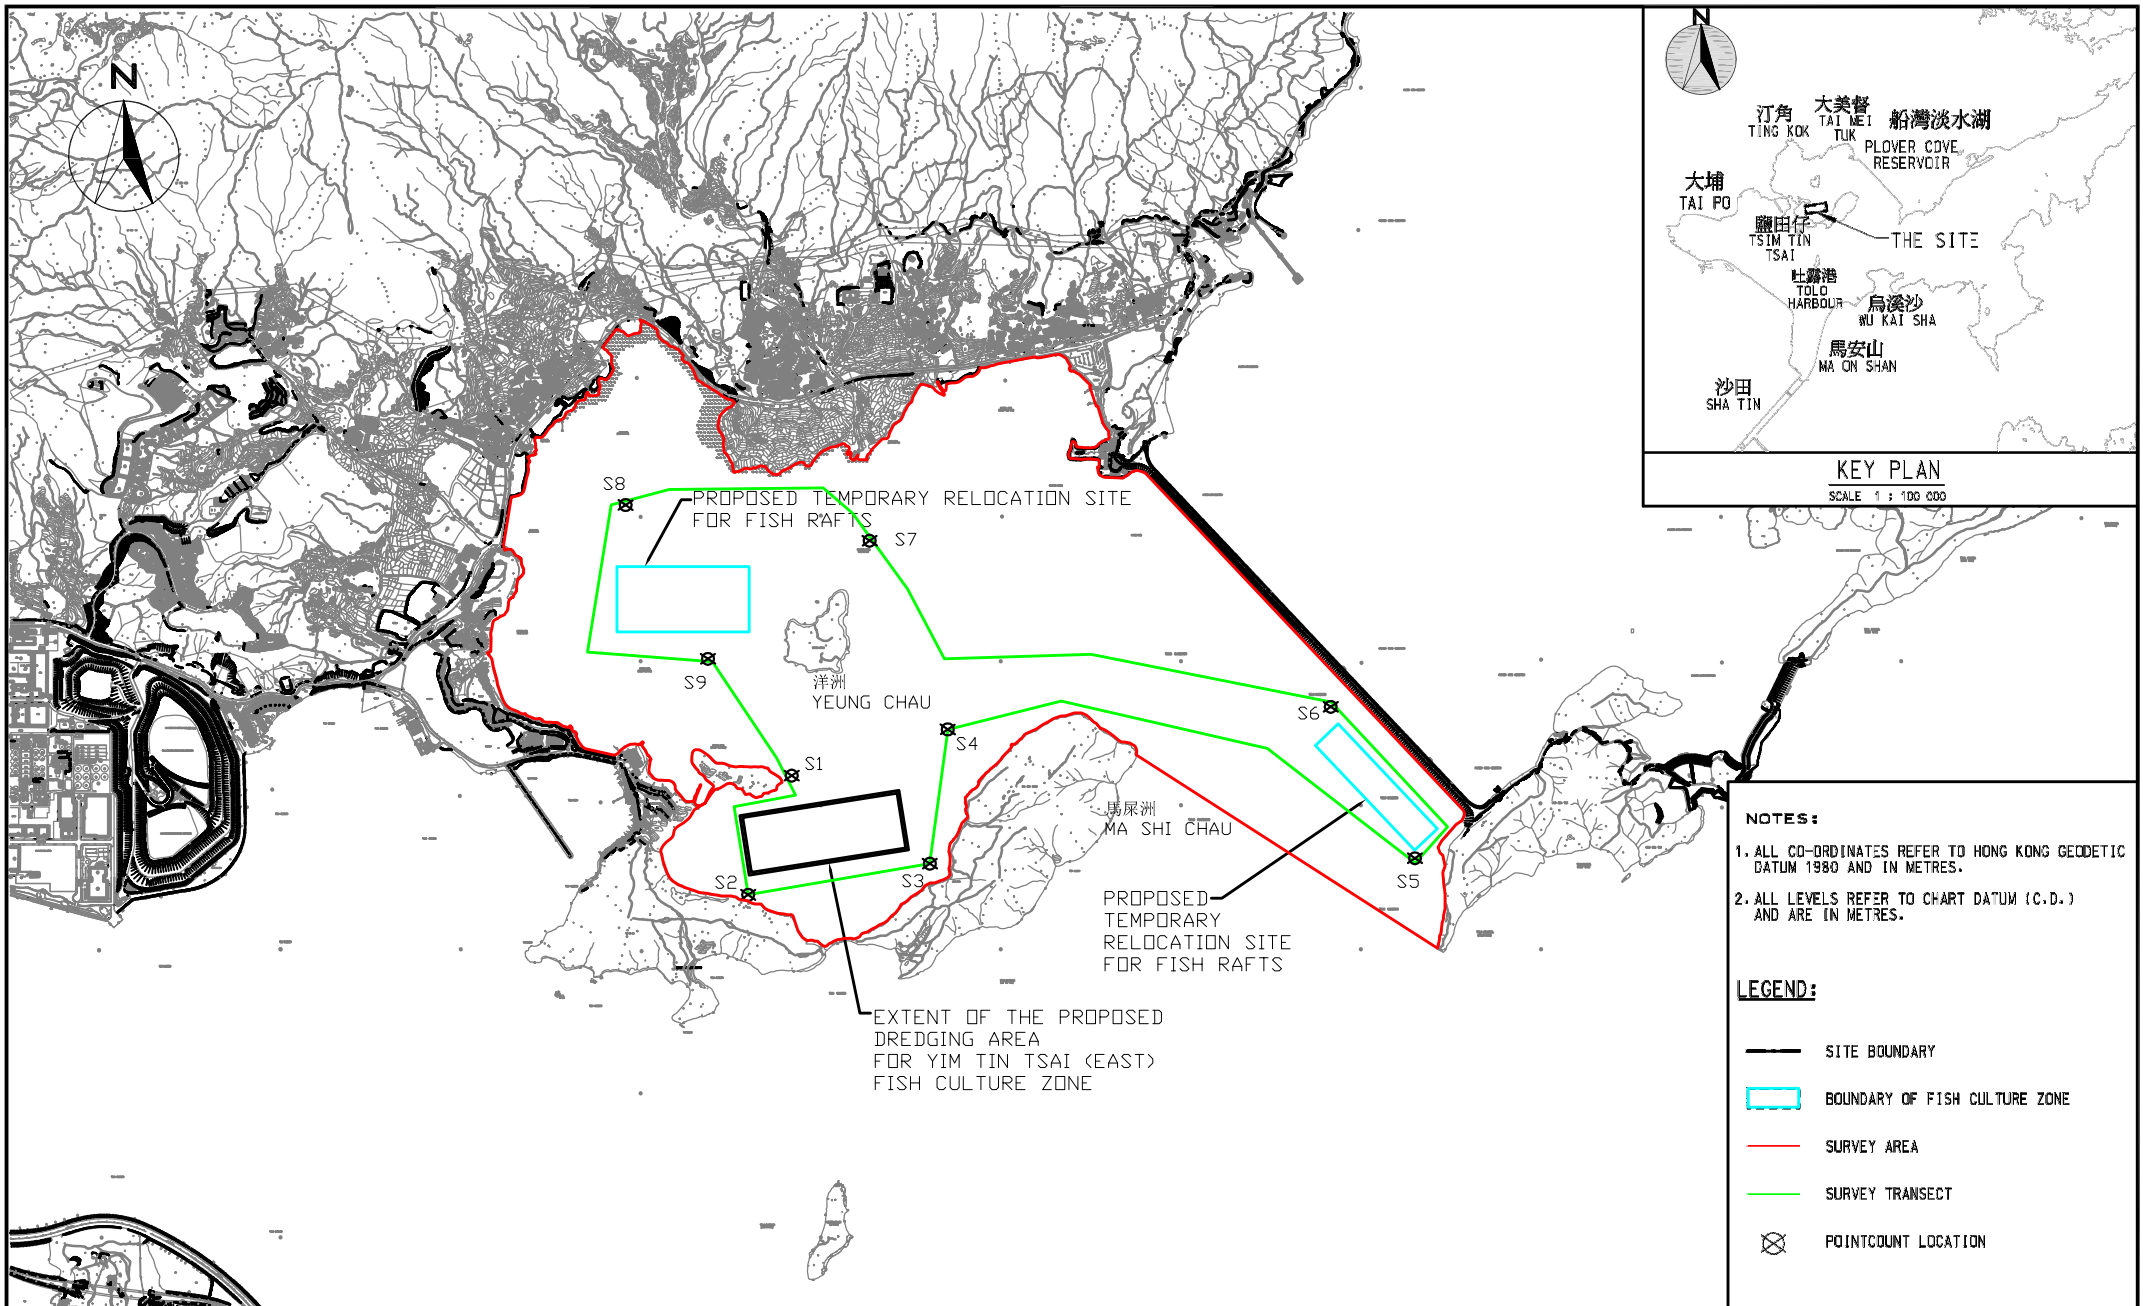
SCALE	1:800 @ A4	DATE	DEC 2013	
CHECK	IT	DRAWN	JW	
JOB No.	MA13027	FIGURE NO.	4	REV —

- 4.3 Transect route with some vantage points is shown in **Figure 4**. There are a total of 9 point count locations. The counting vantage points are selected with at least 500m distance with each other to avoid double-counting. The main focus areas of survey are the location of existing fish rafts before and after dredging works and Yeung Chau, where ardeids were observed in the past records.

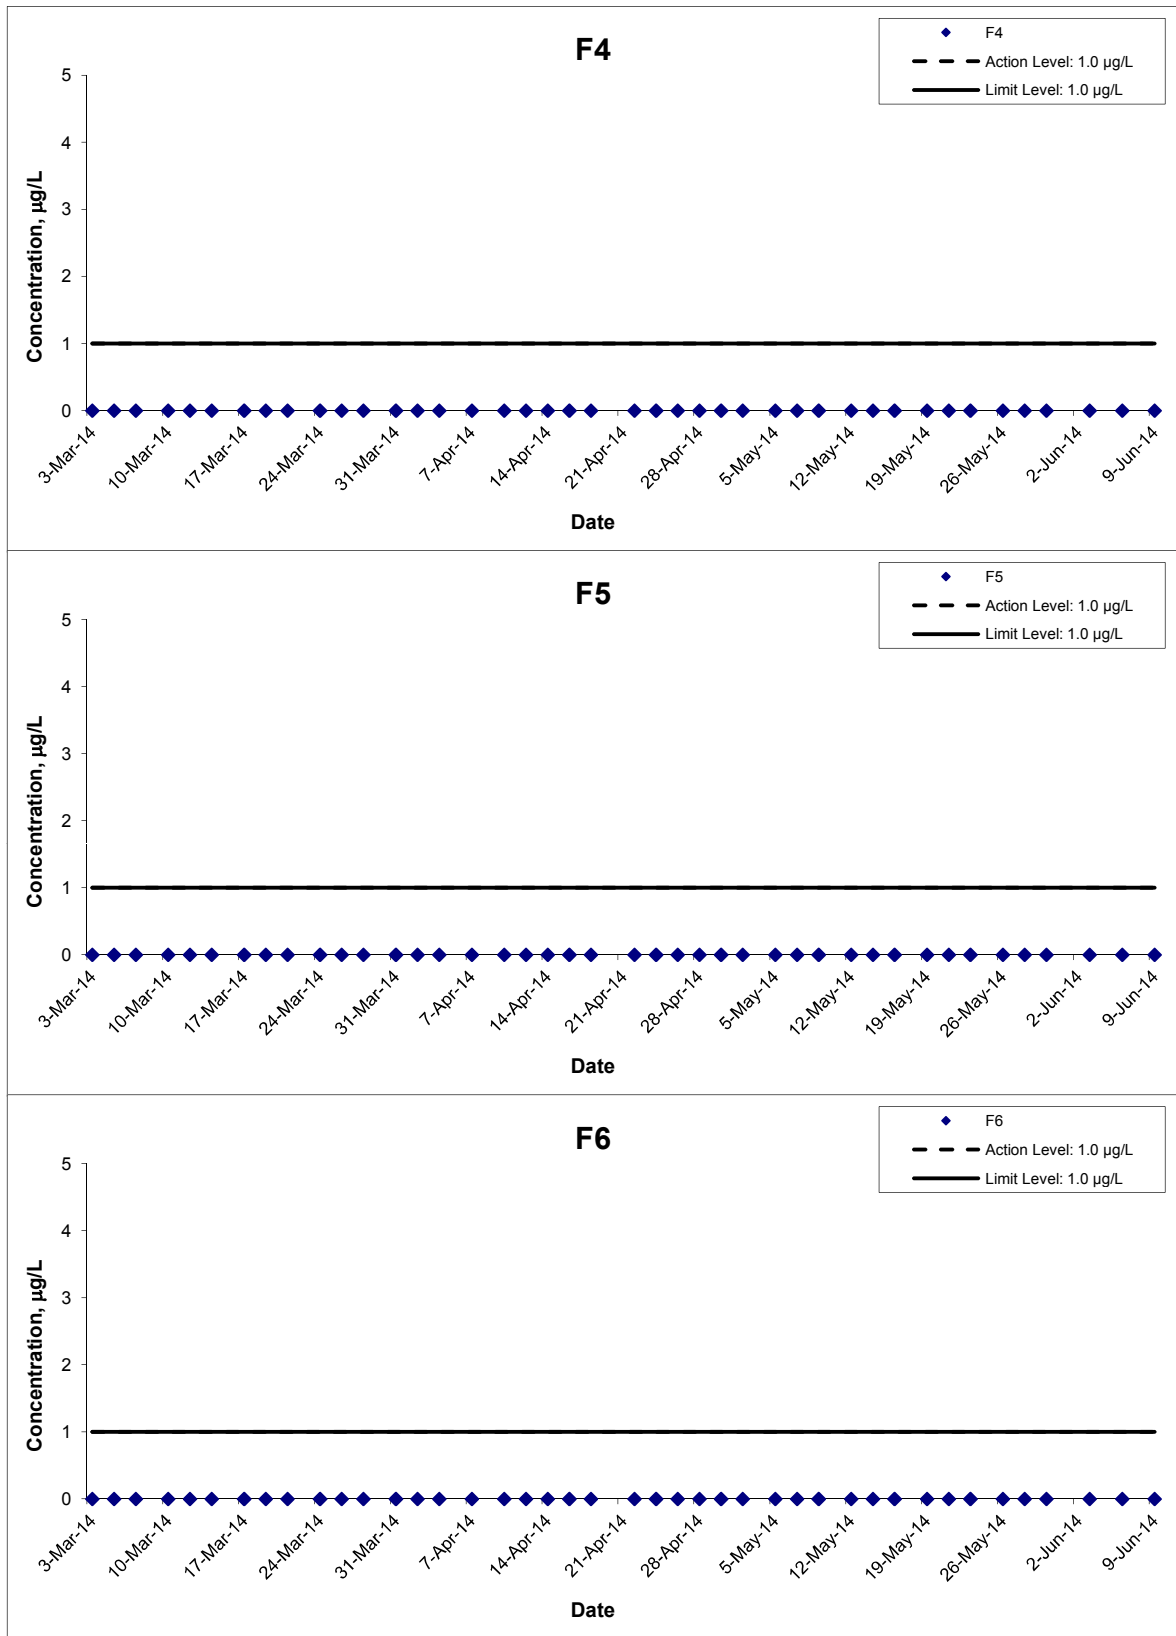
Lead (Depth-averaged) at Mid-Ebb Tide

Remarks: The graphical point at zero concentration is presented as <1µg/L
